Diagnostic Sheet

Noise from the front suspensions while maneuvering

DATE: April 10, 2025

MODELS: Ghibi (M157), Levante (M161) and Quattroporte (M156) (All MY)

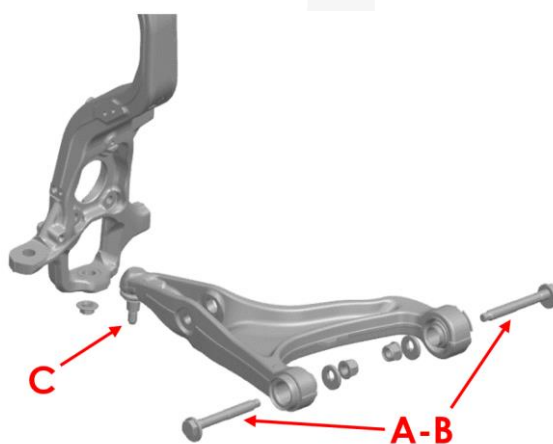
Fig. 1

- Re-install the two bushings fasteners (A and B in fig.1) of the arm to the chassis and the ball joint head (C in fig.1):

A-B) Bushings of the arm to the chassis: The operation must be performed with the vehicle in normal driving condition (wheels on the ground vehicle NOT lifted); loosen by 360° and retighten to the prescribed torque:

- M161 – LEVANTE = 265[Nm].
- M15x – GHIBLI e QUATTROPORTE = 140[Nm].

C) Ball joint to upright: Loosen by 360° and retighten to the prescribed torque:

- M161 – LEVANTE = 70[Nm].
- M15x – GHIBLI e QUATTROPORTE = 70[Nm].
