**Diagnostic Sheet**

# Grecale: Air Suspension System Diagnosis

DATE: April 15, 2025

- M182 Grecale (All MY)

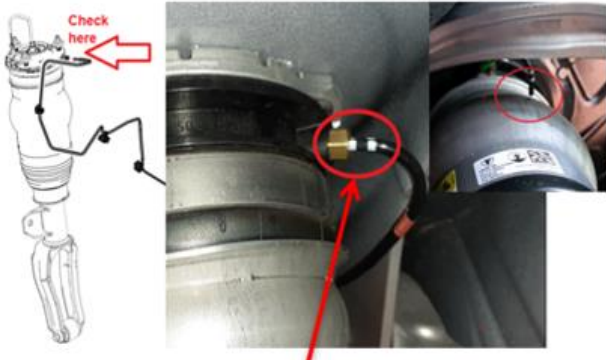
Example of incorrect installation of air suspension system pipes on front axle

The insertion of the pipes into the fittings is correct if only the innermost reference marking (concerning the pipe) is visible (see point B in the pictures above).

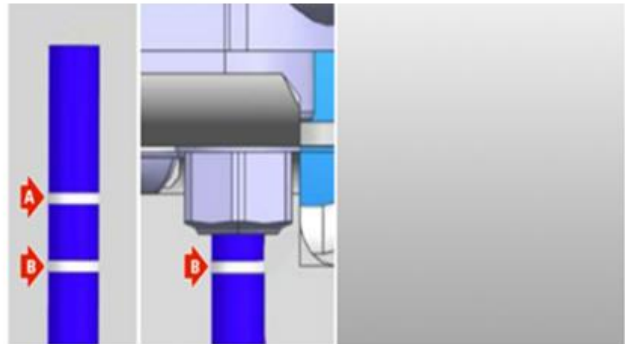
Example of correct installation to be secured in the car (points A and B)

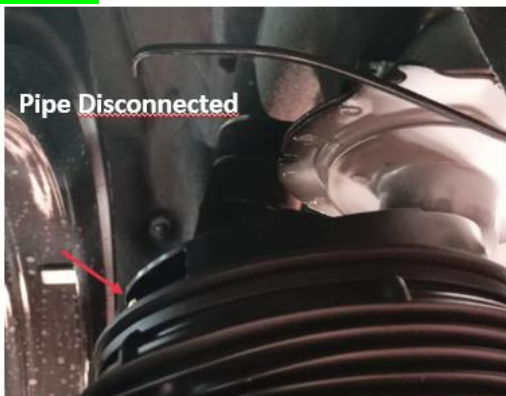
Example of incorrect installation of air suspension system lines on rear axle

The insertion of the pipes into the fittings is correct if only the outermost reference marking (concerning the pipe) is visible.

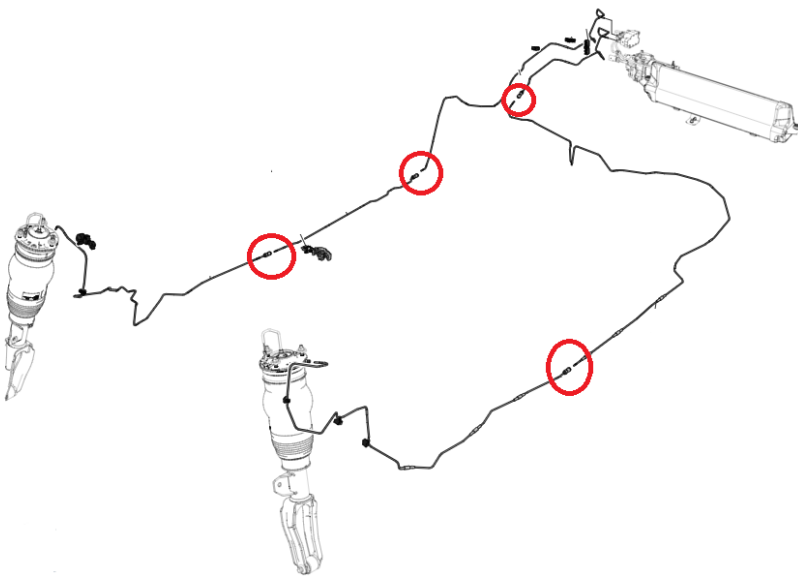
#### Grecale ICE/MHEV pipe junction area

The insertion of the pipes into the fittings is correct if only the outermost reference marking (concerning the pipe) is visible.

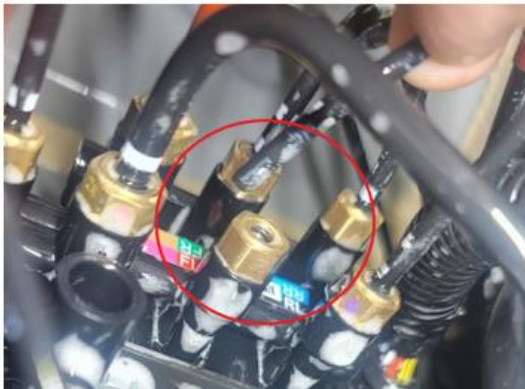
Check pipes on valve block for disconnected and/or incorrectly installed lines

The insertion of the pipes into the fittings is correct if only the outermost reference marking (concerning the pipe) is visible.

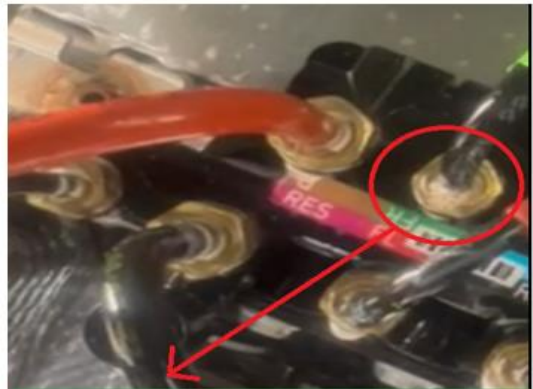
Use a leak detector to detect potential air leaks in the system

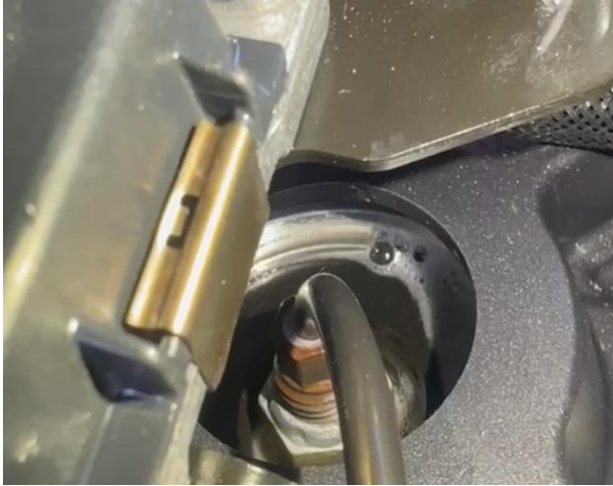
## Area 5 - Shock absorber top mount upper part check

It is normal for bubbles to form in the zone shown in the picture above because the liquid slowly replaces the air in the top mount seat (releasing bubbles at a low frequency compatible with the progressive filling of the seat).

Refer to the image above and the videos attached to this bulletin for cases of "Confirmed leaks" and "Normal operation" (in which case bubbles can still be observed but do not indicate an objective problem).

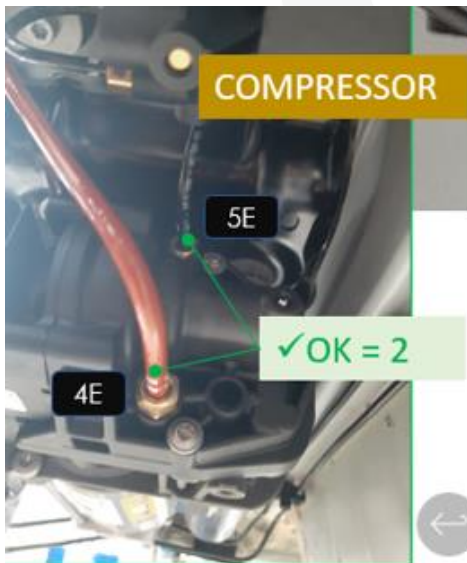
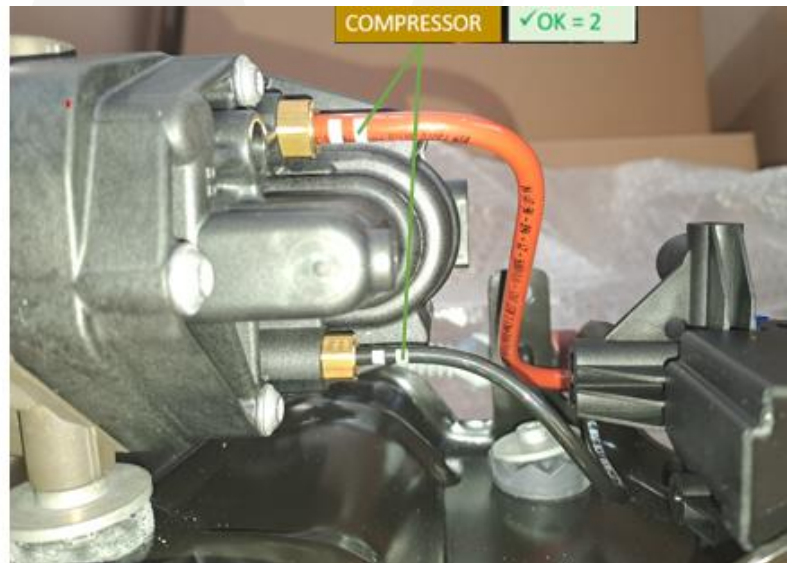
## Area 6 - Compressor

Check all the compressor connections for leaks.

IMPORTANT NOTE: Only in this case, the insertion of the pipes into the compressor connections is correct if two reference markings are visible.
