## Creaking or Ticking Noise Near Panoramic Roof Frame In The Area Of The Roller Sunblind

Topic number	LI77.21-P-079102
Version	1
Function group	77.21 - Panoramic roof
Date	4/21/25
Validity	C167 with panoramic roof (SA code 413) up to production date 18.12.2024
Reason for change

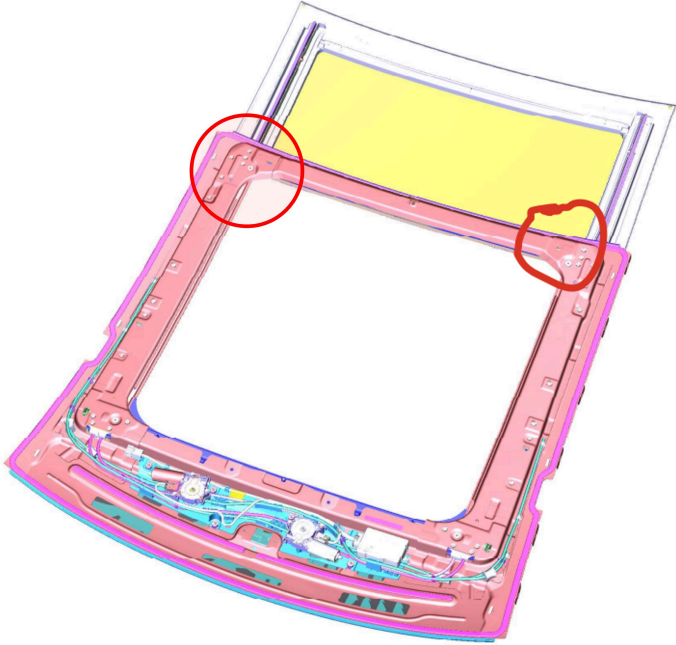
Attachments	
File	Description
<a href="#">Bild_1.jpg</a>

Creaking or ticking noise during driving operation - in particular in the event of stronger body stimuli such as on rough roads - from the left and/or right rear area (near the roller sunblind bearings) of the panoramic roof frame.

Relative movement of the contact areas of the rear crossmember to the side metal component parts of the panoramic roof frame (picture\_1)
