M274 Check engine light, P052E71 Crankcase ventilation valve

Topic number	LI01.20-P-076894
Version	8
Function group	01.20 - Crankcase ventilation, cylinder head cover
Date	4/15/25
Validity	Passenger car with engine M274
Reason for change	Addition of operation codes

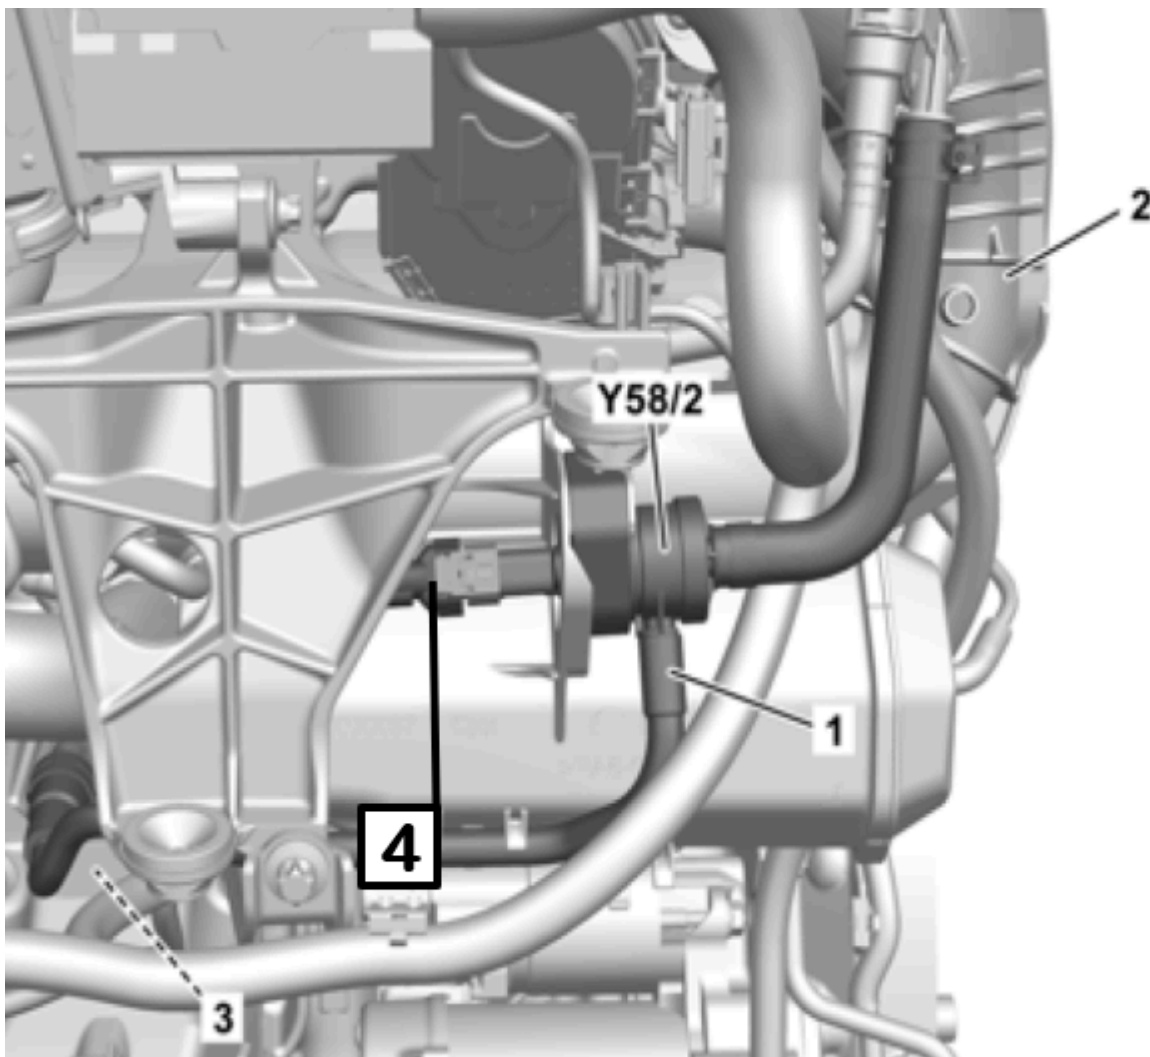
Fault code stored in N3/10 control unit- P052E71 – Positive Crankcase Ventilation Regulator Valve Performance: The valve for crankcase ventilation has a malfunction

The partial-load ventilation valve (a part of the intake line assembly) may not work as intended.

- 1- Perform software update for N3/10 Engine control unit.
- 2- Remove upper engine cover.
- 3- Unclip ME-SFI control unit (N3/10) with bracket and place to one side with connected lines (see AR07.08-P-7013M-RD).
- 4- Release and disconnect electrical connector (4) of partial-load operation crankcase ventilation valve (Y58/2).
- 5- Fit cap A094 545 50 03 on electrical connector (4) of engine wiring harness partial load operation crankcase ventilation valve (Y58/2) and ensure correct seating on plug of electrical connector (4).

6- Strap down electrical line (4) of partial load operation crankcase ventilation system valve (Y58/2) at wiring harness. Ensure that electrical line (4) is routed free of tension.
