# Service Bulletin

Bulletin No.: PIE0822

**Subject:** Engineering Information - (EI Lite)-(Pictures ONLY) for Pre-Delivery Inspection (PDI) and Customer Vehicle Issues Up to 500 Miles. Using the CSMT App do Field Product Reporting (FPR), Please Submit a Report for the Following Issues: Paint Issues or Damage (EXCEPT for Transportation), Moldings, Appliques, Emblems Loose, Warped, Crooked or Missing / Weatherstrips Misaligned, Mis-formed / Sheet Metal and/or Trim Panels Misaligned / Interior Trim Loose, Crooked, Missing / Seats, Seat Trim

Brand:	Model:	Model Year:		Breakpoint:		Engine:	Transmission:
		from	to	from	to		
Cadillac	OPTIQ	2025	2025	—	—	—	—

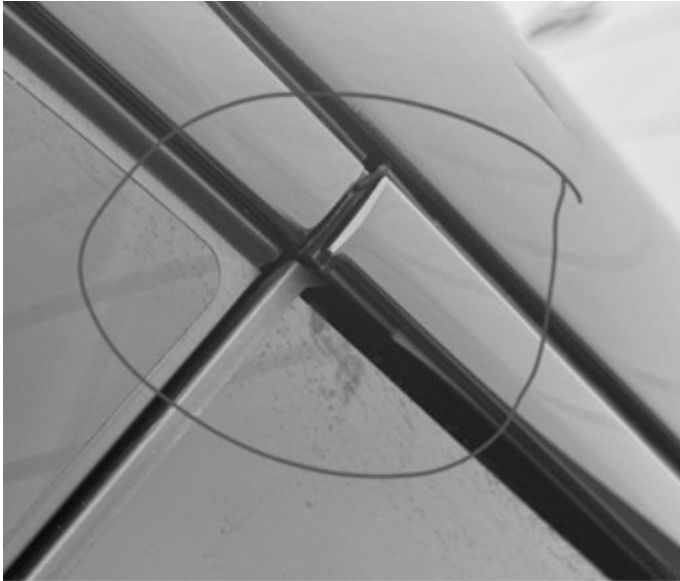
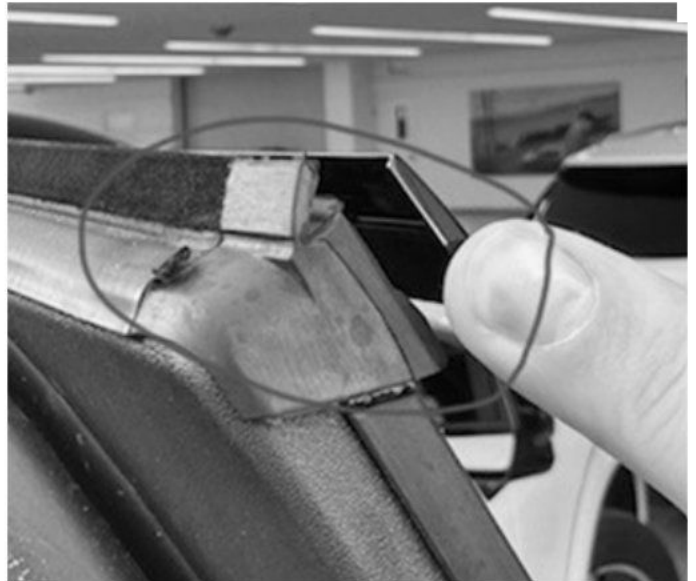
6850471

1. Shown in the picture above are examples of the entire area of the vehicle showing the location of the issue/part on the vehicle.

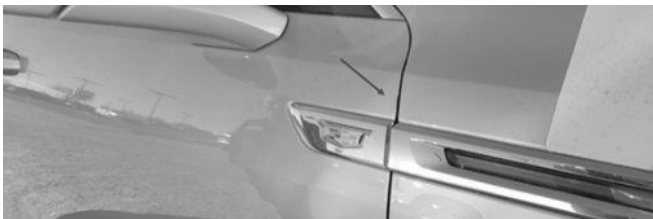
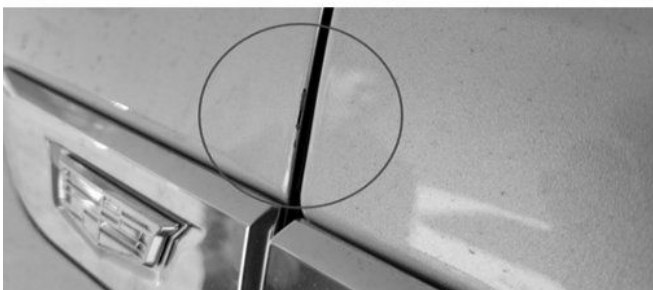
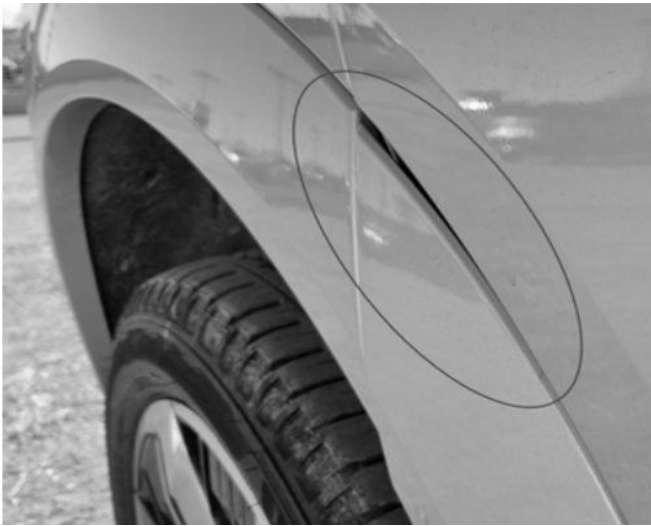
6850473

2. Shown in the pictures above are examples of clear close-up pictures to better show the detail of the issue/part.

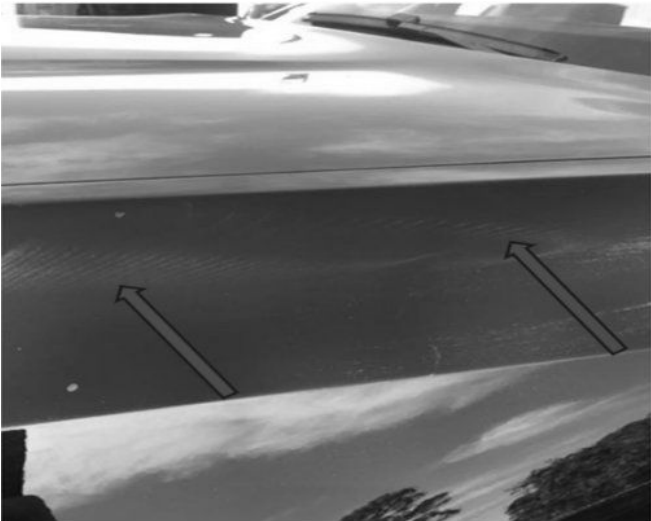
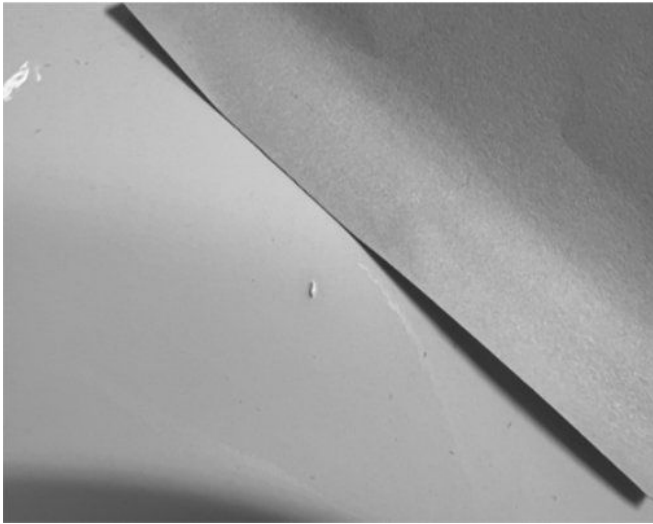
6850534

3. Shown in the pictures above are examples of paint issue. When reporting paint concerns, please take wide shot of the vehicle to help orientate the location and a close-up to identify the issue.
