## STAR ONLINE PUBLICATION

**Case Number:** S2523000033

**Symptom/Vehicle Issue:** Door Window Fitment, Check, And Inspection.

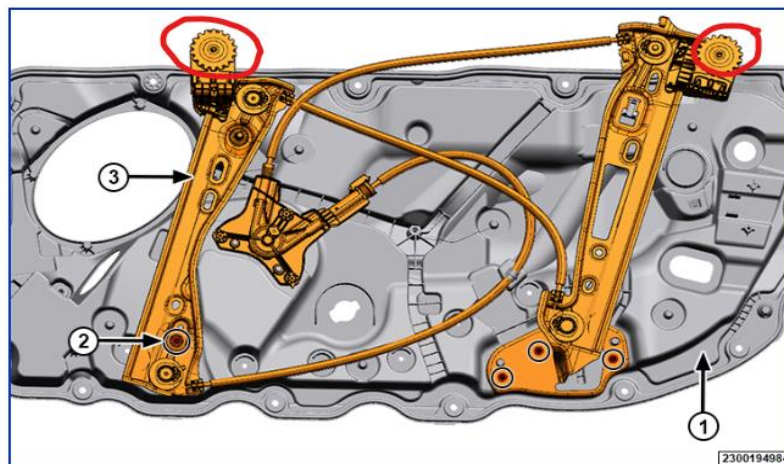
**Customer Complaint/Technician Observation:** Door glass that is not fully engaged into the header seals or has an irregular gap at the header or to the B pillar. If a fitment issue is verified, review the below information in addition to Service Library Service Information.

Star Wheel Location.  
Trim Panel Removed For Visibility.

1. Remove outer belt molding on suspect door. Refer to 23 - Body / Doors - Front / MOLDING / Removal and Installation, Outer Belt Molding.
2. Close door and ensure glass is in full up position. You should see smart UP function enabled.
3. In this position, access the two star wheels inside the door with the flat Mopar wrench required. **Note: using the tool- the door panels do not need to be removed.**
4. Loosen star wheels.

5. Position suction cup to glass to have a secure handle to move up/down and fore/aft.
6. Move glass up until both mirror flag and B pillar glass edge is engaged into the channel.
7. Move glass in fore/aft until you meet a uniform gap of 7.5+/-1mm to the B pillar.
8. Secure the star wheels using the Mopar wrench to hold the glass position.  
Tighten the star wheels to 11NM.
