# Service Bulletin

Bulletin No.: PIE0823

**Subject:** Engineering Information - (EI Lite) - (Pictures ONLY) Lower Fascia and/or Lower Grille Tabs Not Engaged and/or Warped

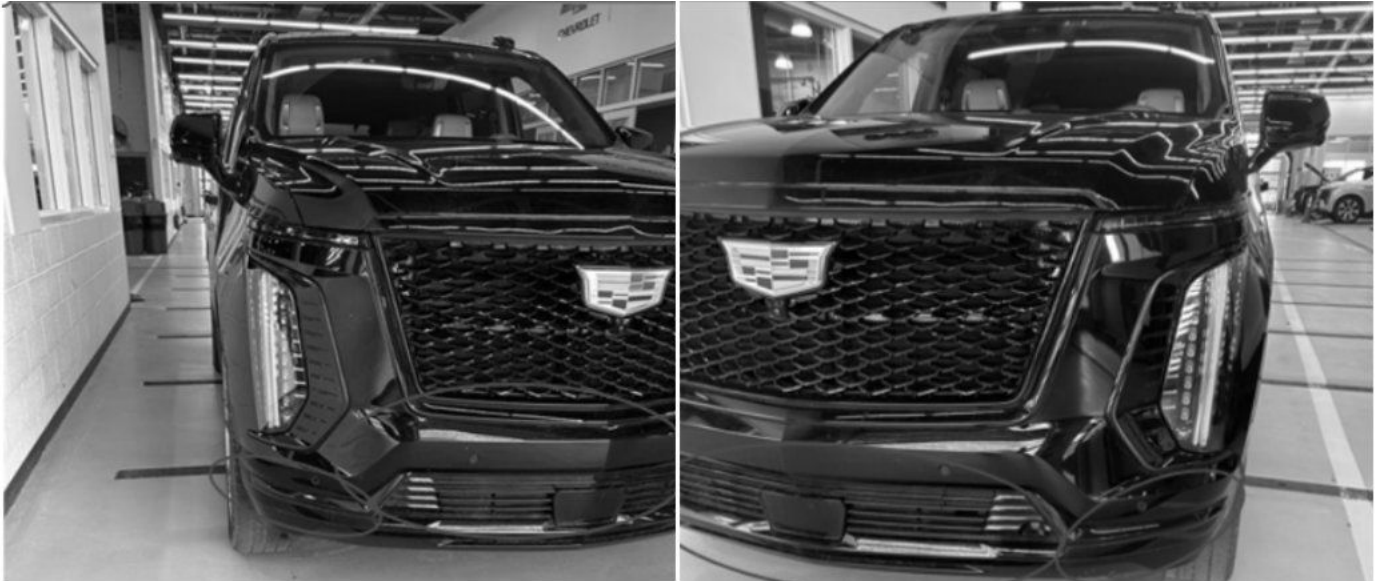
6873133

1. Take a picture of the entire area of the vehicle showing the location of the issue area.

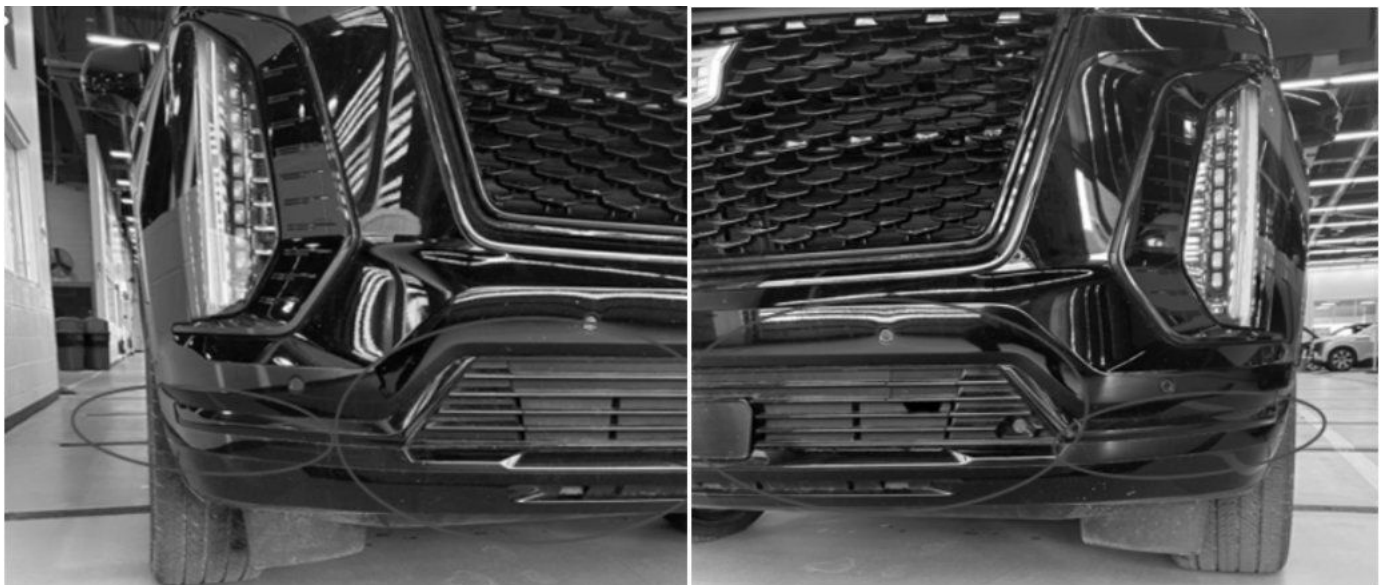
6873151

2. Take a clear close-up picture of the issue area
