Service Bulletin

Bulletin No.: 13-08-116-001K

Subject: Aftermarket ALDL or DLC Interface Devices Causing Multiple Issues
Models: 2026 and Prior GM Passenger Cars and Trucks (including BrightDrop)
Attention: This bulletin also applies to any of the above models that may be Export from North America vehicles.

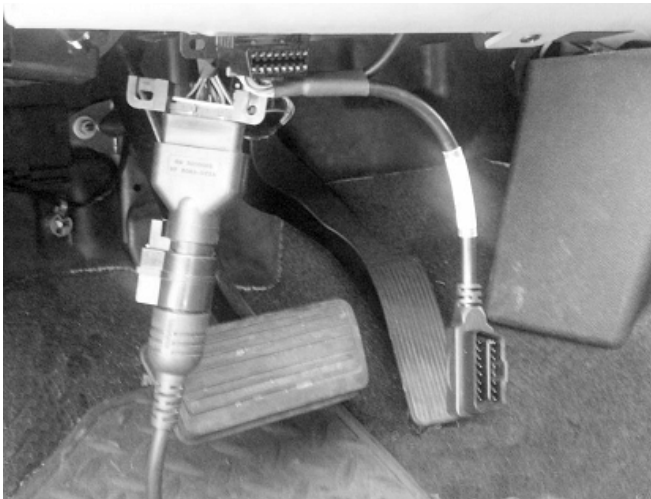
Device W/Secondary DLC Connector

This device has another DLC connector on it. The rest of the harness along with the device can be placed out of sight hidden from the technician, who may not notice the diagnostic connector is not in the factory location.
