Service Bulletin

Bulletin No.: 23-NA-115

Subject: Ticking, Tapping or Snapping Noise from Engine - 5.5L RPO LT6 Realign Camshaft Caps as Required

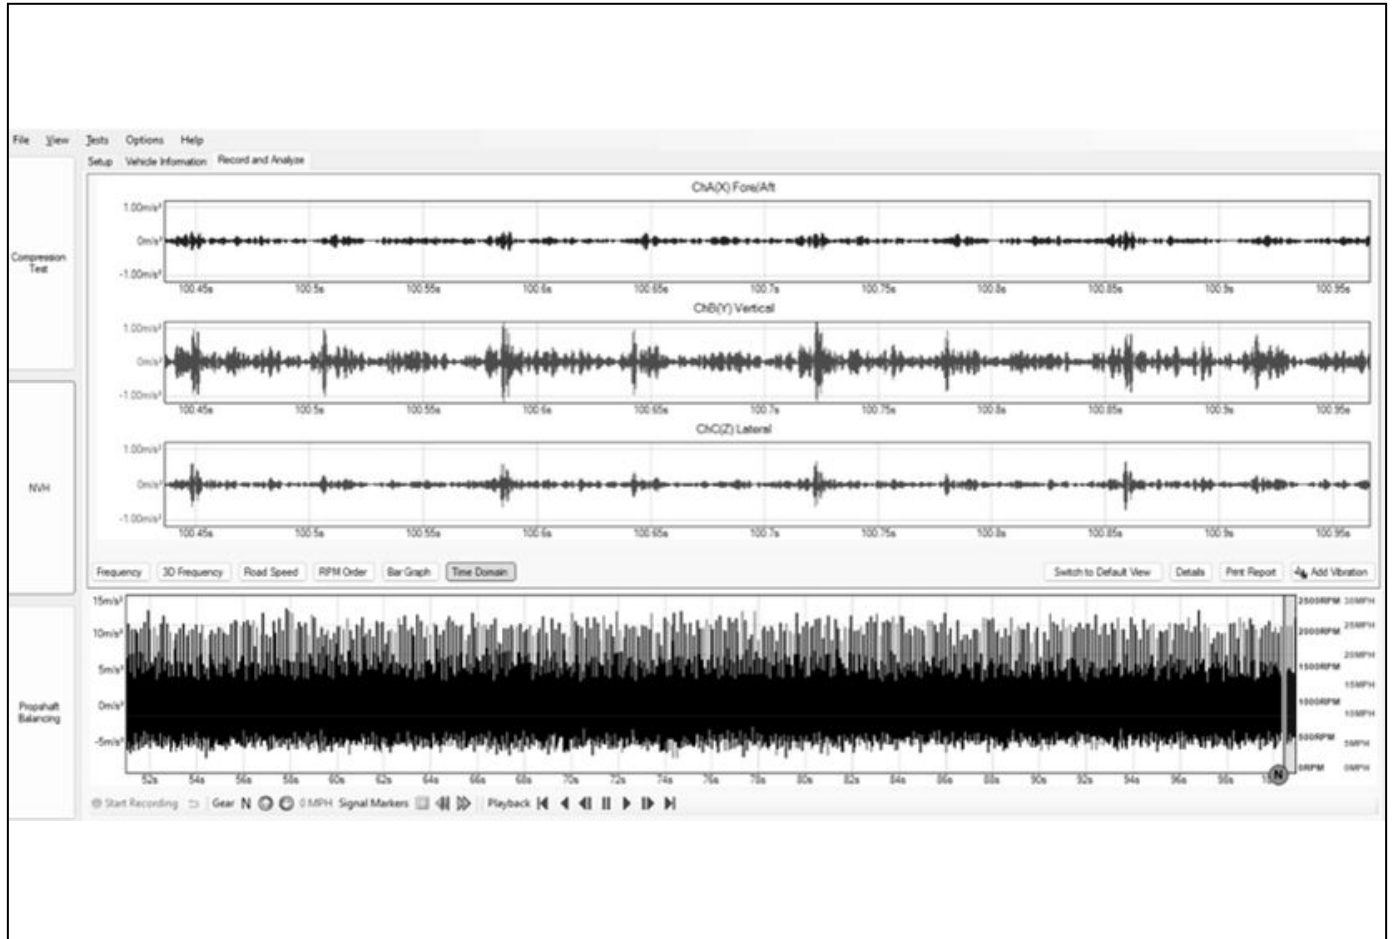
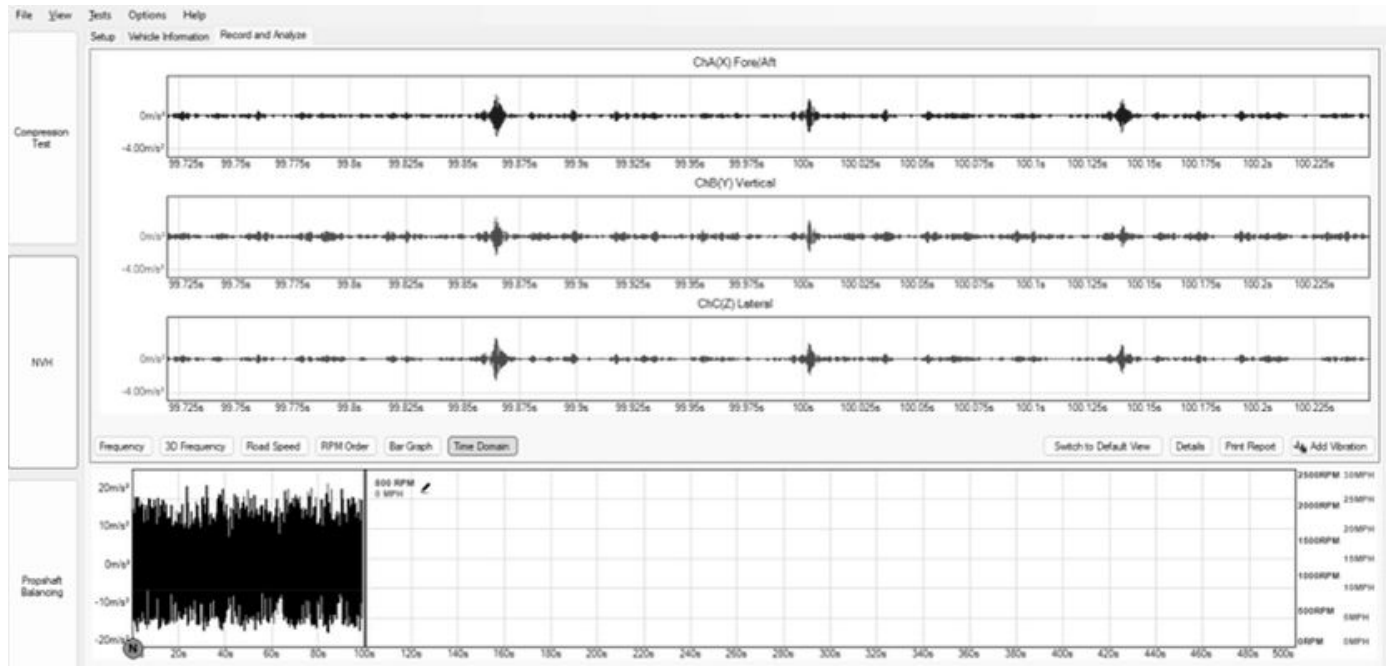
6374935

Examples of Tick:

Once it is determined which bank the noise is coming from, it will be necessary to follow the service procedure below to adjust the camshaft cap torque.
