Service Bulletin

Bulletin No.: 24-NA-021

Subject: Information on Malfunction Indicator Lamp (MIL) Illuminated with Any Combination of DTCs P0521, P06DD and/or P06DE Setting

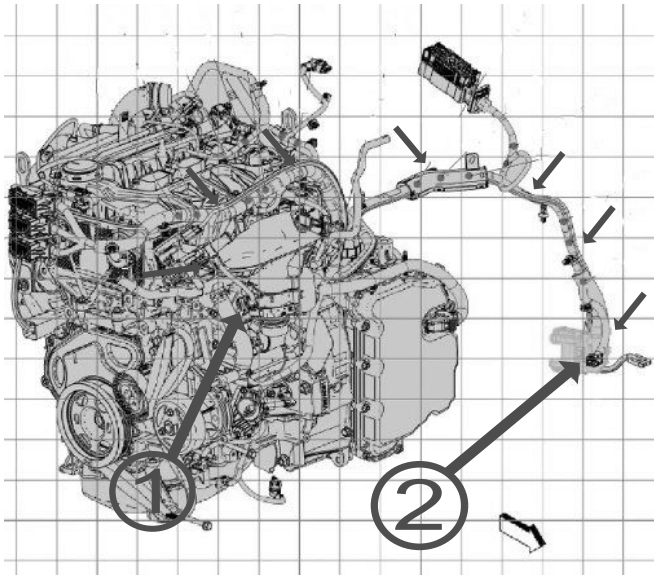
6374708

1. Remove the engine oil pressure control solenoid valve electrical connector and inspect for proper terminal tensions, crimps, and locks.
2. Test for 10 to 30 Ω between the test points.
 - Control terminal 2/B & Ignition terminal 1/A of the engine oil pressure control solenoid valve.
3. If within range, inspect the solenoid valve for signs of debris.
 - ⇒ If no debris are found and the concern is not isolated to the engine oil pressure control solenoid valve, refer to *Engine Oil Pressure Sensor Replacement* in SI to **inspect** the engine oil pressure sensor.
4. Disconnect the engine oil pressure sensor and test for less than 10 Ω between the low reference circuit 580 terminal 2 and ECM connector X1-terminal 23.

- If the resistance is within range, tap and manipulate the engine wiring harness between the oil pressure sensor (1) and X125 (2), while monitoring for a change in the resistance reading.
- If the concern is not isolated to the engine wiring harness, reinstall all components and perform the Engine Oil Pump Screening Test.

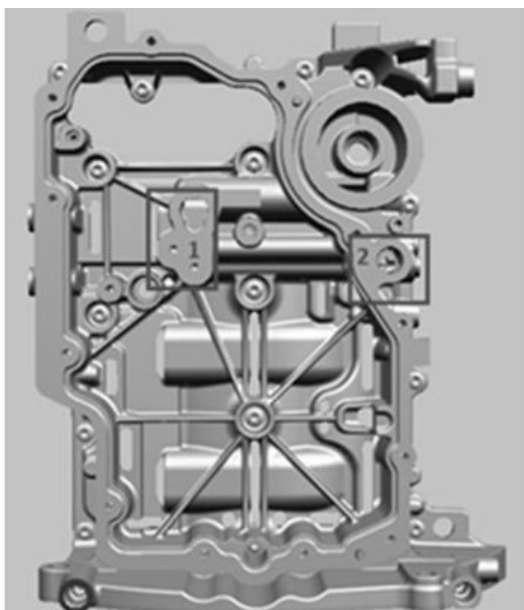
6379894

Caution: If oil pump replacement is needed, ensure the three oil pump oil holes (Area 1) and OCV mounting hole (Area 2) are free of debris BEFORE installing the oil pump and OCV. If debris is found, remove with a lint-free cloth or brush that will not scratch the surface.
