E-Series	Model Description
U10	X2 Sports Activity Coupe
U11	X1 Sports Activity Vehicle

Service Information Bulletin

B41 02 25

POPPING SOUND FROM THE BOTTOM OF THE C-PILLAR

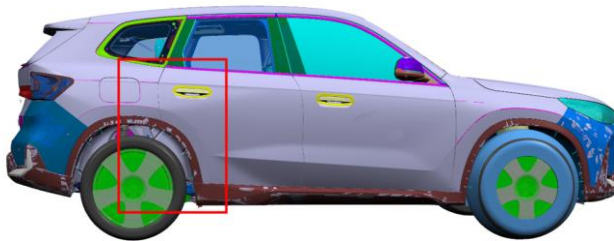
While driving on a smooth and/or uneven road, a “popping” sound is heard from the bottom of the C-pillar area. This can occur on one and/or both sides on the vehicle C-pillars.

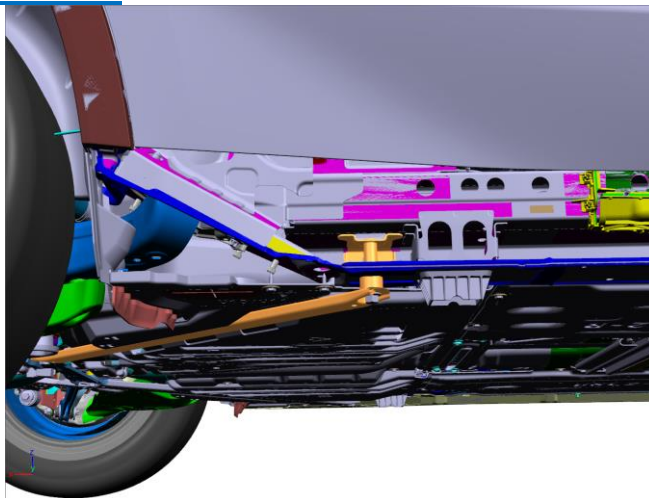
Movement within the mounting bracket **(highlighted in orange)** that secures the torsion strut to the vehicle's body.

Apply adhesive to the top of the mounting bracket that secures the torsion strut to the vehicle's body.

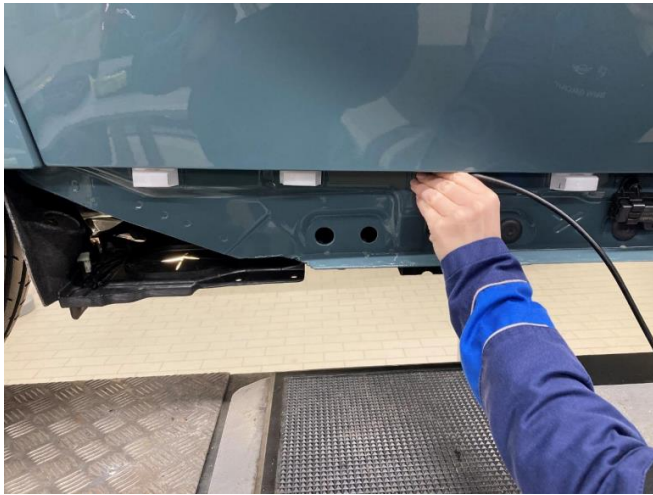
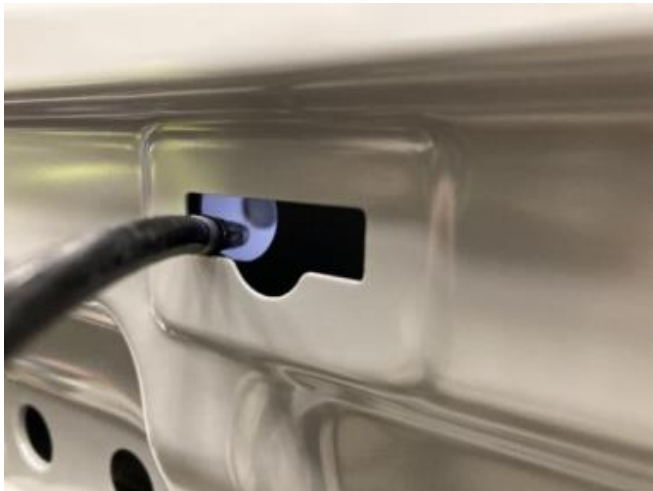
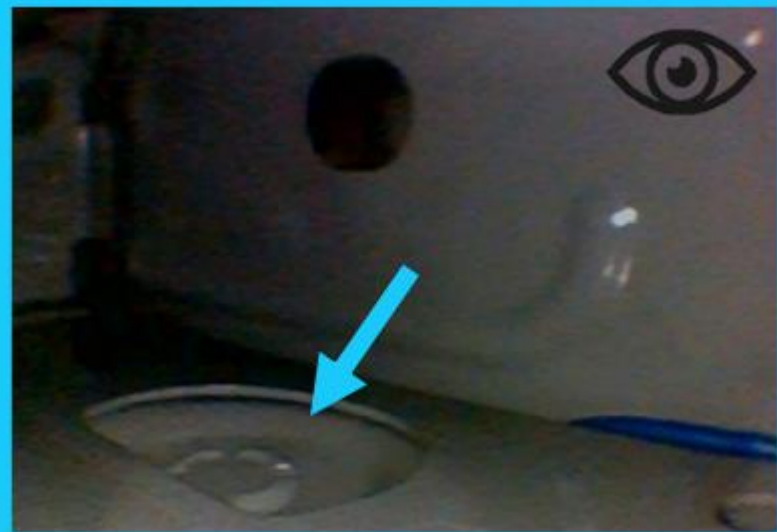
Note: See photos below on what to look for when using the borescope.
