SIB 61 02 25

2025-04-18

DELIVERY STOP: REPLACE 12V POWER CONTROL UNIT (PCU)

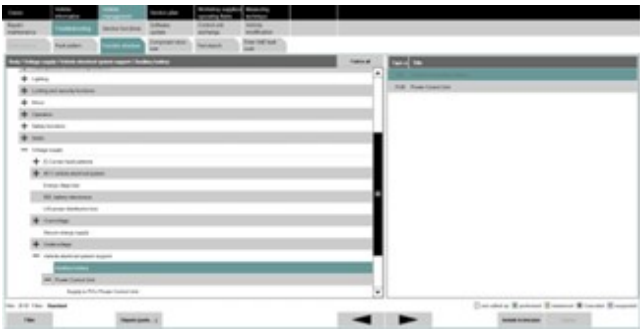
3. Next, evaluate the additional Li-Ion AUX battery with ISTA test module “**ABL-DIT-AT6121\_DSSLTO\_EARS**”, via the path below.

- Vehicle management
- Troubleshooting
- Function Structure
- Body
- Voltage Supply
- Vehicle electrical system support
- Auxiliary battery
- Lithium-ion auxiliary battery

4. When the Li-Ion AUX battery cannot be recovered or is determined to be defective, replace it following repair instruction “**Replacing 12-V lithium-ion auxiliary battery - registering with battery replacement - 61 21 086 | REP-REP-P-6121086-G07\_EMARS - V.4**”.
