SIB 51 07 25
TRUNK LID TRIM PANEL LOOSE

2025-04-17

E-Series	Model Description
G23	4 Series Convertible
G83	M4 Convertible

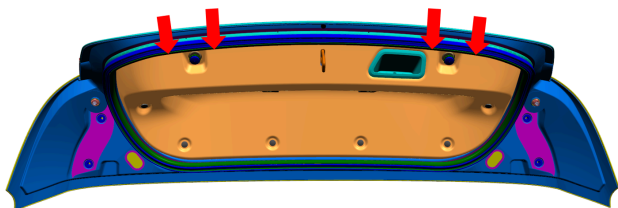
The trunk lid trim panel may partially come loose/dangle (red arrows show the most prevalent areas).

Unfavorable tolerance of the mounting clips that secure the trim panel to the trunk lid.

Replace the three clips that secure the trim panel to the trunk lid with the new updated clips.

1. Verify the customer's concern.
2. Replace the three clips that secure the trim panel to the trunk lid following repair instructions listed in ISTA/AIR 51 49 000.
