April 18, 2025

Warranty Extension: 2017 Accord 6AT Torque Converter – DTC P0741 Stored

Supersedes 23-076, dated August 31, 2023, to revise the information highlighted in yellow.

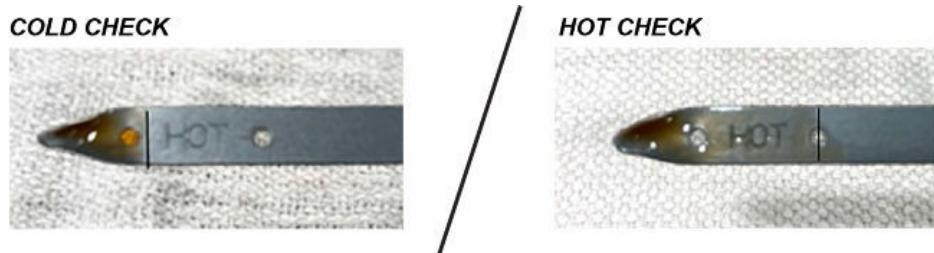
Automatic Transmission Fluid capacity

4.5L (4.8 US qt) with torque converter replacement

1. Check the ATF level.
