Warranty Extension: 2017–19 Multi Model 6AT Torque Converter – DTC P0741 StoredSupersedes 23-078, dated November 29, 2023, to update the information highlighted in **yellow**.**AFFECTED VEHICLES**

Year	Model	Trim Level	VIN Range
2017–18	Pilot	ALL w/ 6AT	Check iN VIN status for eligibility
2017–19	Ridgeline

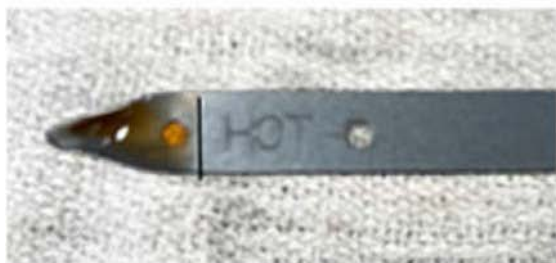
COLD CHECK

- Overfilled transmission level can cause an overheat condition.
 - Check the ATF level when the fluid temperature is greater than or equal to **80°C (176°F)**.
 - If the fluid level is checked at a cooler temperature, it will read low or on the bottom dot of the dipstick.
 - If the transmission fluid is filled to the top dot when cold, the transmission will be overfilled, increasing foaming, and contributing to the overheating problem.
2. Check ATF level.
