# Service Bulletin

Bulletin No.: PIE0824

**Subject:** Engineering Information - Information on Fluid Leaking at the Output Seal and/or Front Slip Yoke (Welch Plug Leak)

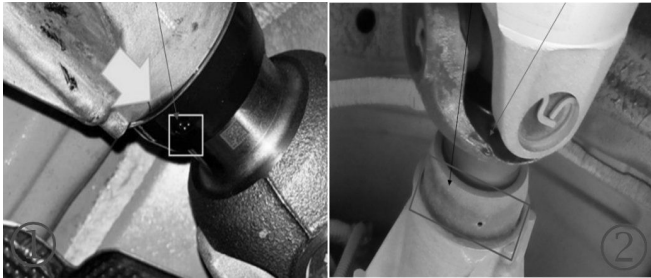
<p style="text-align: right;">6877560</p> <p>Some technicians may comment during inspection that fluid is leaking at the output seal (1) and/or leaking at the front slip yoke (welch plug leak) (2), as shown in the picture above.</p>
<p><b>Cause</b></p>	<p>GM Engineering is attempting to determine the root cause of the above condition. Engineering has a need to gather information on vehicles PRIOR to repair that may exhibit this condition. As a result, this information will be used to "root cause" the customer's concern and develop/validate a field fix.</p>

1. Determine if the leak is coming from the transfer case rear output seal and/or the front slip yoke (welch plug leak) and take a clear picture.
2. If the leak is determined to be coming from the welch plug, follow SI instructions for repair.
3. If the leak is determined to be coming from the transfer case rear output seal, please contact GM engineering for support and for further instructions.
