GROUP	NUMBER
ENGINE ELECTRICAL	25-EE-002H
DATE	MODEL(S)
APRIL 2025	SONATA (DN8/DN8A)

SUBJECT: MULTI-FUSE REPLACEMENT & BLOWER WIRING REPAIR

Description: Certain Sonata (DN8) and Sonata (DN8A) vehicles may experience issues with the air conditioning due to damaged wiring in the engine room junction box. This bulletin provides instructions to replace the multi-fuse, reroute the damaged wiring using the blower wiring kit, and replace the fuse label.

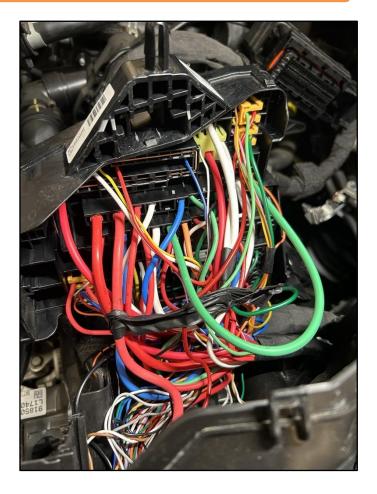
- Verify if the blower fuse and terminals are discolored.
 - If either the blower fuse and/or terminals are discolored, then proceed with the service procedure.
 - If the blower fuse and terminals are <u>NOT</u> discolored then this TSB does <u>NOT</u> apply. Continue with a normal diagnosis.

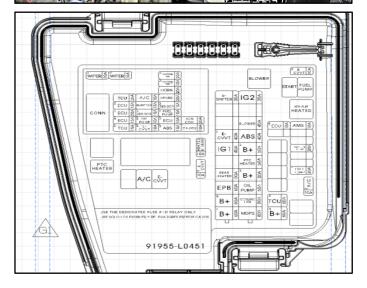
Modified fuses (18980-09910) are replaced with new ones, while reused fuses (18980-09920) remain in place.

Remove the following parts:

- engine room junction box connector
- terminals
- 2 multi-fuse
- band cable (A)
