<b>REFERENCE:</b>	<b>TSB:</b> 08-122-25 REV. A <b>GROUP:</b> 08 - Electrical	<b>Date:</b>	April 23, 2025	<b>REVISION:</b>	08-122-25
<b>VEHICLES AFFECTED:</b>	<b>2022 - 2024 (WL) Jeep Grand Cherokee/Grand Cherokee L</b> This bulletin applies to vehicles equipped with the 2.0L I4 DOHC DI Turbo PHEV Engine (Sales Code ECX).	<b>MARKET APPLICABILITY:</b>			
		<input checked="" type="checkbox"/> NA <input type="checkbox"/> MEA <input type="checkbox"/> SA <input type="checkbox"/> IAP <input type="checkbox"/> EE <input type="checkbox"/> CH			
<b>CUSTOMER SYMPTOM:</b>	<b>Customers must experience a Malfunction Indicator Lamp (MIL) illumination and the vehicle must set the following Diagnostic Trouble Code (DTC):</b> <ul style="list-style-type: none"> <li>B3A11 - A/C Refrigerant Expansion Valve Actuator Control Circuit Performance.</li> </ul> <b>Customer may also comment on the following:</b> <ul style="list-style-type: none"> <li>A/C system blowing warm air.</li> </ul>

This bulletin involves replacing the battery chiller.

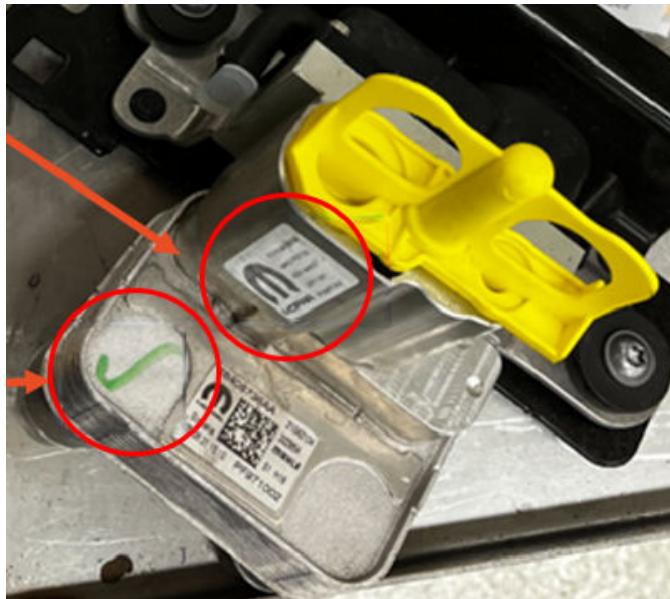
**Fig. 1**

<b>CAUSE:</b>	Supplier quality spill

1. Open the hood and check the chiller for part numbers 68470822AA or 68470822AB, then look for any green check marks [Fig. 1](#).
2. Are there part numbers 68470822AA or 68470822AB and any green check marks on the chiller [Fig. 1](#)?
  - YES >>> Proceed to [Step 3](#).
  - NO >>> This bulletin does not apply. This bulletin does not apply.

Chiller With Green Check Mark And Part Number Location

3. Replace the battery chiller. Refer to the detailed service procedures listed in DealerCONNECT>Service Library>Service Info under: 12 - Electrified Powertrain System / Battery Cooling / Chiller / Removal and Installation.
4. **For model years 2022 and 2023 only**, install wire harness jumper 68510660AA.
5. Clear any DTCs.
6. Fast charge the vehicle and drive for 16 km (10 mi) and confirm DTC is cleared.
