**Technical Service Bulletin (TSB)**  
**Front Door Weather Strip Lip Deformed**

<b>REFERENCE:</b>	<b>TSB:</b> 23-020-25 <b>GROUP:</b> 23 - Body	<b>Date:</b>	April 23, 2025	<b>REVISION:</b>	—
<b>VEHICLES AFFECTED:</b>	<b>2023 - 2024 (GU) Alfa Romeo Stelvio</b> This bulletin applies to vehicles built on or after <b>October 04, 2023 (MDH 1004XX)</b> and on or before <b>July 26, 2024 (MDH 0726XX)</b> .			<b>MARKET APPLICABILITY:</b>	
				<input type="checkbox"/> NA	<input checked="" type="checkbox"/> MEA
				<input type="checkbox"/> SA	<input type="checkbox"/> IAP
				<input checked="" type="checkbox"/> EE	<input type="checkbox"/> CH
<b>CUSTOMER SYMPTOM:</b>	<b>Customers may comment on the following:</b> <ul style="list-style-type: none"> <li>One or both front door weatherstrip door belt moldings are deformed.</li> </ul>				
<b>CAUSE:</b>	Supplier manufacturing issue

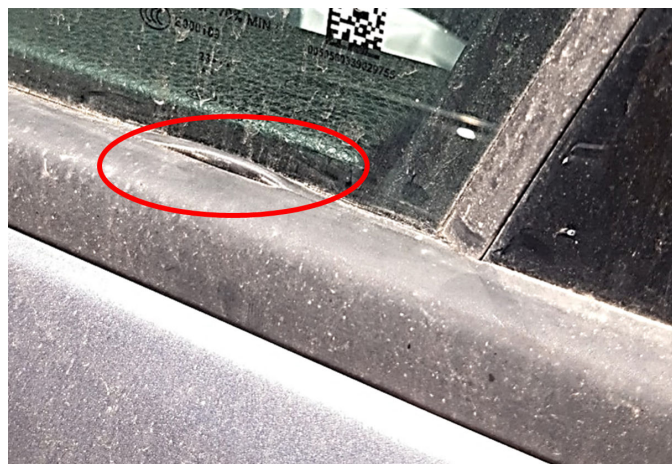
**Fig. 1**

1. Inspect both the left and right front weatherstrip door belt moldings for deformation [Fig. 1](#) and [Fig. 2](#).

Weatherstrip Door Belt Molding Deformation

2. Was either the left or right front weatherstrip door belt moldings deformed [Fig. 1](#) and [Fig. 2](#)?
  - YES >>> Proceed to [Step 3](#).
  - NO >>> This bulletin has been completed. Use Inspect LOP (23-51-16-9M) to close the bulletin.
3. Replace the left or right front door weatherstrip door belt moldings as required. Refer to the detailed service procedures available in DealerCONNECT/Service Library under: Service Info> 23 - Body / Doors - Front / Molding, Door Belt, Outer / Removal and Installation.

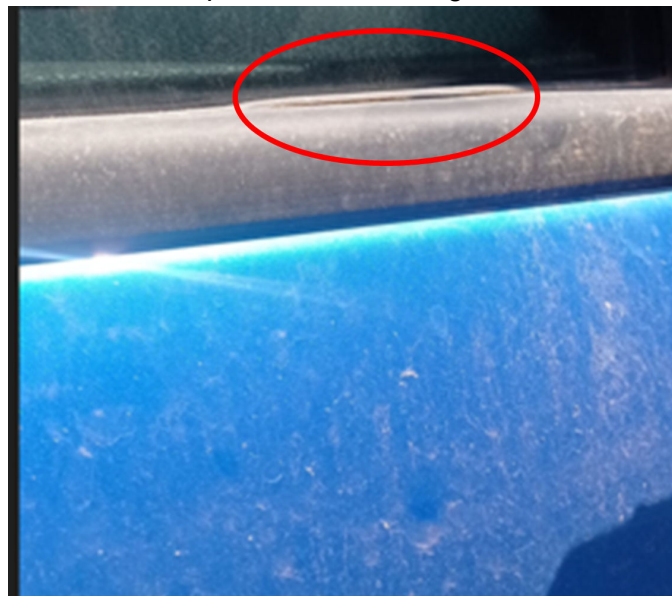
**Fig. 2**

Weatherstrip Door Belt Molding Deformation
