Technical Service Bulletin (TSB)
Liftgate Will Not Properly Open Or Close

REFERENCE:	TSB: 23-021-25 GROUP: 23 - Body	Date:	April 23, 2025	REVISION:	-
VEHICLES AFFECTED:	2024 - 2025 (WS) Jeep Wagoneer /Grand Wagoneer This bulletin applies to vehicles built on or before December 02, 2024 (MDH 1202XX) .	MARKET APPLICABILITY:			
		<input checked="" type="checkbox"/> NA <input type="checkbox"/> MEA <input type="checkbox"/> SA <input type="checkbox"/> IAP <input type="checkbox"/> EE <input type="checkbox"/> CH			
CUSTOMER SYMPTOM:	<p>Customers must experience a Malfunction Indicator Lamp (MIL) illumination and the vehicle must exhibit/set one or more of the following Diagnostic Trouble Codes (DTCs):</p> <ul style="list-style-type: none"> • B197B-29 - Ratchet fork switch- signal invalid. • B197C-29 - Pawl detent switch signal invalid. <p>Customers may also experience the following:</p> <ul style="list-style-type: none"> • Liftgate will not properly open or close. • Possible 'Liftgate Open' warning light on. • Possible 'Liftgate Open' chime sound.

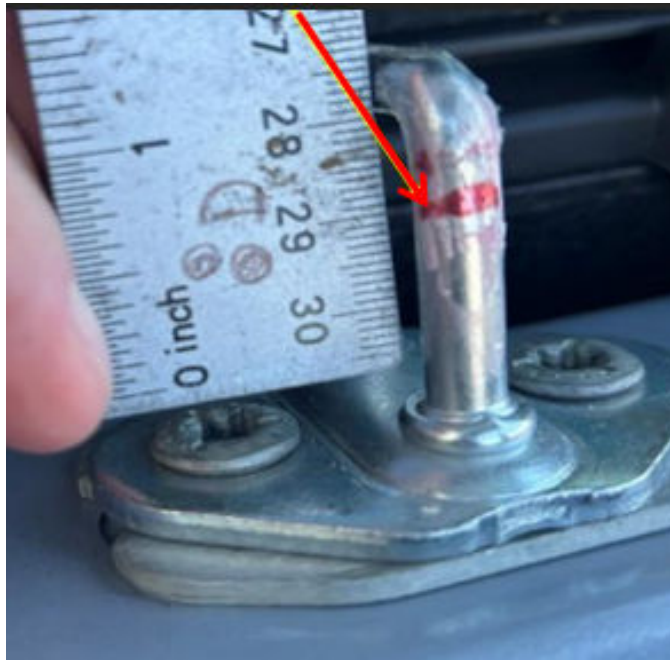
Fig. 2
Striker Spacer Installed

CAUSE:	Design stack-up issue

2. Mark the mounting location of the striker, then remove striker. Refer to the detailed procedures available in DealerCONNECT > Service Library > under: 23 - Body / Decklid/Hatch/Liftgate/Tailgate/Swing Gate / Striker, Liftgate Latch / Removal.
3. Insert the door latch striker spacer underneath the liftgate striker.

4. Install striker using marked reference. Refer to the detailed procedures available in DealerCONNECT > Service Library> under: 23 - Body / Decklid/Hatch/Liftgate/Tailgate/Swing Gate / Striker, Liftgate Latch / Installation. Tighten fasteners to 28 N·m (21 Ft. Lbs) [Fig. 2](#).
