GENERAL MOTORS
DCS 7207
URGENT - DISTRIBUTE IMMEDIATELY

Subject: REVISION: N232427510-01 - Service Update
Software Enhancements for SuperCruise

N232427510 Software Enhancements for SuperCruise

Revision: 01

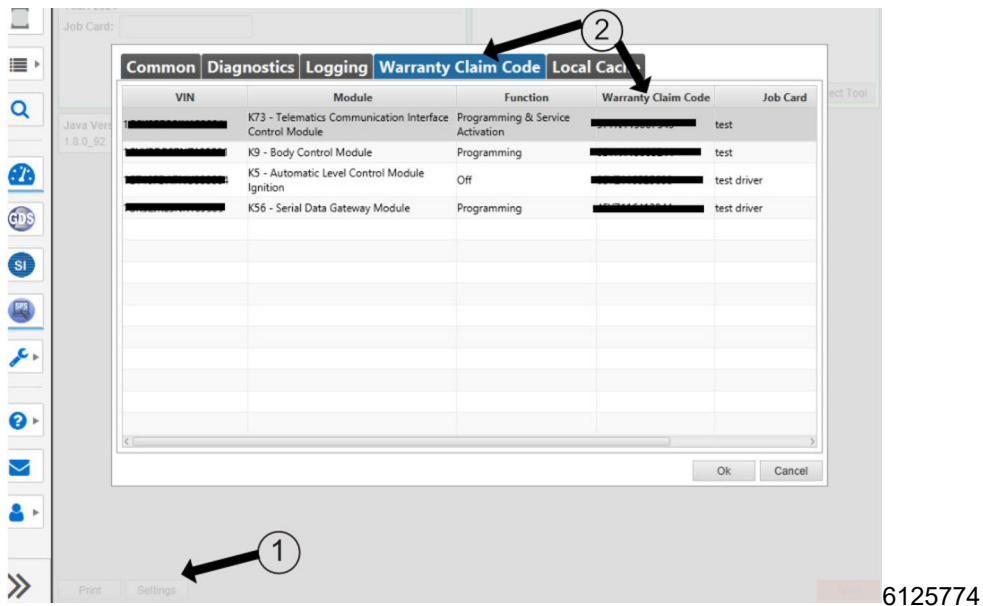
Warranty Claim Code Information Retrieval

If the Warranty Claim Code was not recorded on the Job Card, the code can be retrieved in the SPS2 system as follows:

1. Open TLC on the computer used to program the vehicle.
2. Select and start SPS2.
3. Select Settings (1).
4. Select the Warranty Claim Code tab (2).

The VIN, Warranty Claim Code and Date/Time will be listed on a roster of recent programming events. If the code is retrievable, dealers should resubmit the transaction making sure to include the code in the SPS Warranty Claim Code field.

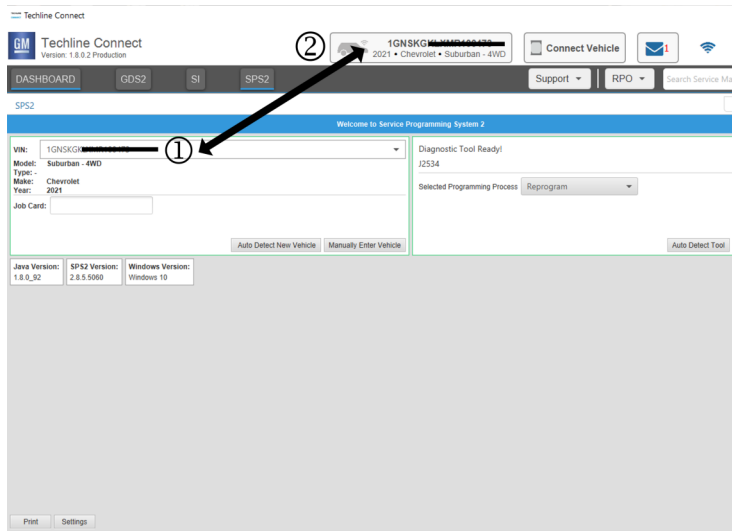
5743643

Caution: Be sure the VIN selected in the drop down menu (1) is the same as the vehicle connected (2) before beginning programming.

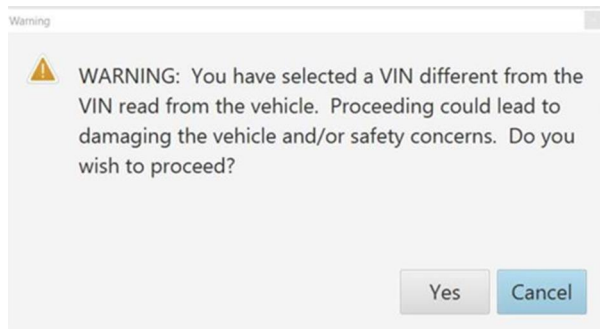
5877000

Important: If the vehicle VIN DOES NOT match, the message below will be shown.

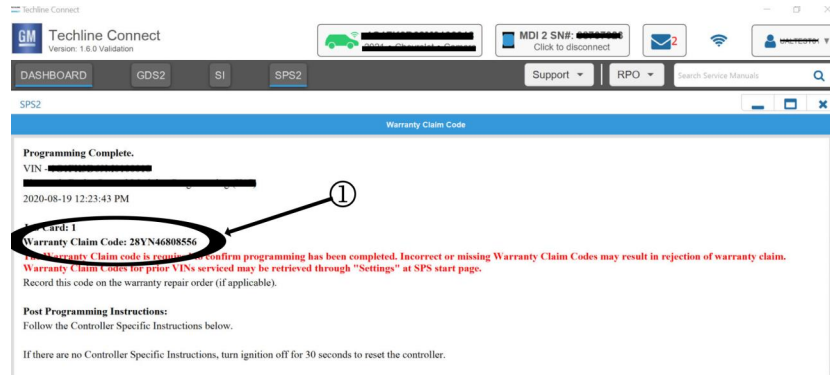
5644478

Note: The screenshot above is an example of module programming and may not be indicative of the specific module that is being programmed. Module selection and VIN information have been blacked out.

Important: To avoid warranty transaction rejections, you **MUST** record the warranty claim code provided on the Warranty Claim Code (WCC) screen shown above on the job card. Refer to callout 1 above for the location of the WCC on the screen.

2. Record SPS Warranty Claim Code on job card for warranty transaction submission.
