GROUP	MODEL
<b>Voluntary Service Campaign</b>	<b>2024-2025MY Sorento (MQ4a)</b>
NUMBER	DATE
<b>SC339</b>	<b>April 2025</b>

### **RIGHT-HAND 2<sup>ND</sup>-ROW SEAT WIRING HARNESS INSPECTION/REPLACEMENT AND REROUTE (SC339)**

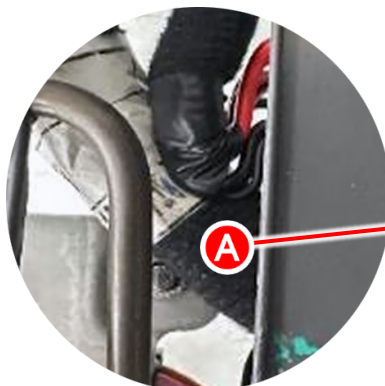
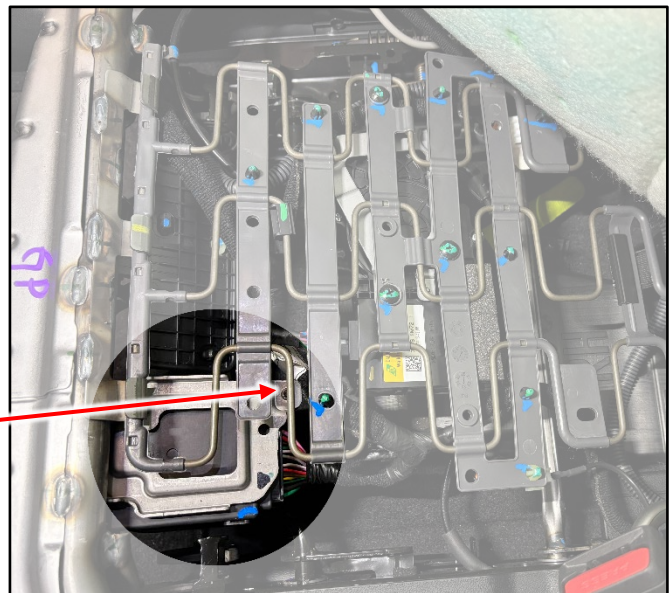
3. Look under the seat cushion foam to locate the heater ECU bracket and the wiring harness for inspection (A).

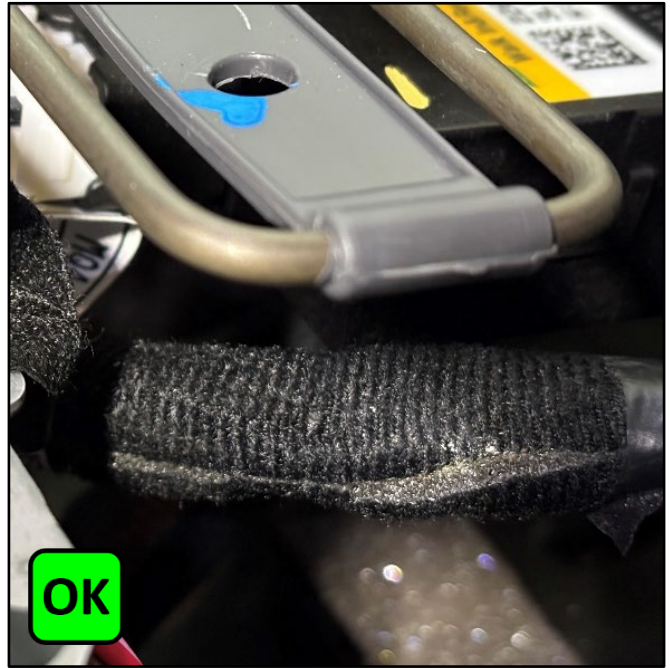
**OK Condition** - Proceed to the 'Repair Procedure' (Wire Harness Rerouting & Retaining Clip Cutting) on page 5.

- No insulation damage is present or minimal insulation cloth rubbing is visible (**Wiring is not visible**).

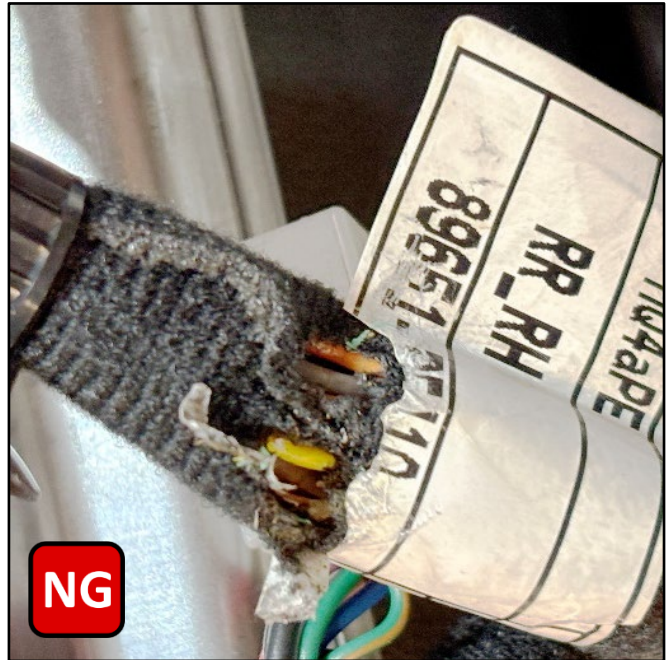
**NG Condition** - Proceed to replace the seat wire harness 'Replacement Procedure' (Seat Wiring Harness) on page 7.

- Torn or cut through insulation cloth covering (**Wiring is visible**) or/and damaged wires/copper exposed.
