**SERVICE BULLETIN**

**APPLICABILITY:** 2022-25MY WRX

**NUMBER:** 05-92-25R

**SUBJECT:** Click/Crack Sound from Front  
Lower Control Arm

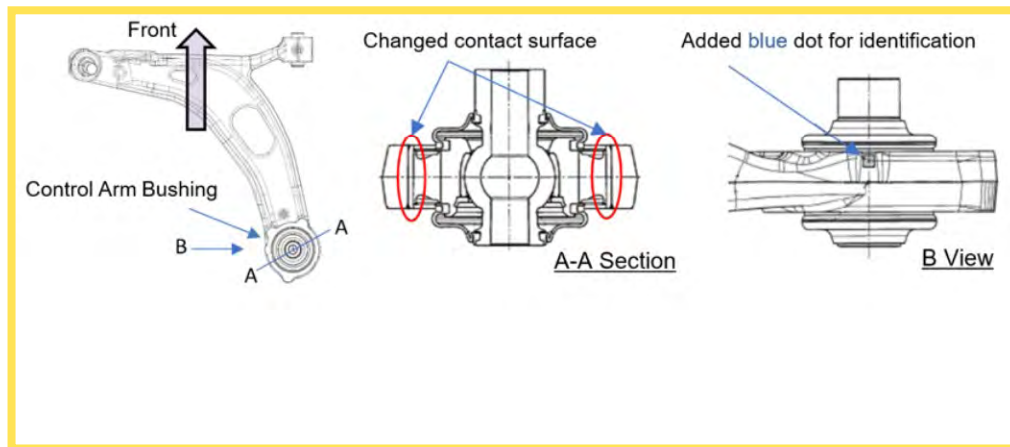
**DESCRIPTION OF DESIGN CHANGE:**

This bulletin announces the design change made to the front lower control arms developed to address cases of a click or cracking type sound heard when moving forward or backward at low speed with the steering wheel fully turned position. This is caused by the coarse surface of the lower arm allowing slight movement of the outer portion of the bushing. The new arms have a smooth finish on the contact surface providing an increased fixed positioning of the bushing. If this is reported by a customer and can be duplicated, replace the affected lower control arm using the part information supplied in this bulletin.

The new control arm assemblies have been incorporated into vehicle production as per starting VIN R9814013.

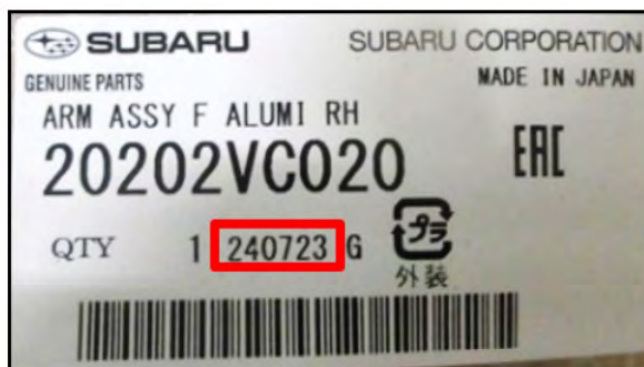
The design change was implemented on parts with a production date code of 240723 (July 23, 2024) and after. The production date code can be located on the part number label. See the example below.
