SERVICE BULLETIN

APPLICABILITY: 2015-21MY WRX/STI 2.5L Turbo MT **NUMBER:** 09-131-25
SUBJECT: Diagnosis Procedures for DTCs P2404 & P0420 **DATE:** 03/04/25
REVISED: 04/08/25

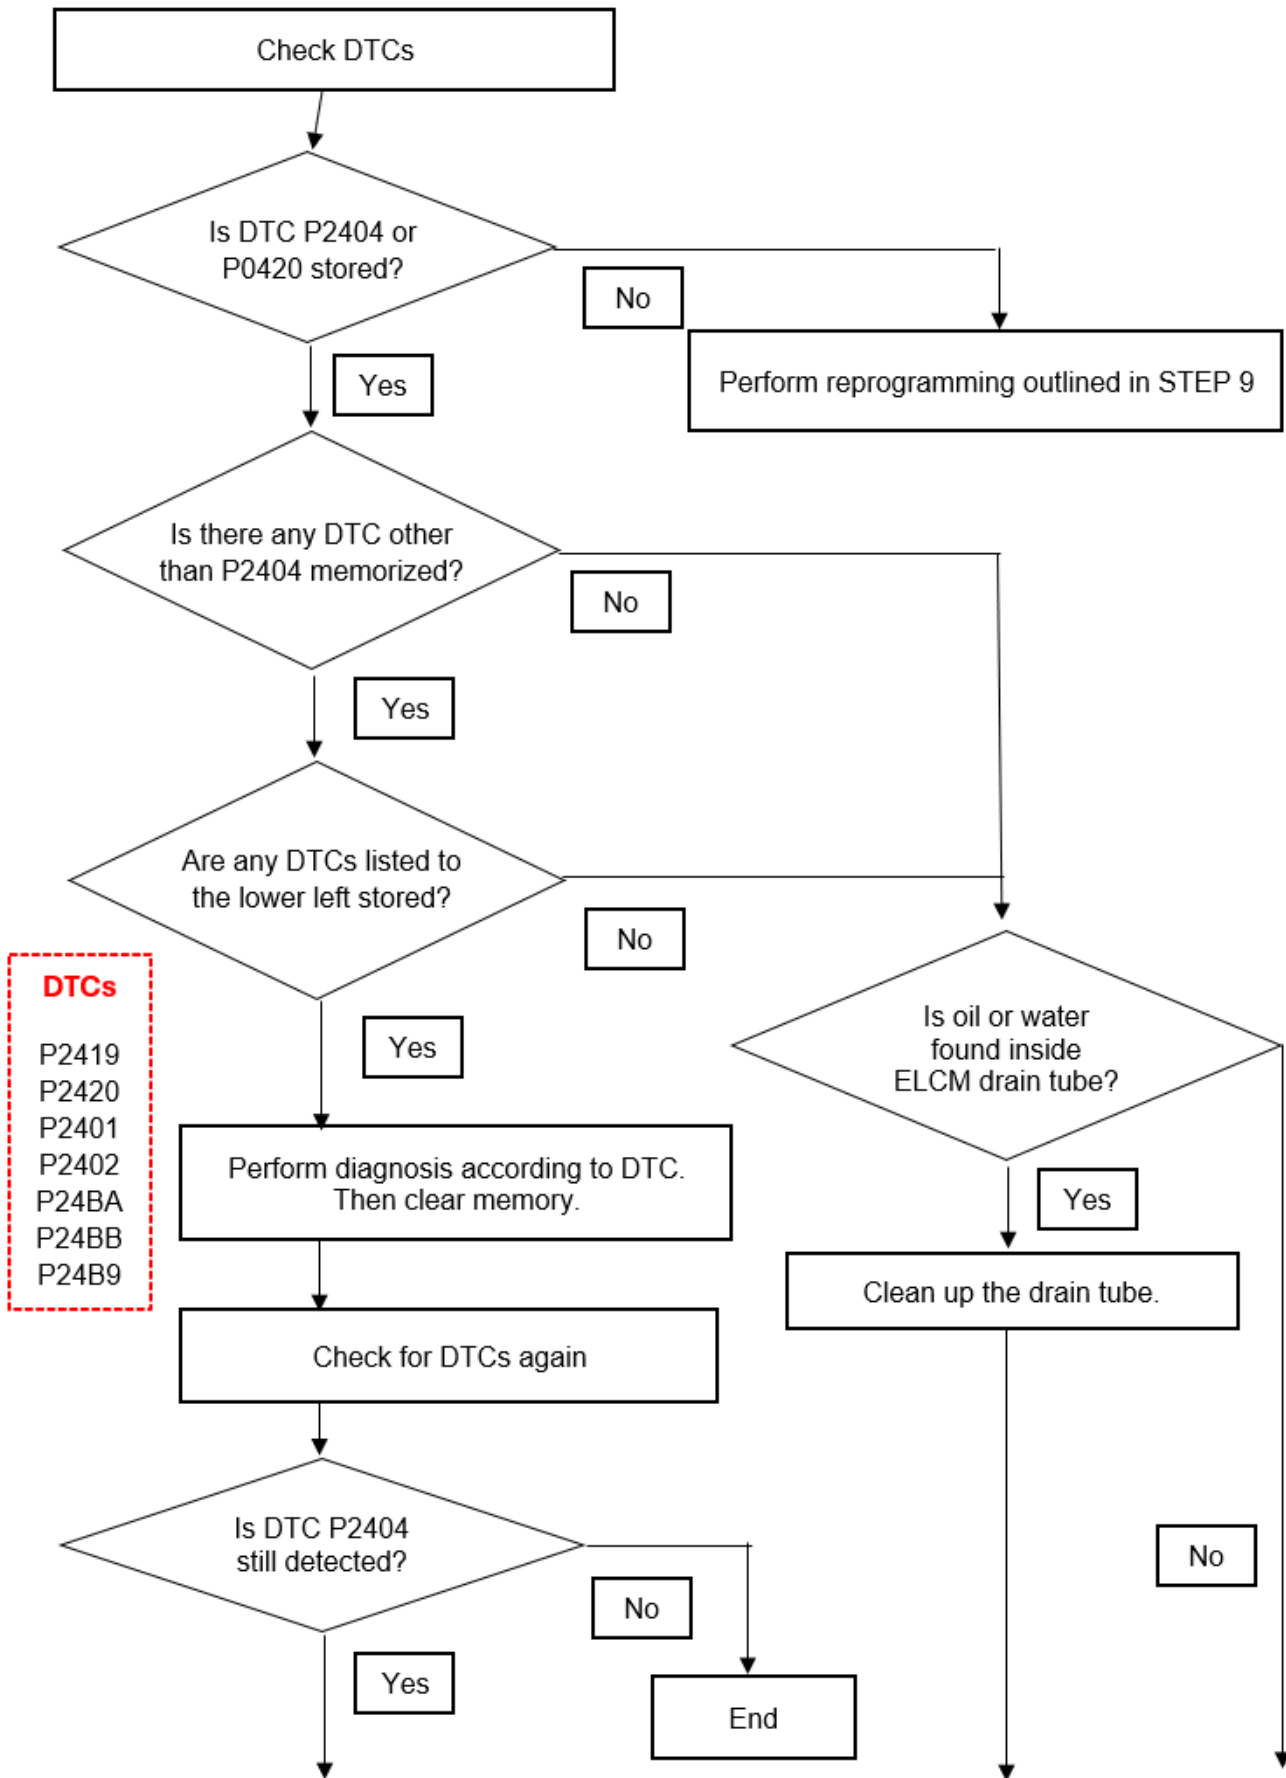
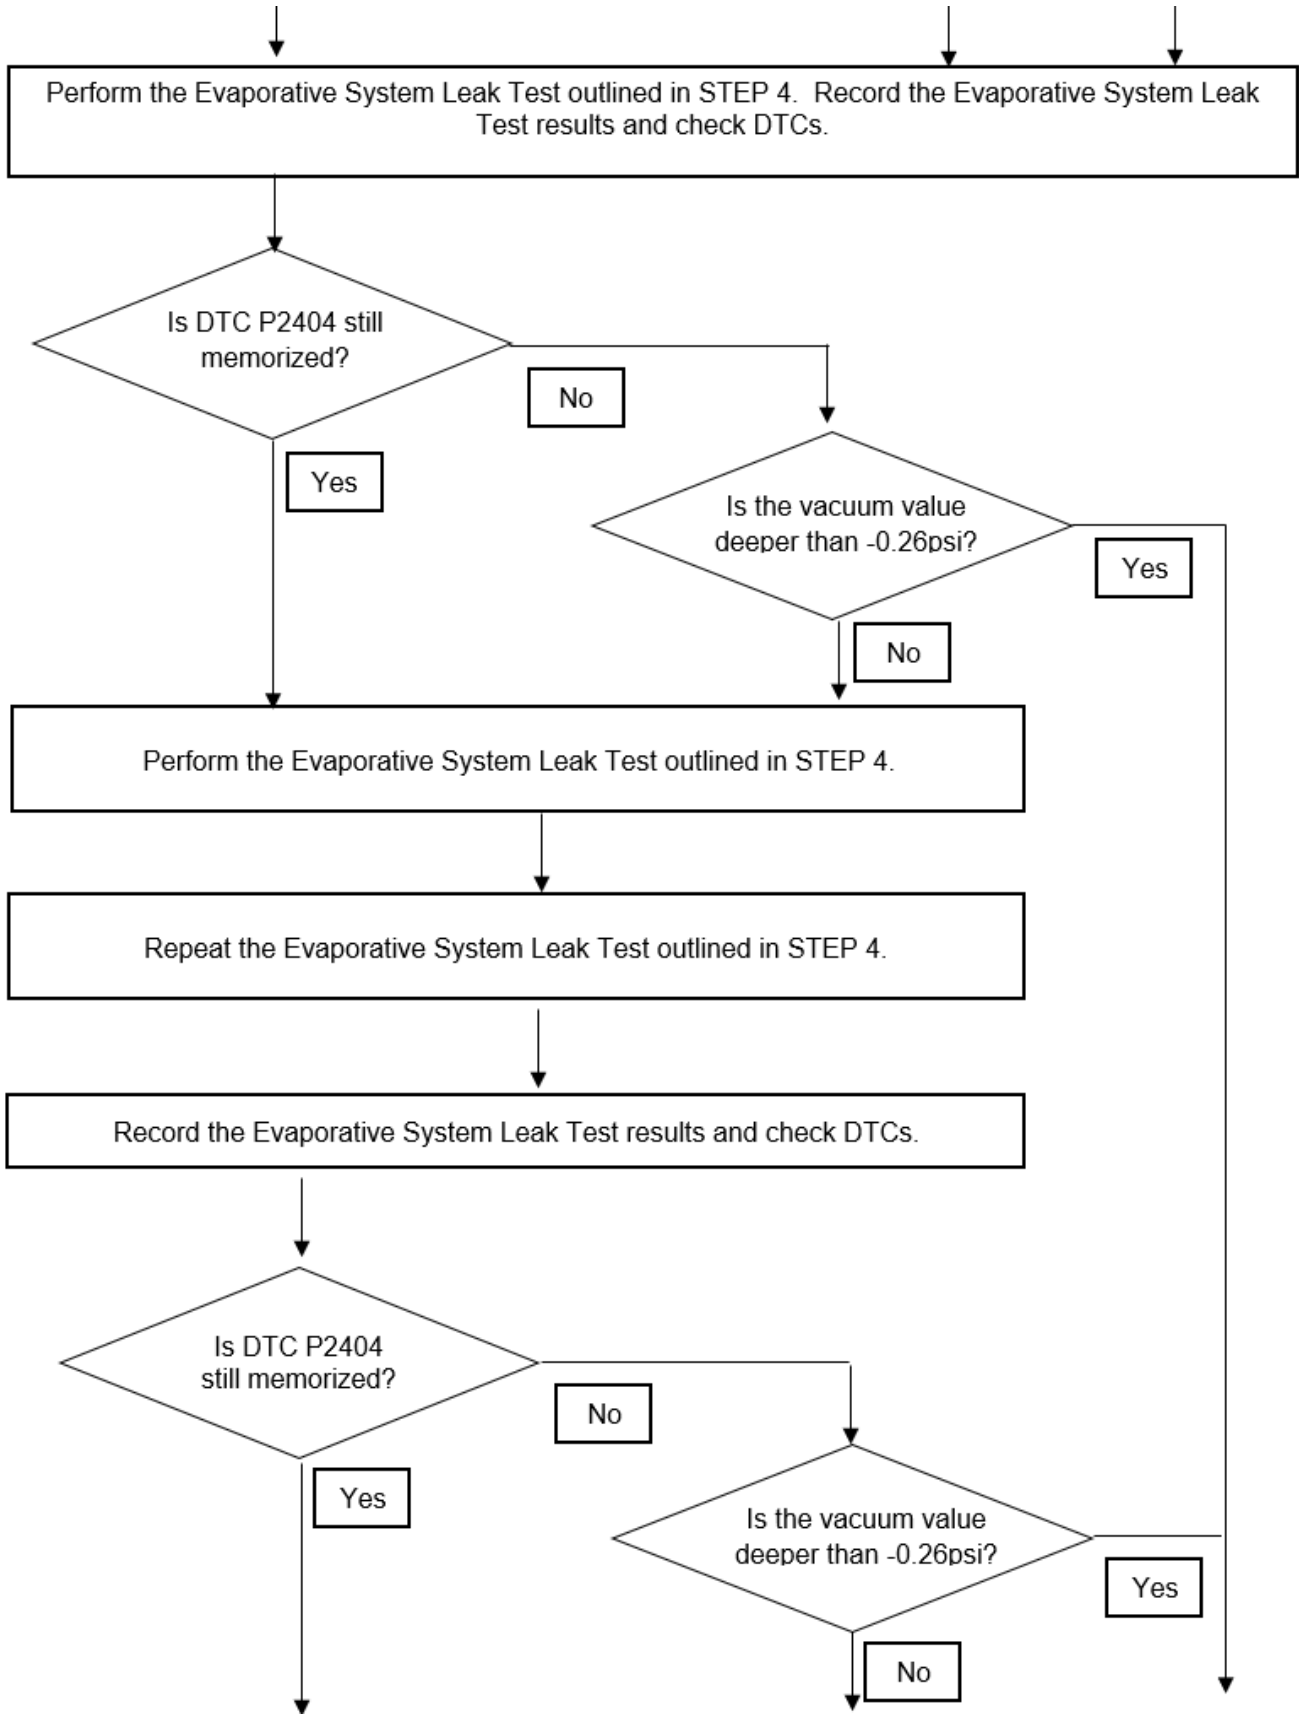
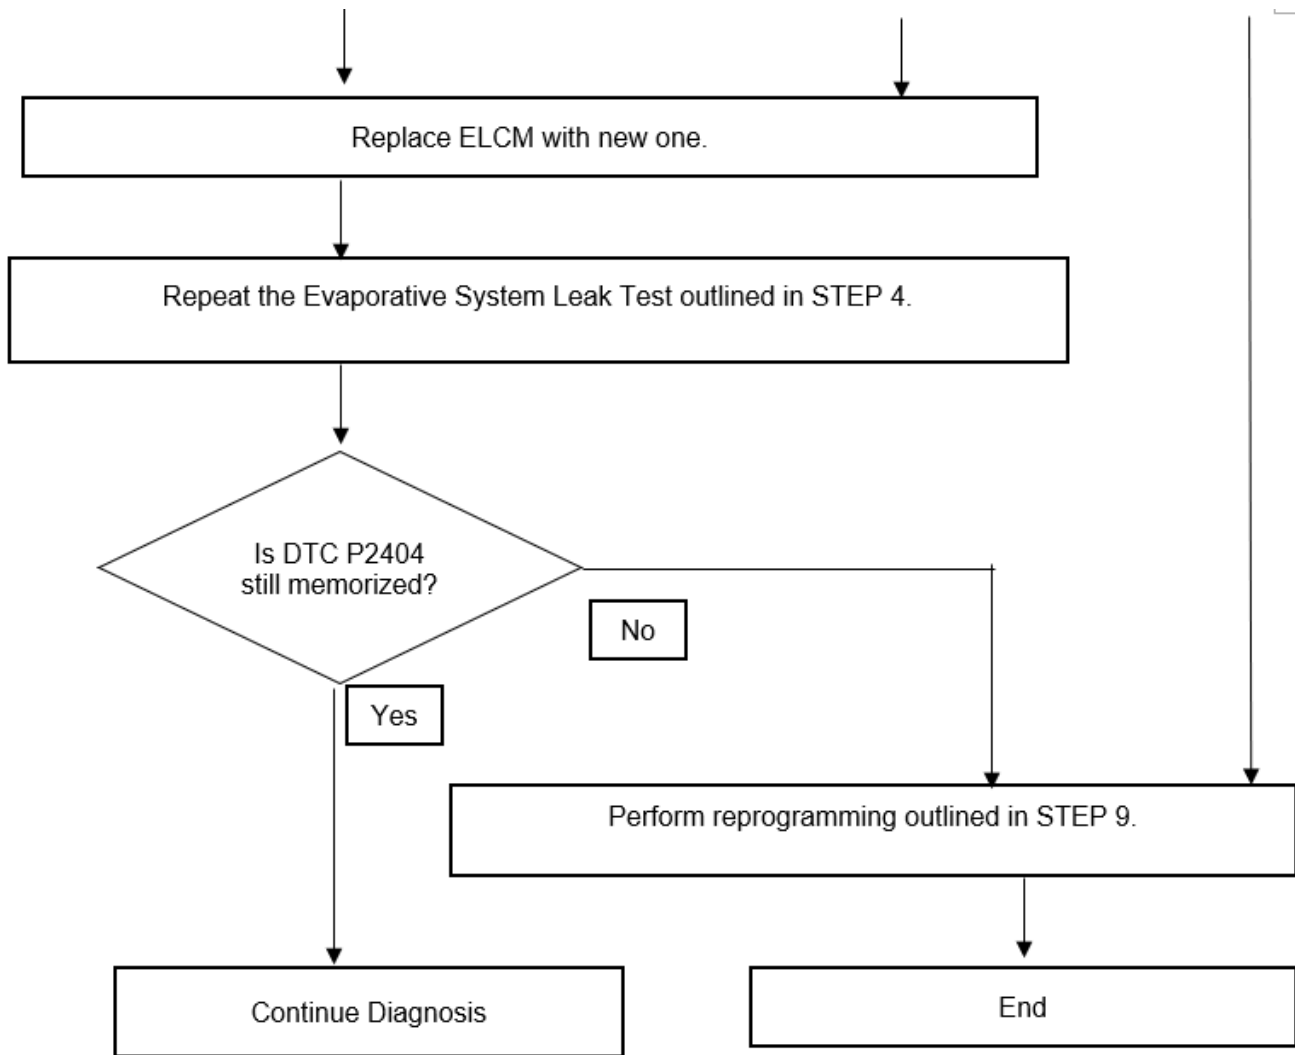
SERVICE PROCEDURE FLOWCHART:

The ELCM may accumulate condensation causing the inaccurate detection of P2404. P0420 may become falsely detected due to unstable combustion caused by a downshift. The new reprogramming files contains enhanced software allowing for condensation conditions and downshift rotational speeds be more accurately detected by the Engine Control Module (ECM). If P2404 and/or P0420 are found to be detected by the ECM, perform the service procedures outlined in this bulletin.

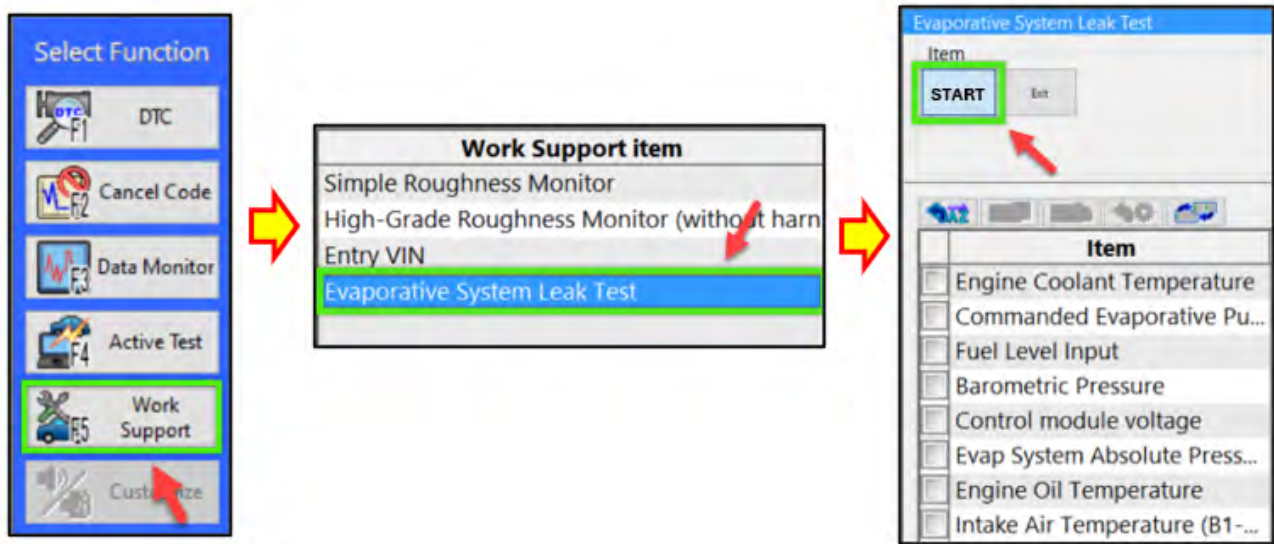
Once the evaporative system leak test is complete, check the DTCs and examine the vacuum value results. Record the value shown in the row labeled MID: \$3C, TID: \$C4, and Scaling ID: \$FE. This value should be lower than -0.26 PSI.

STEP 4: Connect the vehicle to a recommended power supply. See APPENDIX A for addition information regarding power supply. Using SSM, perform the Evaporative System Leak Test. Collect and save all data.
