SERVICE BULLETIN

APPLICABILITY: 2020-24MY Legacy & Outback 2.5L
 2017-24MY Impreza & Crosstrek
 2019-23MY Forester
 2022-23MY BRZ

NUMBER: 09-115-24R

SUBJECT: Oxygen Sensor Design Change / P0137, P0138, P0140, & P0141

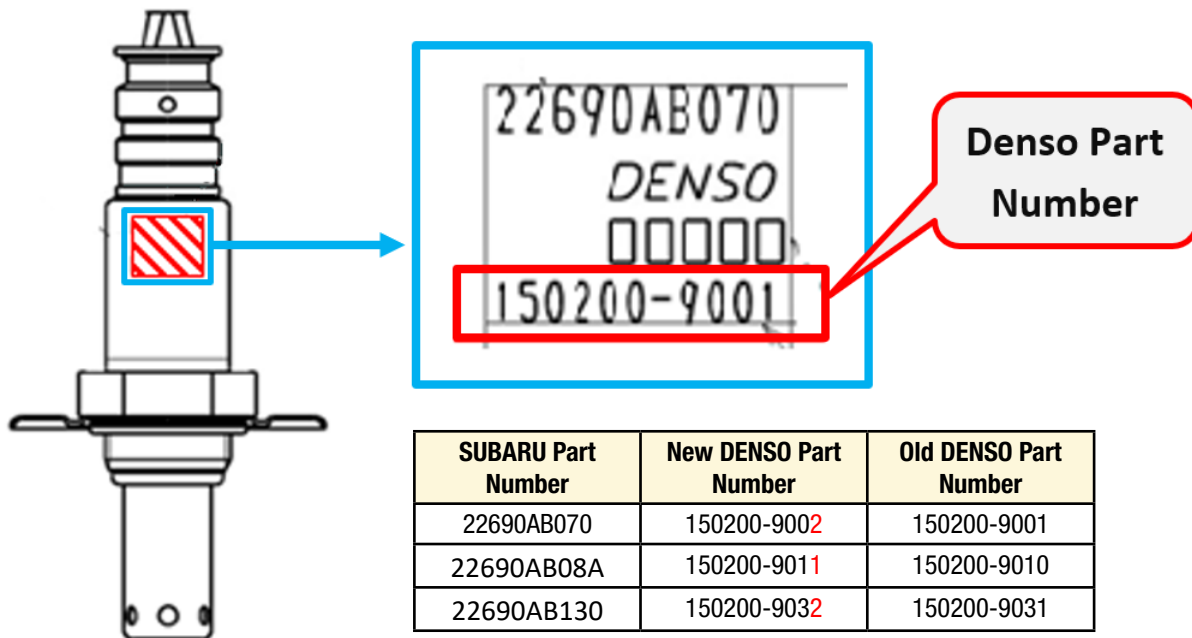
PART IDENTIFICATION:

The part numbers have not been changed. The new parts can be identified by the Denso part number engraved on the sensor.
