NUMBER: 02-193-24R

SERVICE BULLETIN

APPLICABILITY: 2020-24MY Legacy and Outback 2.5L NA

SUBJECT: Walnut Blast Cleaning Procedure for Carbon

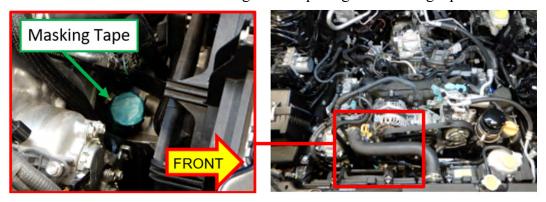
2.0L DIT & 2.4L DIT: Cover the turbo charger duct opening with making tape.

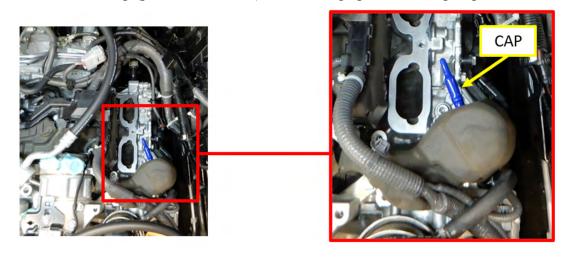
2.4L DIT: Install the cap (p.n. 16519AA100) on to the high pressure fuel pump connection.

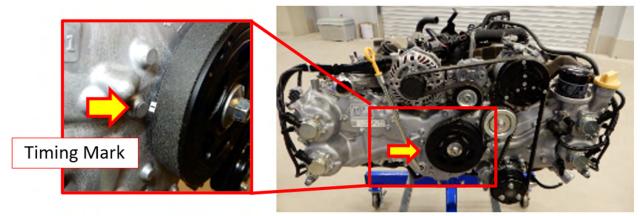
STEP 5: Rotate the crank pully clockwise until the timing mark matches the position indicated below.

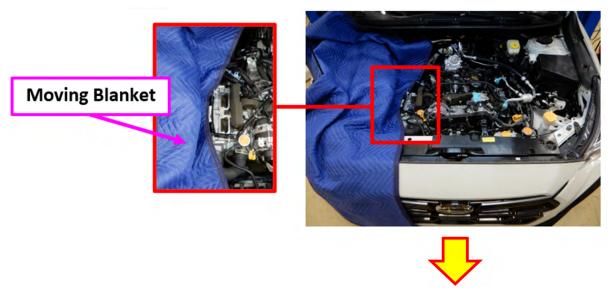
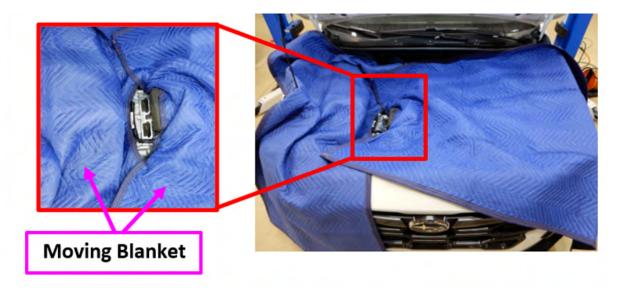
STEP 8: Cover the area around the intake port with two moving blankets. This will help prevent any walnut shell material from contamination.

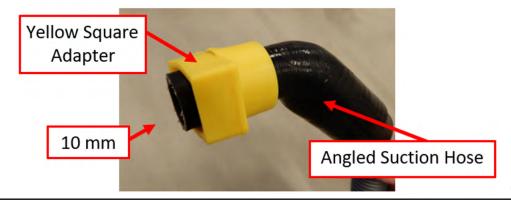
STEP 10: Prepare the angled suction hose by inserting the square yellow adapter onto the end of the hose. Allow approximately 10mm of the hose to protrude from the adapter. This will provide added stability when cleaning.

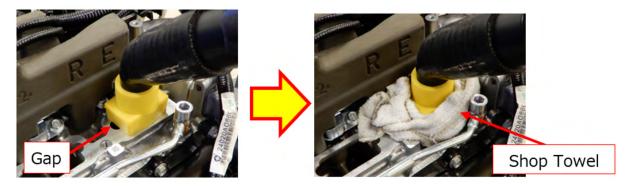
STEP 11: Set the hose into the cylinder #1 intake port. Cover any gaps with a shop towel.

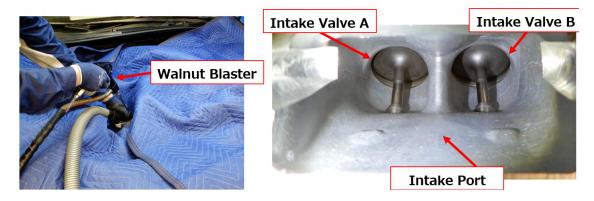
STEP 12: Clean the intake valve and intake port of cylinders #1.

- A. Confirm the walnut blaster is turned on.
- **B.** Insert the nozzle of the walnut blaster into the suction hose.
- **C.** Pull the trigger and allow the abrasive material to pass through the nozzle.
- **D.** Aim the nozzle in the direction of Valve A.
- **E.** Aim the nozzle in the direction of Valve B.
- F. Move the nozzle up, down, left, and right to ensure the entire area is cleaned.

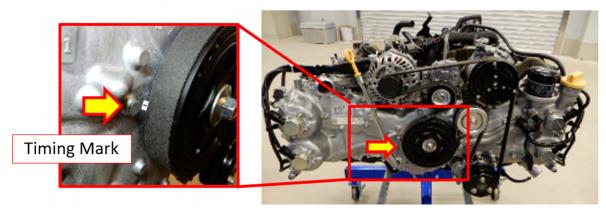
STEP 16: Rotate the crank pully clockwise 360 degrees until the timing mark matches the position indicated below.

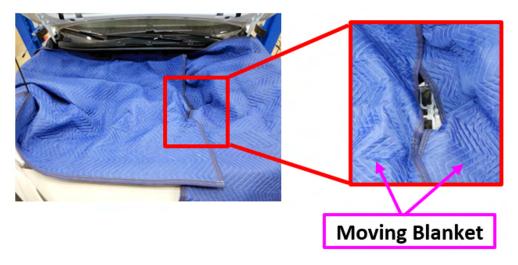
STEP 19: Cover the area around the intake port with two moving blankets. This will help prevent any walnut shell material from contamination.
