SERVICE BULLETIN

APPLICABILITY: 2019MY Legacy & Outback **NUMBER:** 15-318-24R
 2019-21MY WRX/STI **DATE:** 02/23/24

SUBJECT: Data Communication Module (DCM) Bypass Box **REVISED:** 04/28/25

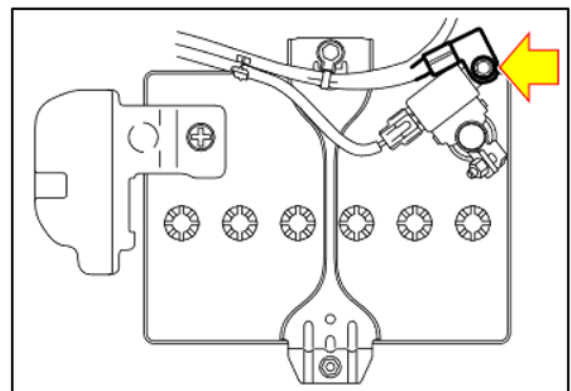
STEP 2: CAREFULLY disconnect the battery sensor from the negative ground terminal and wait at least 60 seconds before continuing.

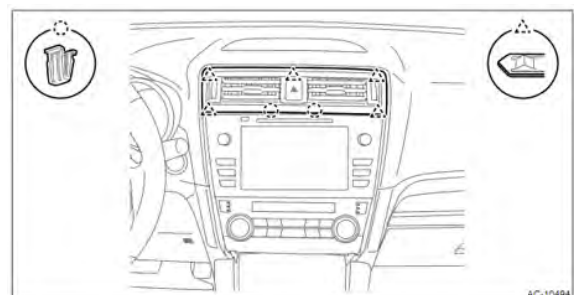
STEP 3: Remove the Center Grille Assembly.

- Release the clips and claws.
- Disconnect the connector and remove the Grille Assembly.
- Disconnect and remove the hazard switch.

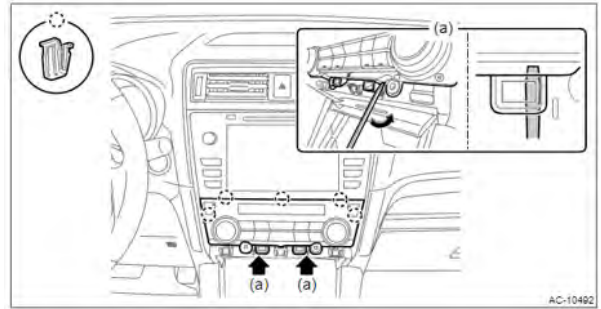
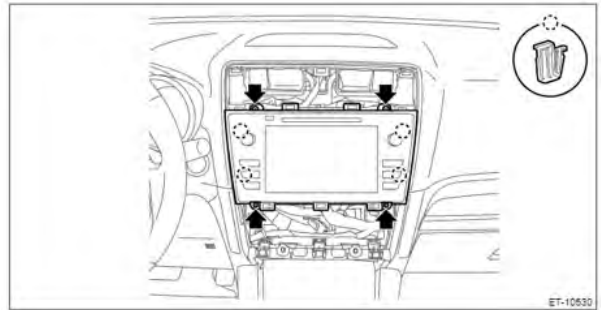
STEP 4: Remove the Heater Control Assembly.

- A. Release the clips and claws.
- B. Remove the panel.
- C. Remove the mounting screws.
- D. Detach the heater control assembly.

CAUTION: A flat head screwdriver with protective tape can be used as shown in the right image. Use special care to not damage the heater control assembly.

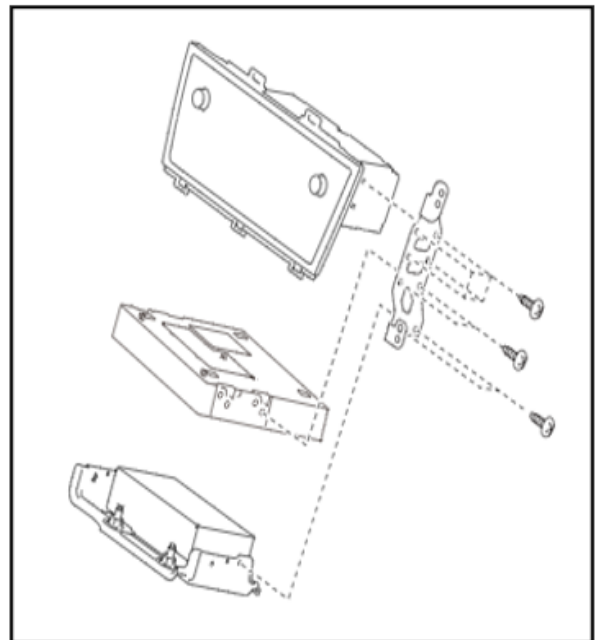
STEP 6: Remove the DCM.

- A. CAREFULLY remove the bracket mounting screws.
- B. Remove the DCM and the backup module assembly together.

CAUTION: Be mindful to not cause any damage to the mounting screws during removal. The mounting screws are to be reused.

STEP 7: Install the new DCM and reinstall all parts in the reverse order of disassembly.

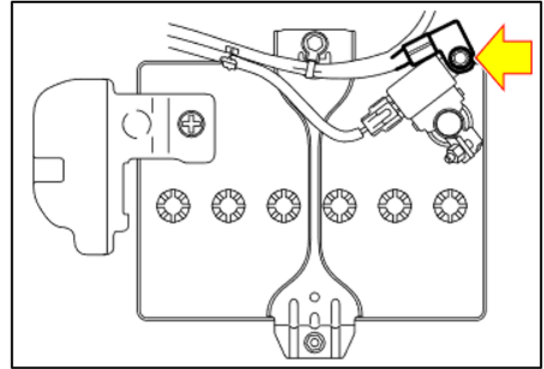
STEP 2: CAREFULLY disconnect the battery sensor from the negative ground terminal and wait at least 60 seconds before continuing.

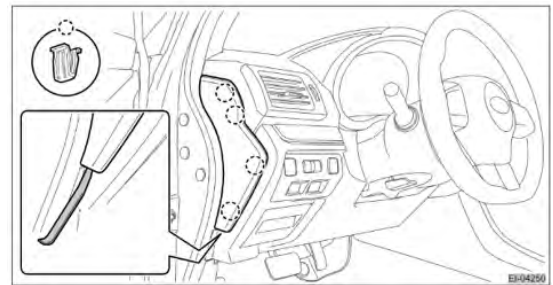
STEP 3: Using a plastic trim tool, remove the left side instrument panel cover.

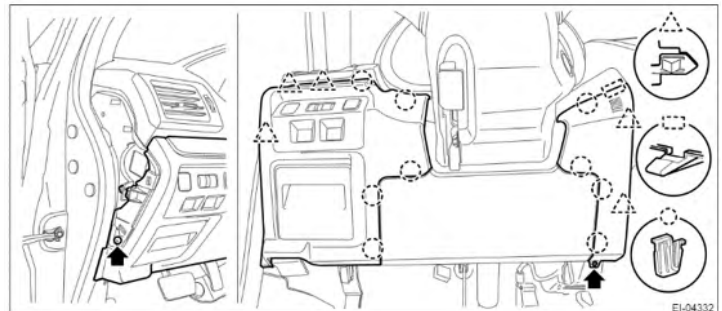
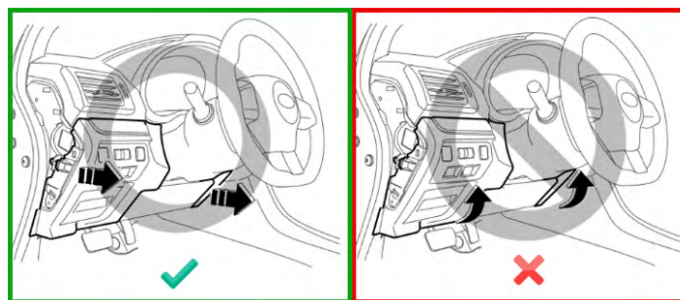
STEP 4: Remove the left inner and outer lower instrument panels.

- A. Remove the mounting screws.
- B. Release the mounting clips and claws.
- C. Pull both panels toward the rear of the vehicle.
- D. Disconnect all electrical connections.

CAUTION: ALWAYS pull the panels **toward the rear of the vehicle**. Pulling in an upward or downward direction may cause damage to the mounting claws.

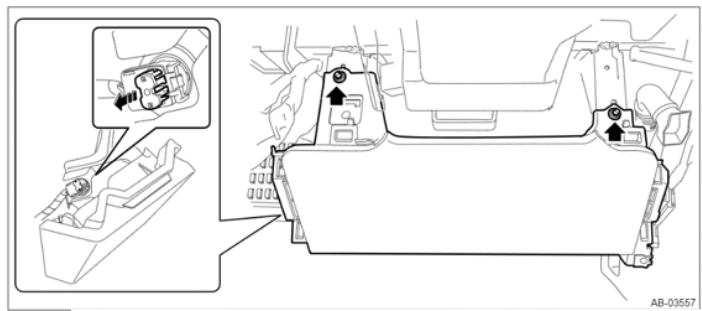
STEP 5: Remove the knee airbag module.

- A. Remove the mounting nuts.
- B. CAREFULLY disconnect the electrical connection.

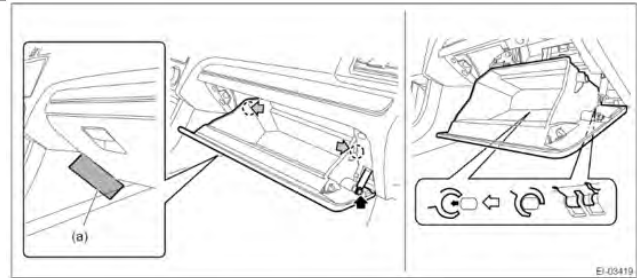
STEP 6: Remove the glove box assembly.

- A. Apply protective tape to the lower center panel section shown as (a) in the right image.
- B. Disconnect the damper from the glove box.
- C. Release the stoppers and pull the glove box toward the rear of the vehicle.

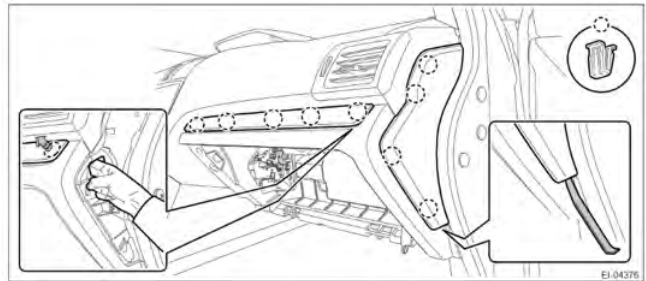
STEP 7: Remove the glove box backing panel.

- A. Using a plastic trim tool, remove the right side instrument panel cover.
- B. Release the clips and removed the instrument panel ornamental trim.

TIP: The instrument panel ornamental trim can be removed by applying pressure from the backside.

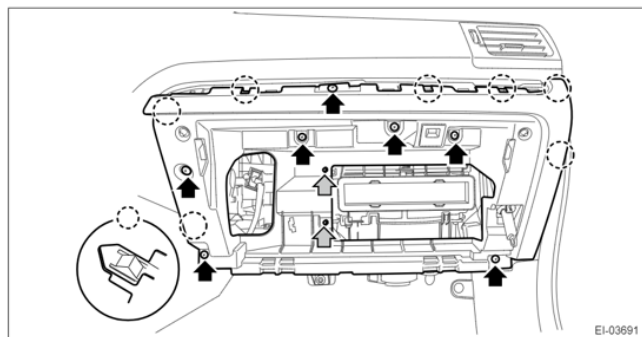
- C. Remove the glove box LED and disconnect the electrical connection.
- D. Removed the mounting screws.
- E. Release the claws and harness clamp.
- F. The glove box backing panel can then be removed.

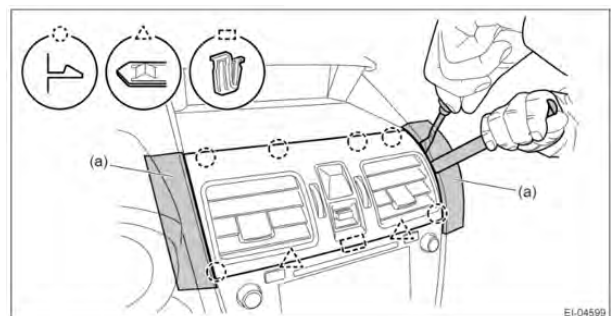
STEP 8: Remove the center grille assembly.

- A. Apply protective tape to the instrument panel section shown as (a) in the right image.
- B. Release the claw using a plastic trim tool or a clip removal to with protective tape applied to the contact area.
- C. Disconnect the electrical connector and remove the center grille assembly.

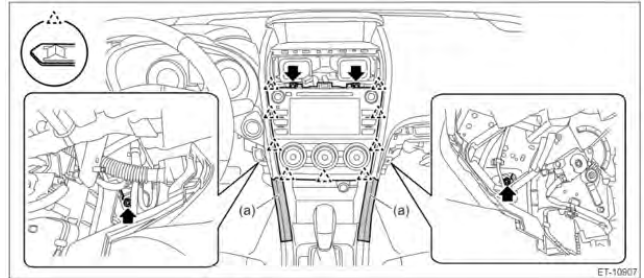
STEP 9: Remove the audio assembly.

- A. Apply protective tape the center storage area section indicated as (a) in the lower right image.
- B. Remove the mounting screws and bolts.
- C. Release the mounting claws and partially remove the audio assembly to gain access to the electrical connections.

CAUTION: If the antenna cable interferes with the removal side mounting bolts, move the antenna cable before attempting to remove the bolts.

- D. Disconnect the electrical connectors and remove the audio assembly.

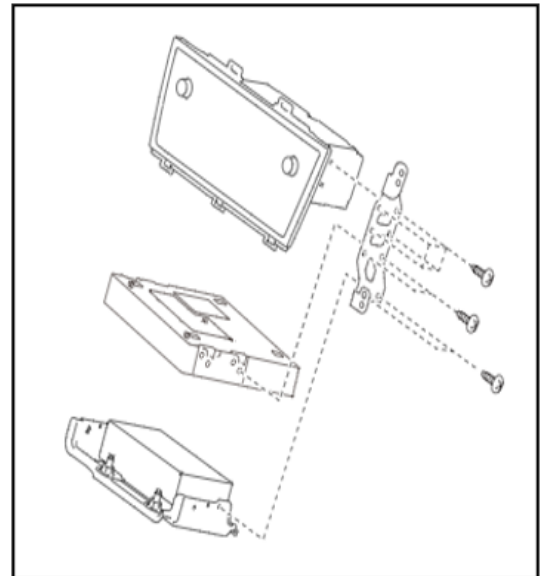
STEP 10: Remove the DCM.

- A. CAREFULLY remove the bracket mounting screws.
- B. Remove the DCM and the backup module assembly together.

CAUTION: Be mindful to not cause any damage to the mounting screws during removal. The mounting screws are to be reused.

STEP 11: Install the new DCM and reinstall all parts in the reverse order of disassembly.

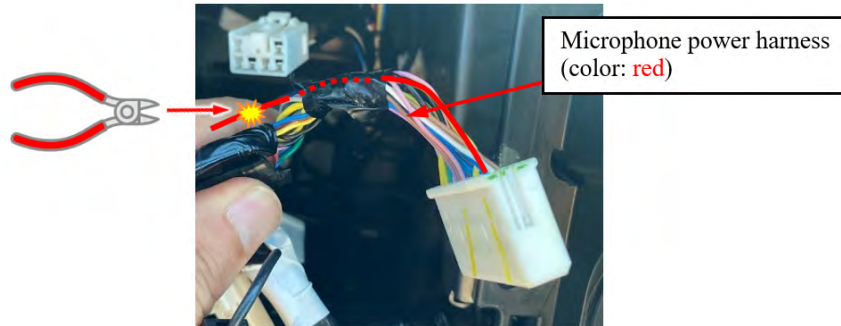
- A. Remove the screws and release the clip.
- B. Disconnect the connector and remove the audio assembly.
- C. Cut the microphone power wire (color: red) at the end of connector i87 pin #4.

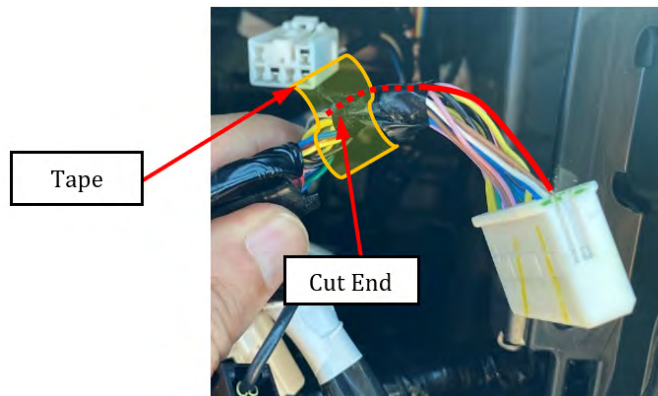
- D. Bundle the cut red wire for the microphone into the vehicle harness so the cut end is covered.

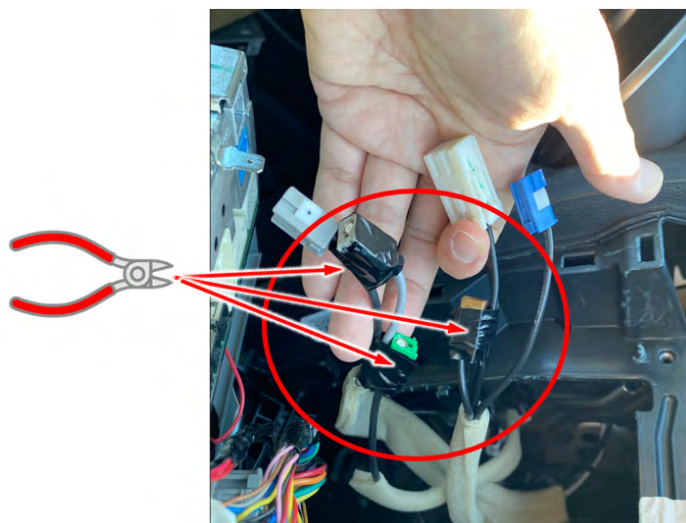
- E. Remove the tape from the three bundled antenna connectors.
