SERVICE BULLETIN

APPLICABILITY: 2020-24MY Legacy & Outback
2019-25MY Ascent

NUMBER: 12-267-25

SUBJECT: Hood Lock Assembly / Design Change

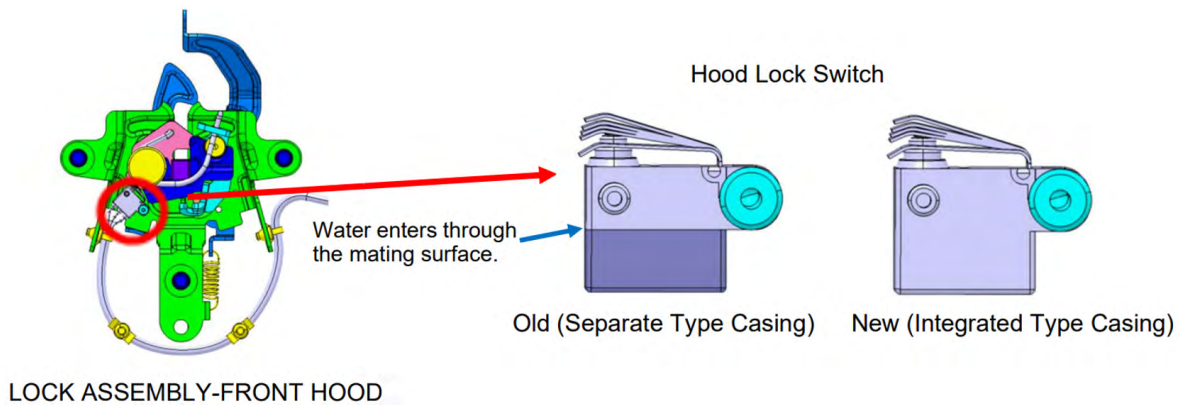
This bulletin announces a design change to the hood lock switch portion of the hood lock assembly. The new hood latch switch is a one-piece design, optimizing its waterproof characteristics. This has been developed to address customers' concerns of the instrument cluster giving a false indication of the hood being ajar, a flashing Auto Start Stop warning light and customers being unable to remote start their vehicle. If any of these conditions are verified, perform testing of the hood latch switch and replace it if found to be defective.
