## SERVICE BULLETIN

**APPLICABILITY:** 2020-24MY Legacy and Outback  
2019-24MY Ascent

**NUMBER:** 07-189-21R

**SUBJECT:** Door Window Regulator- Erratic Operation

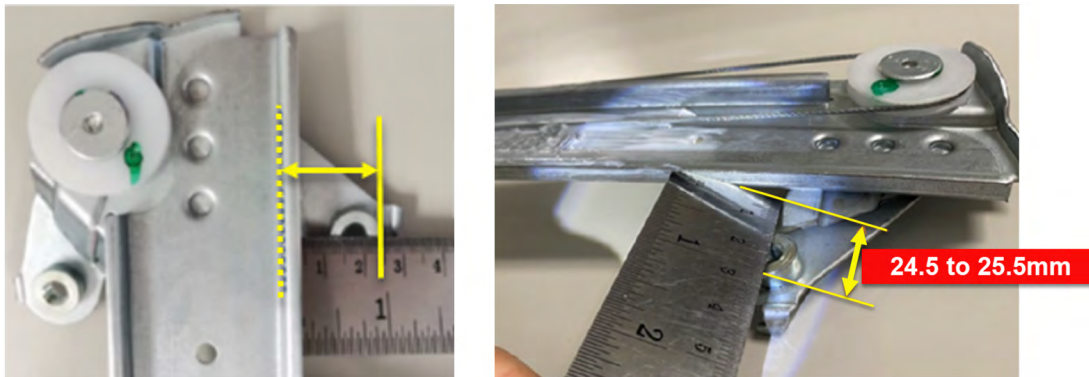
**STEP 2:** Measure the regulator upper roller frame to confirm the regulator was correctly assembled. If the measured distance between the outside of the rail guide (see dashed line below) and the outer side of the mounting nut is not within **24.5 to 25.5mm**, the regulator will require replacement. A 30mm wide ruler is recommended.

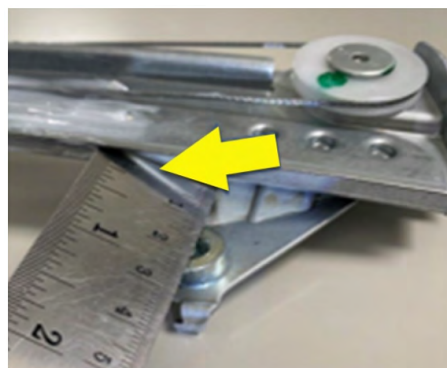
**IMPORTANT NOTE:** ALWAYS confirm there is no gap between ruler and the frame.

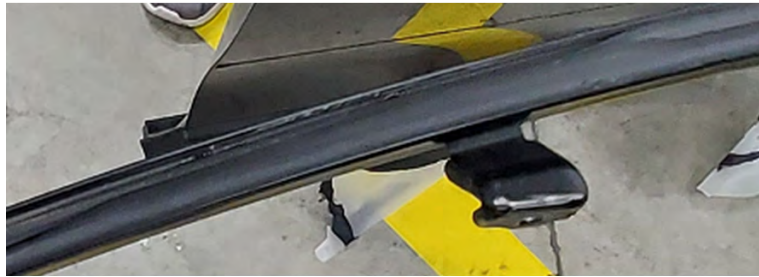
**STEP 3:** When inspection determines window regulator replacement is required, the door glass run channel seal will also require replacement. See the example photo below of the door glass run channel seal.

The service procedures for window regulator assembly and door glass run channel replacement remain unchanged. Always refer to STIS and review the full requirements of the repair being performed. The Service Manual procedures contain information critical to performing an effective repair the first time, every time. This includes but is not limited to important SAFETY precautions, proper inspection criteria, necessary special tools, required processes and related one-time-use parts needed for a complete and lasting repair.
