### SERVICE BULLETIN

**APPLICABILITY:** All Models with Gen 2 & Gen 3 Telematics

**SUBJECT:** DTC B2A16

**NUMBER: 15-251-19R**

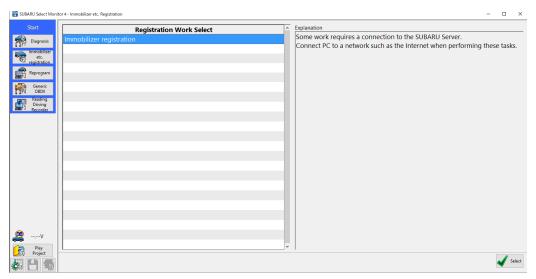
**NOTE:** When selecting G, H, or I Type, the latest SSM4 software (July 2019 version or later) is required along with a secure network connection. Refer to TSB **15-246-19** for additional details.

If DTC B2A16 is found in the DCM, start by registering the DCM with the vehicle immobilizer system to avoid a potentially unnecessary DCM replacement. Follow the instructions found in the applicable Immobilizer Registration Manual. See the basic SSM screenshots and additional information provided below for reference.

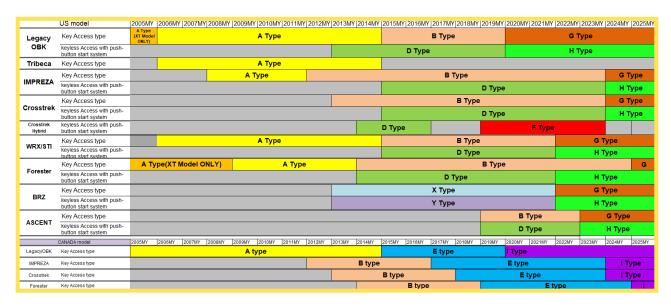
**IMPORTANT:** Whenever either the Keyless Access Module (KAM) <u>or</u> the DCM is replaced on a STARLINK Gen2 Telematics -equipped vehicle, the DCM **MUST** be registered with the vehicle immobilizer system.

Always refer to the applicable Immobilizer Registration Manual for the Model Year vehicle being repaired. These manuals can be found on STIS by searching Online Publications > Publication Type > Other/Miscellaneous and searching with the keyword "Immobilizer".
