## Technical Service Bulletin

**GROUP****GENERAL  
INFORMATION****NUMBER****25-GI-009G****DATE****APRIL 2025****MODEL(S)****ALL****SUBJECT:** SERVICE GUIDE FOR HORN INSPECTION & REPLACEMENT

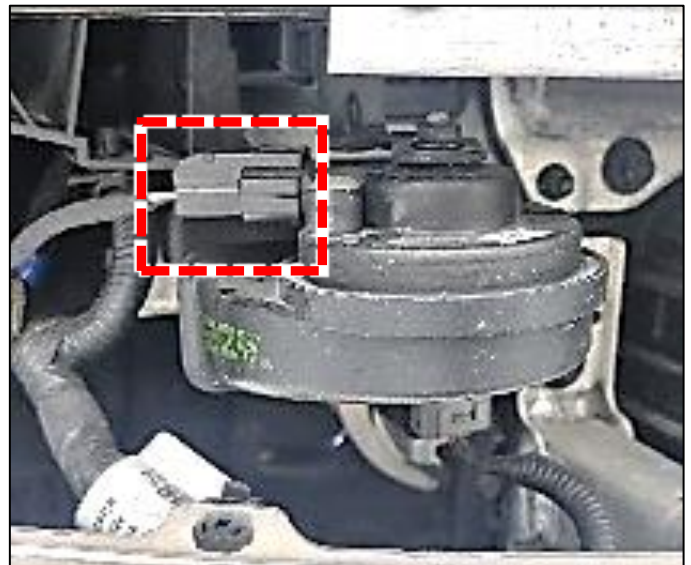
1. Verify horn function:
  - **NO** operating sound heard from both horns.
    - Proceed to the **Repair Order (RO) Documentation & Horn Replacement** section.
  - Operating sound heard.
    - Proceed to the next step.
2. Verify the sound from the high and low horn:
  - Disconnect the low horn connector and verify if the high horn sound.
  - Disconnect the high horn connector and reconnect the low horn connector to verify the low horn sound.

3. If a horn is defective, then proceed to the **Repair Order (RO) Documentation & Horn Replacement** section.
