# Technical Service Bulletin

<b>Subject:</b>  SQUEAKING NOISE FROM RUBBING BETWEEN DRIVER'S SEAT BACK AND REAR CONSOLE LID	<b>Bulletin No.:</b> 09-016/25
	<b>Last Issued :</b> 04/01/2025

2020-2025 CX-30

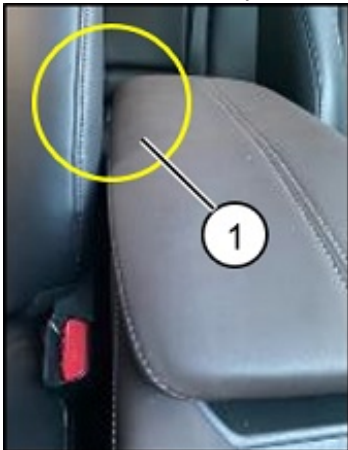
Some customers may complain of a squeaking noise from the driver side seat back. The noise may be due to rubbing between the lumbar part of the driver's seat back (1) and the rear console lid.

The lumbar support pad may be deformed outward and may rub against the rear console lid while driving or when adjusting the seat memory. This can cause a squeaking noise.

When receiving a customer complaint for this concern, install a bracket to the driver's side front seat back frame to prevent lumbar support deformation and replace the driver's side front seat back pad with a modified part according to the following procedures.

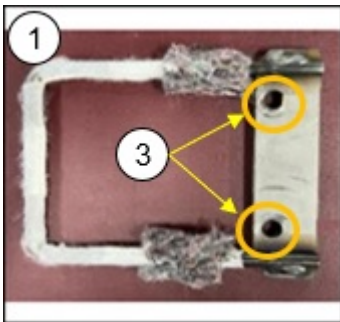
(1) Bracket  
(3) Mounting holes

1. Verify customer concern.
2. Remove the driver's side seat back trim according to the instructions on MGSS FRONT SEAT BACK TRIM REMOVAL/INSTALLATION.
3. Install the bracket (1) with the nuts and bolts to the driver's side front seat back frame (2) to prevent the seat back lumbar support deformation according to the following images.

**Tightening torque: 7.8-10.8 N·m {80-110 kgf·cm, 69-95 in·lbf}**

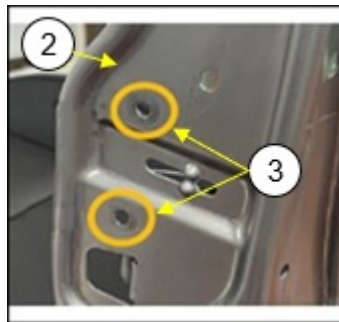
(2) Seat back frame  
(3) Mounting holes

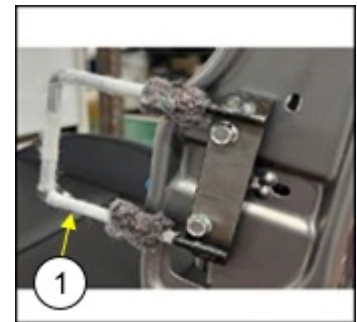
After bracket installation:  
(1) Bracket

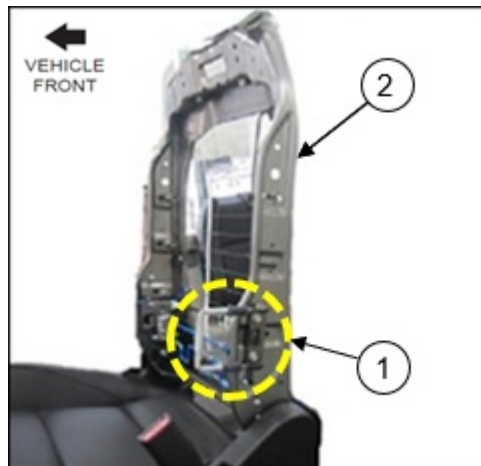
Bracket has been installed to seat back frame.  
(1) Bracket

(2) Front Seat back frame (driver's side)

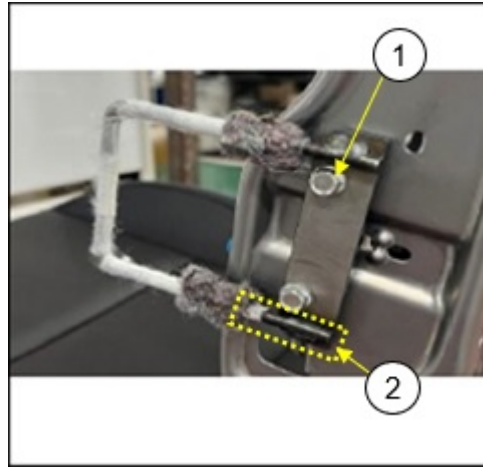
**GOOD**

- (1) Bolt head must be outside of bracket.  
 (2) Welded part of bracket must be outside.

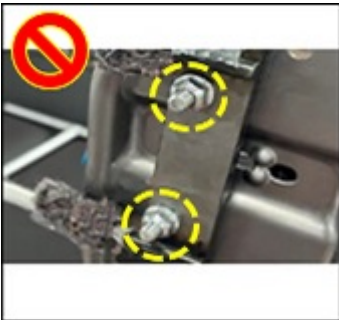
**NO GOOD**

Nuts are installed outside.

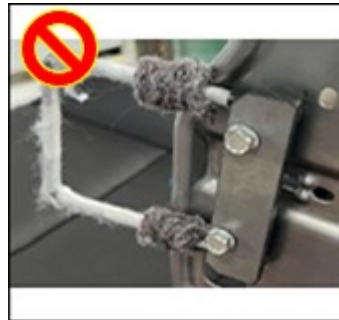
**NO GOOD**

Bracket is installed inside out.

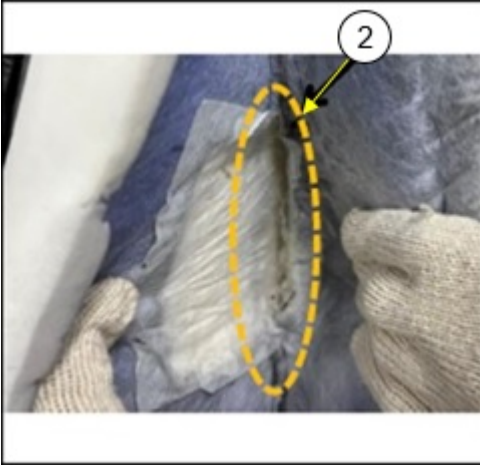
(2) Slit of the seat back pad

**NOTE:** When installing the seat back pad to the frame, insert the bracket (1) into the slit (2) of the seat back pad.

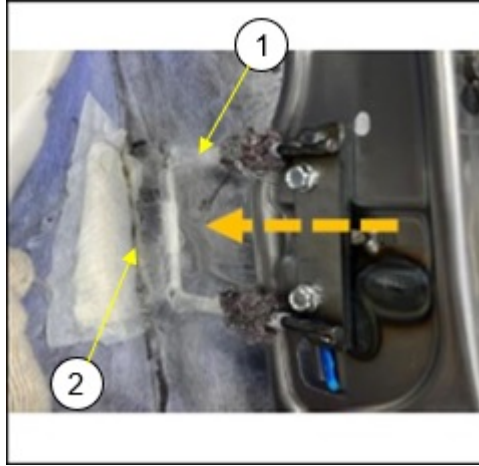
(1) Bracket  
(2) Slit of the seat back pad

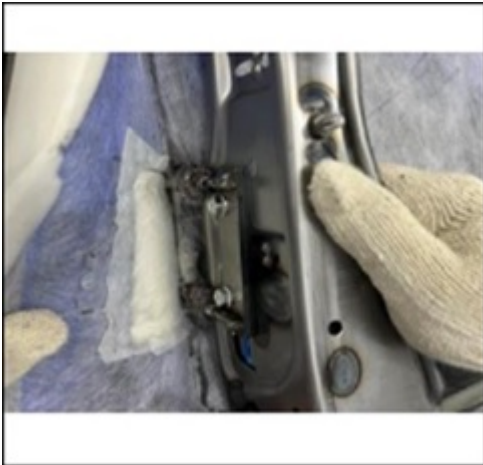
**CAUTION:** When installing the seat back pad, the lumbar must be set to low.

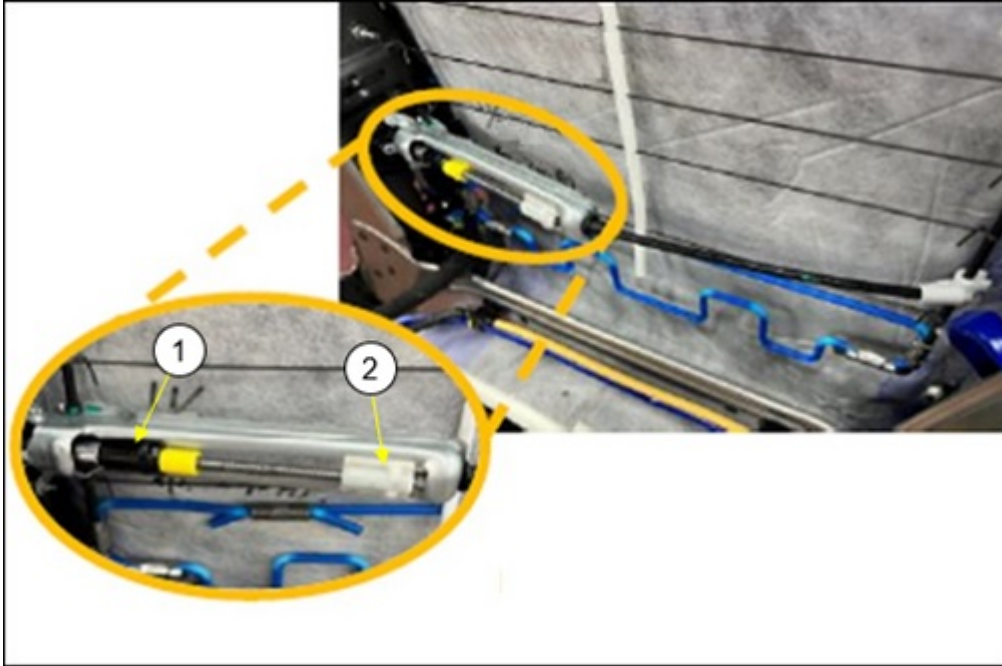
**GOOD:** There is enough space between the seat back pad and the slider because the lumbar is set to low. Put knob (1) and (2) at the end of the slider as per the image to loosen the slider.

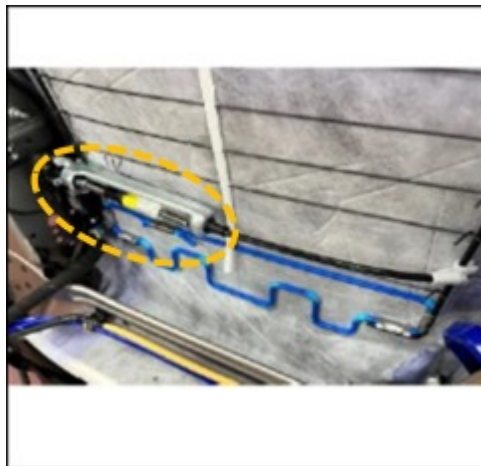
**NO GOOD:** There is no space between the seat back pad and the slider because the lumbar is set to high.

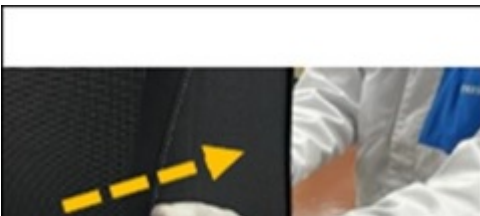
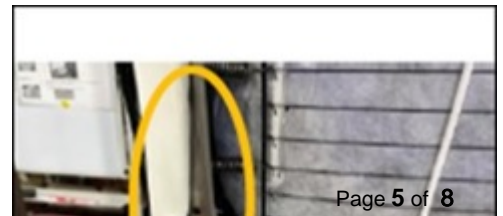
Pull the bolster and check if the bracket is inserted into the slit properly.

**GOOD:** The winding part of the seat back pad is on the seat back frame.

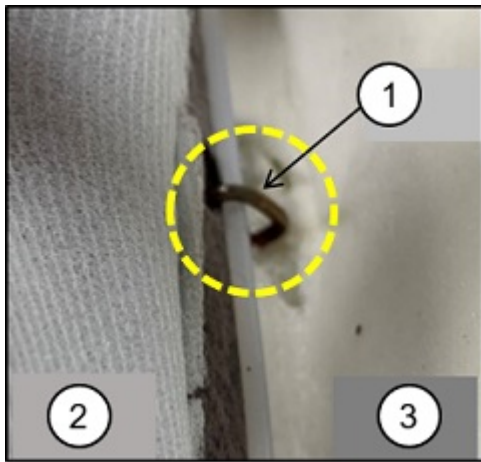
- 1) When replacing the seat back trim, the lumbar support of the seat memory must be set to "low" in advance.
  - 2) If removing the seat assembly with setting too "high" at the seat memory and replacing the trim with the new one, the C-ring (1) may not be able to be tightened properly.
- As a result, a gap between the trim's resin (2) and pad (3) may occur.

Part	Bad Example	Good Example
1	C-ring	There is a gap between trim (2) and pad (3).	Tighten until trim (2) and pad (3) contact properly.
2	Trim	-	-
3	Pad	-	-

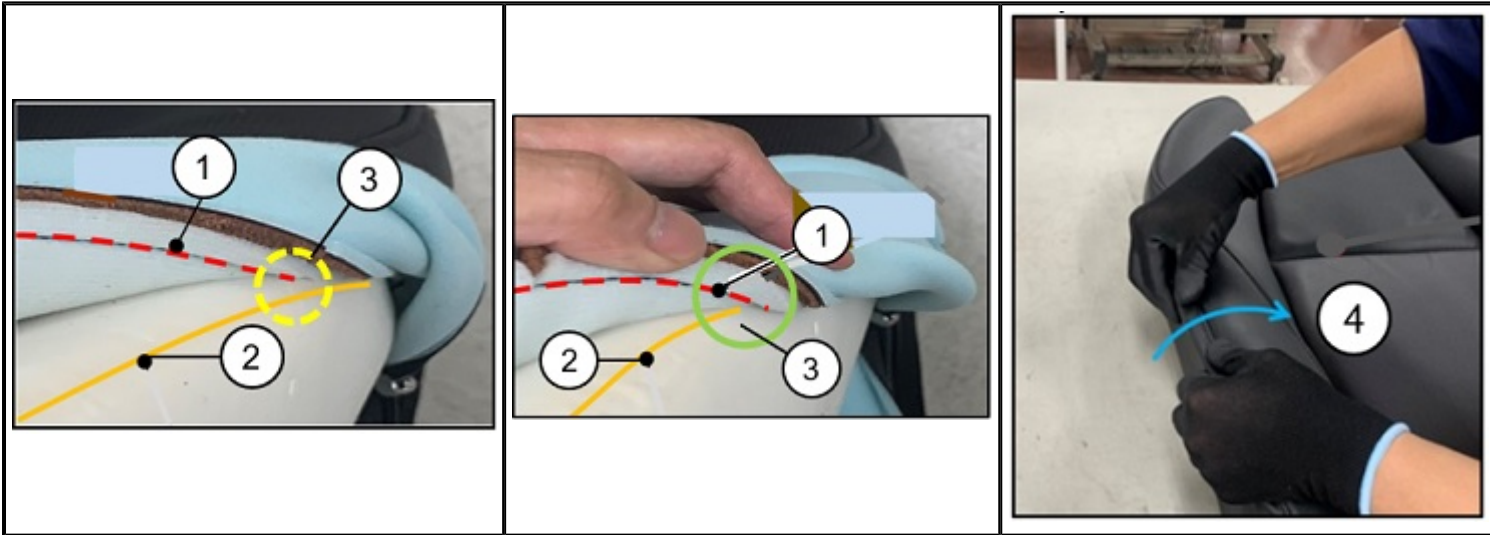
Fig.2 Bad/Good examples of installing the Trim cover.

3) Tighten the C-ring firmly, then confirm that the pad's bolster top (2) stays inside the trim's stitch (1).

Part	Bad Example	Good Example
1	Stitch	---	---
2	Bolster top	---	---
3	---	The bolster top (2) is outside the stitch (1).	The bolster top (2) is inside the stitch (1).
4	(Operation)	---	When assembling the trim and pad, pull the bolster top (2) of the pad inside the bolster stitch line (1) by hand.
