Technical Service Bulletin

Subject: CLICKING, SQUEAKING OR RUBBING NOISE WHEN OPENING/CLOSING FRONT DOOR	Bulletin No.: 09-018/25
	Last Issued : 04/09/2025

2024-2025 CX-90

2025 CX-70

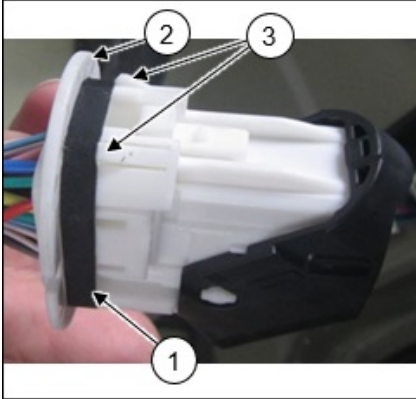
- A clicking noise may be caused from the door connector sliding right and left, repeatedly connecting/half-connecting the connector tab, resulting in the stick-slip noise in the door side panel when opening/closing the front door.
- A squeaking or rubbing noise may be caused by the door harness interfering with the bottom edge of the door harness grommet when opening/closing the front door(s).

c. Attach the one piece of the non-woven fabric tape (1) along the brim (2) of the door connector once as shown in the figure. (one piece of the non-woven fabric for one side)

CAUTION: DO NOT attach the tape (1) on the tab (3).

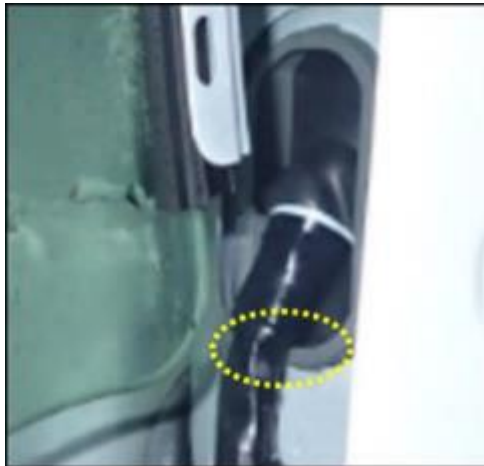
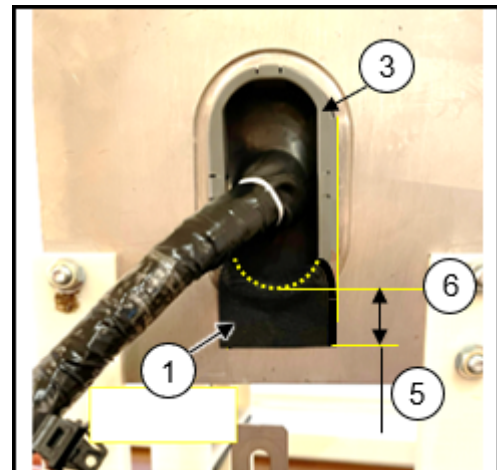
DETAIL OF B

The harness interferes with the bottom edge of the door harness grommet.

- The right edge of the non-woven fabric must be aligned with the door harness grommet (3).
- Fold the remaining non-woven fabric over the other side of the hole.

(5) 15 mm (0.6 inches) from the underside of the hole (6) of the door harness grommet (3)
