Technical Service Bulletin

Subject: EXTERIOR LIGHT WARNING WITH DTC B10A3:86	Bulletin No.: 09-019/25
	Last Issued : 04/15/2025

APPLICABLE MODEL(S)/VINS

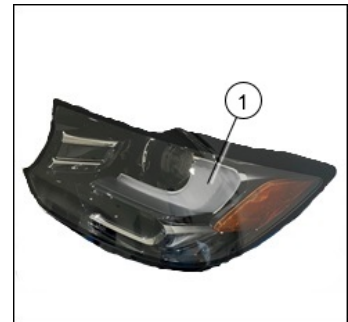
Some vehicles equipped with the Adaptive Front lighting System (AFS) may exhibit the exterior light warning light/ exterior light warning indication on while driving or when the ignition is turned on and DTC B10A3:86 (Error signal received from swivel actuator (LH)) stored in memory.

Exterior light warning light

Combination light with AFS
(1): Parking light/daytime running light (DRL)

NOTE: The combination light with AFS can be distinguished if it is equipped with the parking light/daytime running light (DRL) that illuminates while the ignition is turned on.

This may be caused by the AFS Control Module detecting a false headlight malfunction. This concern will likely occur when the light returns to the center position after swiveling. To eliminate this concern, the control software of the AFS control module has been further modified. Customers having this concern should have their vehicle repaired using the following repair procedure.
