Technical Service Bulletin

Subject: RATTLING NOISE FROM LIFTGATE WHEN DRIVING	Bulletin No.: 09-020/25
	Last Issued : 04/23/2025

2024-2025 CX-90 with VINS lower than JM3KK*****224789 (produced before January 7, 2025)

2025 CX-70 with VINS lower than JM3KJ*****122126 (produced before January 7, 2025)

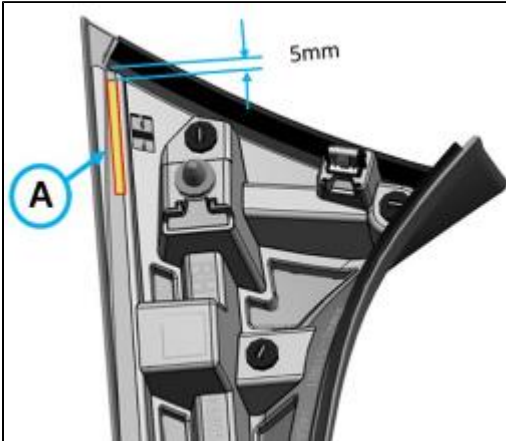
Some customers may experience a rattling (vibration) noise from the liftgate when driving on rough roads. This noise may be caused by the gap at the attaching point of the side spoiler metal clip to the rear spoiler. To eliminate this concern, a protector has been added onto the side spoiler to prevent the vibration.

3. Attach the High-Density Urethane Pad to the rear side spoiler.

a. Cut the High-Density Urethane Pad to make a 50 x 5 mm pad.

b. Remove grease from the pad attachment area and then attach the pad to (A) indicated in the image

NOTE: The pad must be attached on the flat surface, right next to the curved surface.
