Technical Service Bulletin

Subject: A CREAKING NOISE OCCURS NEAR THE DOOR WHILE DRIVING	Bulletin No.: 09-021/25
	Last Issued : 04/23/2025

2024-2025 CX-90
2025 CX-70

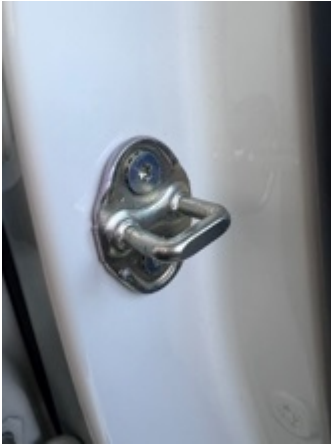
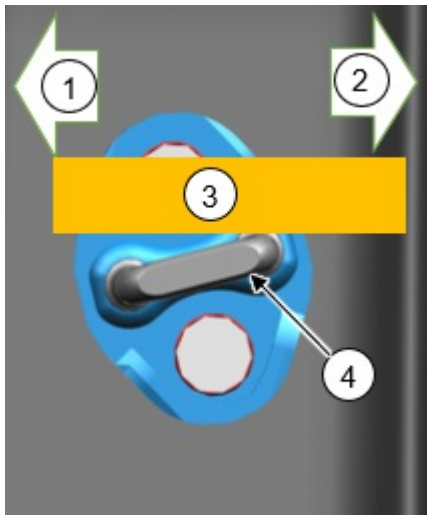
Adjust the staple position of the striker

To measure the tilt, place the scale horizontally

- (1) Inner side
- (2) Outer side
- (3) Scale
- (4) Staple

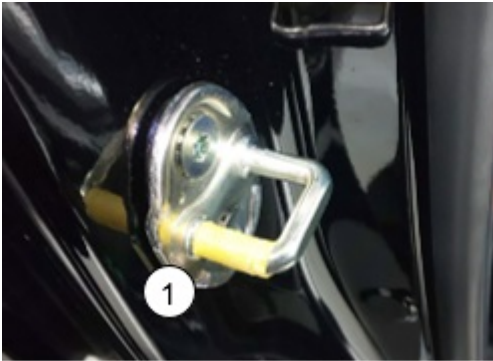
Wrap tape around the striker.

(1) Masking tape

Wrap masking tape around the engagement point of the striker, wrapping the tape around the striker to increase its diameter by approximately 0.04 inch (1 mm). For example, assuming a tape thickness of 0.1 mm, wrap around 5 to 6 times.
