SIB 17 01 25

## DELIVERY STOP: ELECTRIC DRIVE UNIT COOLANT CONNECTION

E-Series	Model Description	Production Date
G60	i5 Sedan	January 16, 2025 – February 17, 2025

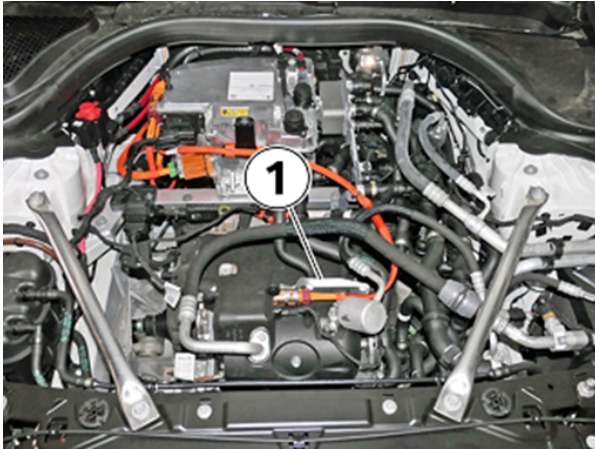
The coolant hose is located on the front of the electric motor behind the electric AC compressor (EKK) (1).

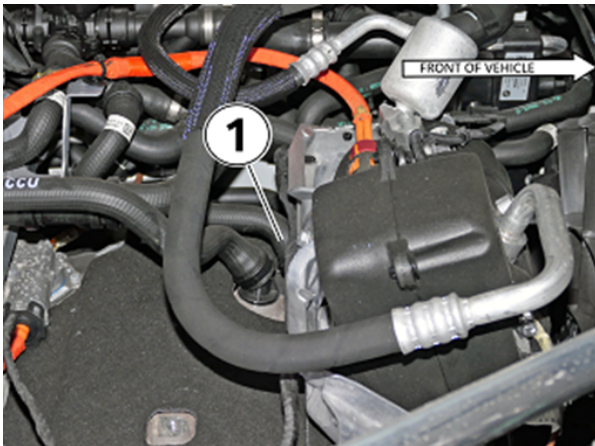
The coolant hose which runs from the combined charging unit (CCU) to the front electric motor's housing may develop a leak at the motor end of the hose.

Manufacturing flashing on the plastic fitting at the electric drive could prevent proper sealing of the coolant hose.

The coolant hose that requires inspection is the lower hos on the motor (1)

**The coolant hose must be replaced if there is any indication of a coolant leak.**

Reference Repair Instruction **1712702** “**Removing and installing coolant hose, electric drive unit, front axle - electric drive unit, rear axle**”.

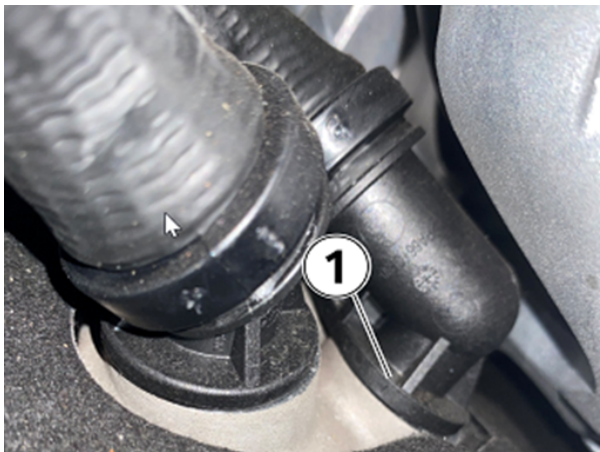
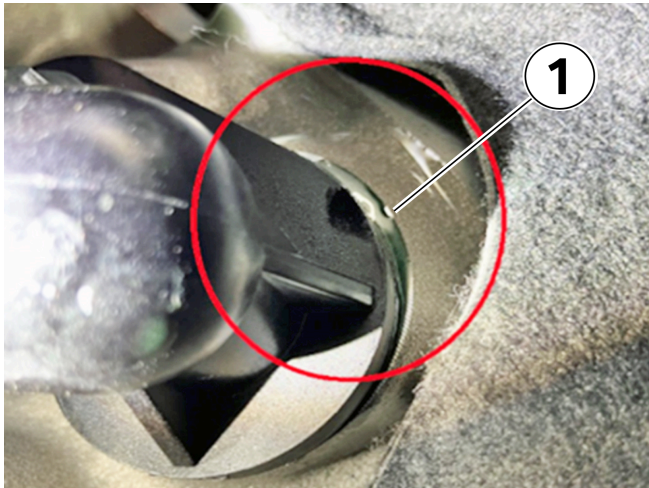
Closer view of coolant hose that requires inspection is the lower hos on the motor (1)

3. With the test plan running (coolant pumps running), use an ultraviolet leak detection light to inspect for coolant leaking around the coolant line connection in the electric motor (1).
