# Service Bulletin

Bulletin No.: 23-NA-074

**Subject: Service Engine Soon (SES), Reduced Power, Service Brake, Reduced Steering and/or StabiliTrak Message Illuminated on Driver Information Center (DIC), DTCs P0232, P023F, P0641, P0651, P06A3, P0697, P07BE, P1000, P1009, P2535, P129D, P12A6, P12A8, P2635, P3051, P3052, P3055, P3056, P305B, U0074, U0077, U0121, U0131, U0151, U0415, U0420, U0672, U111A, U18A2, U18C6, U18D2, U2502, U2616, P07BF, P176C Set**

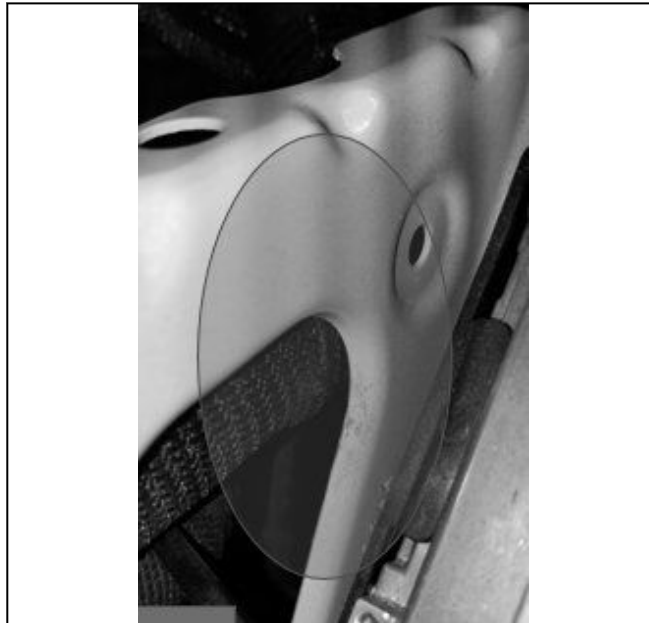
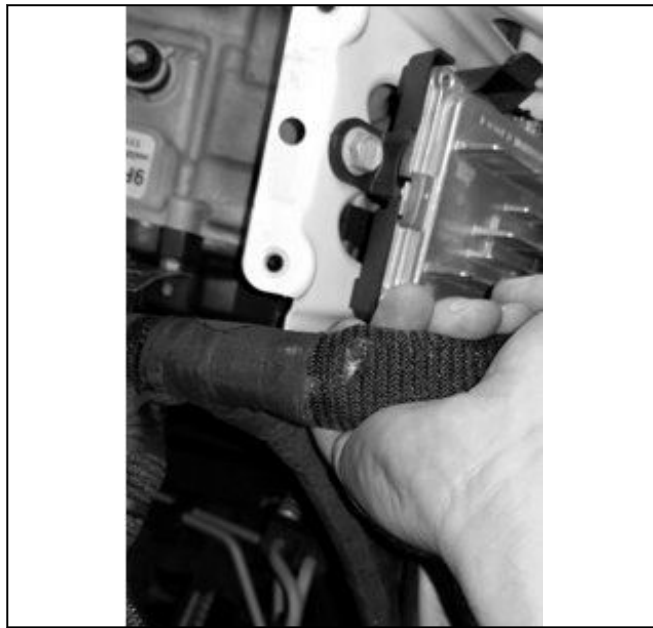
5874840

This condition may be caused by wire chafing on the battery tray support bracket.

1. Cut 76 mm (3") long strips of deadener and wrap around the edges on the battery tray bracket, as shown in the picture above.
