# Service Bulletin

Bulletin No.: 23-NA-157  
Date: April, 2025

**Subject:** HPCM2 Software Update for DTC U3620–U362E and U3630–U3636

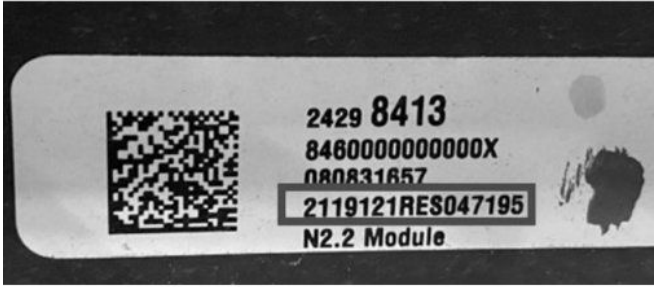
| Condition | <p>Some customers may comment on a Malfunction Indicator Lamp (MIL) illuminated in the Driver Information Center (DIC), a Reduced Propulsion message, and charging limited to 30% State of Charge (SOC).</p> <p>Technicians may find DTC U3620, U3622, U3624, U3626, U3628, U362A, U362C, U362E, U3630, U3632, U3634 or U3636 set current or in recent history.</p> |
| Cause | <p>The cause of the condition may be battery cell faults or a software anomaly.</p> <p>There are some scenarios that may induce a DTC without a true battery cell issue.</p> |
| Correction | <p><b>Important:</b> It is crucial to use the High Voltage Battery identification Number (BIN) label number to determine if the vehicle requires a HV battery replacement per the instructions below. Example shown is a BIN label with pre-breakpoint battery that would require replacement:</p> <div></div> <p>Updated Hybrid Powertrain Control Module (HPCM2) software released September 26, 2024, has been developed to repair a DTC false failure.</p> <p>1. Verify the battery pack BIN indicates the battery pack is eligible for a calibration-only repair:</p> <ul style="list-style-type: none"><li>BIN xx21244RESxxxxxx and prior (BIN may display 'SNT' instead of 'RES') – you must replace battery pack and then program the HPCM2 following published Si procedures</li></ul> |

| | <ul style="list-style-type: none"> <li>• BIN xx21245RESxxxxxx and later (BIN may display 'SNT' instead of 'RES') – proceed with next step</li> </ul> <p>2. Program the HPCM2.</p> <ul style="list-style-type: none"> <li>• If the same calibration (or later than 9-26-24) is already present, proceed with normal SI diagnostics and replace the failed battery cell/row or battery pack as applicable.</li> <li>• If programming is successful, release the vehicle to the customer.</li> </ul> <p>Refer to Bulletin <b>19-NA-194</b> for GMNA battery pack ordering process and refer to Bulletin <b>18-NA-236</b> for section/row replacement.</p> |
