Service Bulletin

Bulletin No.: 24-NA-028

Subject: Power Tonneau Cover Diagnostic Tips

Brand:	Model:	Model Year:		VIN:		Engine:	Transmission:
		from	to	from	to		
GMC	HUMMER EV Pickup	2022	2025	—	—	All	All

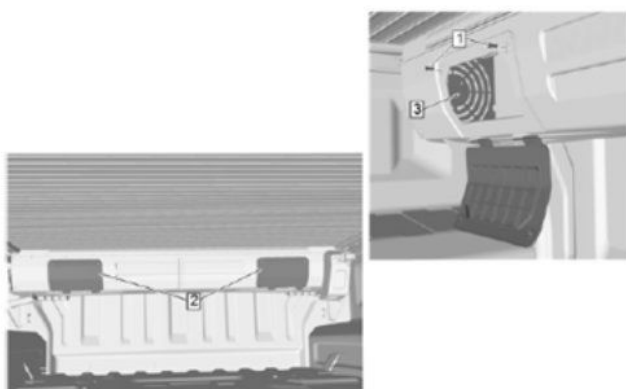
6540968

- Tonneau cover will make more noises during electric operation, especially in cold weather, compared to manual inspection. If noise is combined with noticeable binding, lubricate tracks and drum springs with silicon spray.

- Keep side rail tracks clean and apply silicon spray as needed.
- Add silicon spray to drum springs as directing in the owner's manual or SI DOC 6152455.

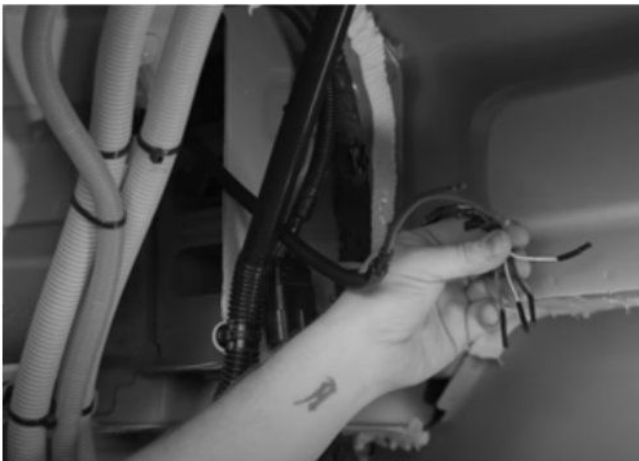
6540970

Showing the location of 4 wires in the main body wire harness that must be connected to the power tonneau cover asm. Inspect the wire-to-wire splice connectors for proper sealing and crimping.
