04/15/2025
CAL FTL 54-036_Revised

Subject: New Cascadia BCA Electrical Connection Inspection

Make: Freightliner

Model: New Cascadia

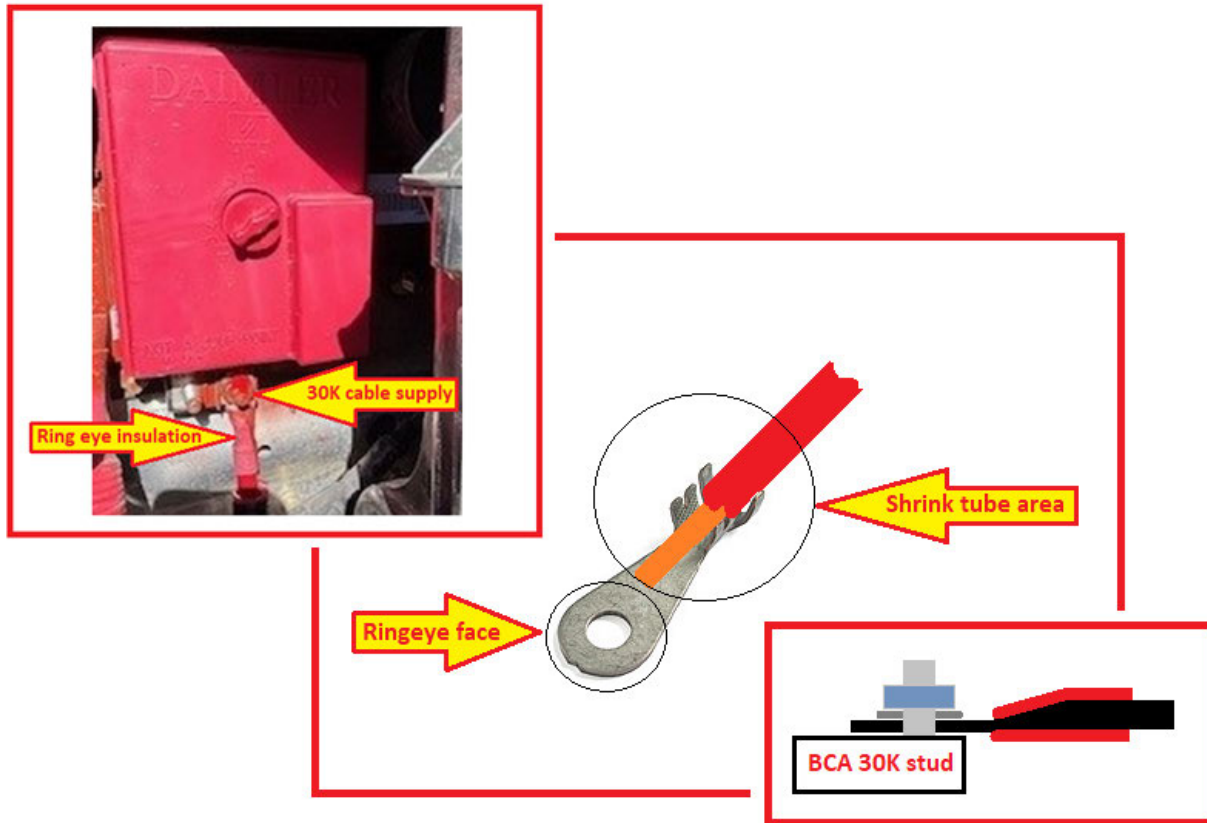
Battery Cable Access (BCA) Inspection	Comments
Identify and note in comments which stud the BCA 30K supply cable is attached to. Remove BCA 30K supply cable and inspect. Neither the heat shrink nor the sealant shall encroach upon the working surface of the terminal. Terminal Insulation spec 4.2.6.4. Trim ring eye heat shrink if interference exists between ring eye and mounting washer or bus bar. See Fig.1	
Inspect the bus bar for damage. See Fig. 2.

Fig. 1, BCA 30K Cable Location. No Shrink Tube Between Ring Eye and Mounting Washer and Terminal Insulation (heat shrink) spec.

- 4.2.6.1 Apply heat shrinkable tubing when required by the assembly drawing or when required by the ring terminal or splice specification. A nominal diameter tubing may be referenced, but the supplier must utilize the appropriate size to meet the requirements of this document and supplier processes. Harness supplier must send notification to DTNA engineering when heat shrinkable tubing is used which is different than that specified in the harness bill of material.
- 4.2.6.2 The tubing must completely cover the cable strands protruding from the core crimp wings and extend beyond the insulation crimp wings.
- 4.2.6.3 The tubing must completely collapse to encompass the terminal and the insulation diameter.
- 4.2.6.4 Neither the tubing nor the sealant shall encroach upon the working surface of the terminal.

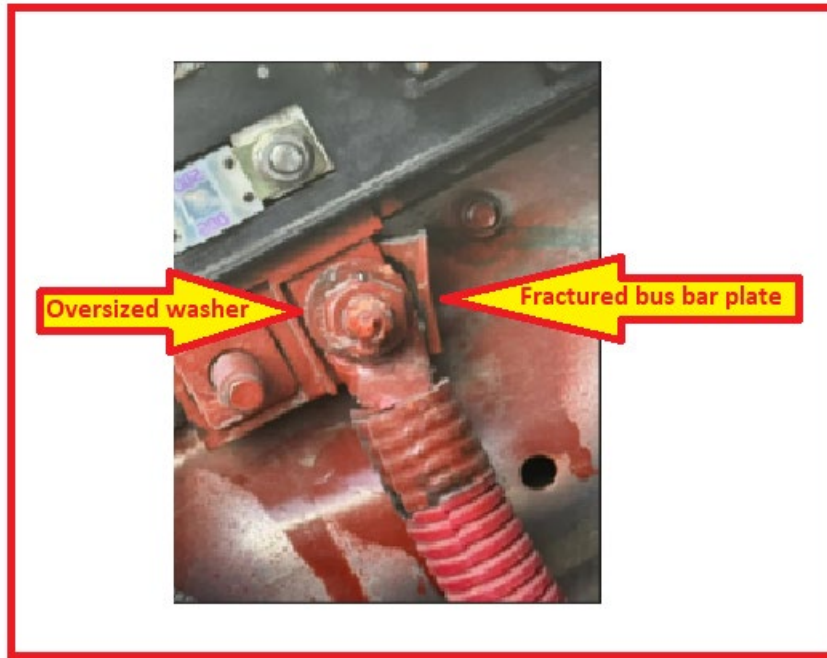
Fig. 2, 30K Cable Inspection At BCA

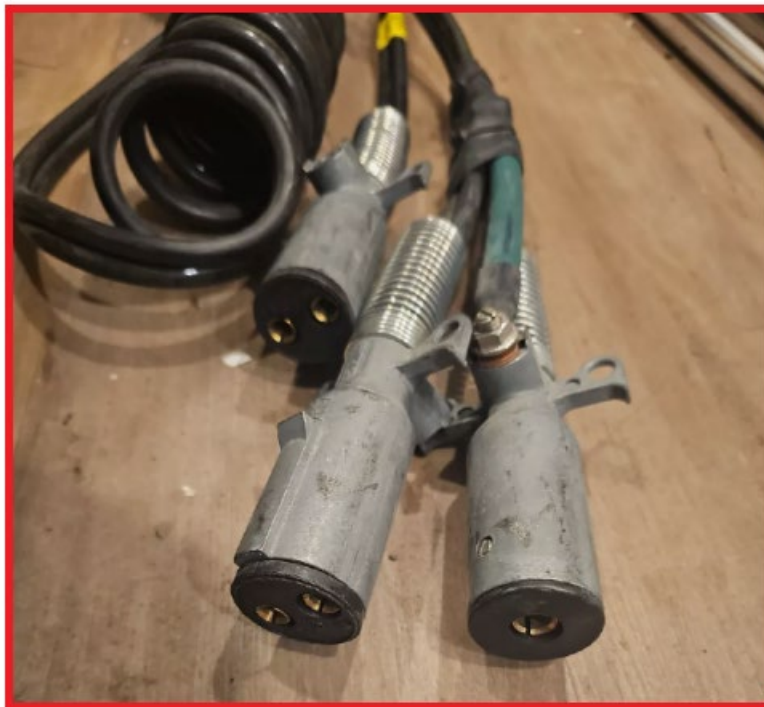
Fig. 9, PHM 23 2630 Cable Assembly

<p>Locate and identify the 30L cable that connects the tractor to the trailer. See Fig. 9.</p>	
<p>Inspect the 30L cable for any corrosion, chafing, or separation, at both the single and dual pin connector. Inspect the ground cable to ensure it is secure on the single pin connector and there is no corrosion, chafing or separation. Replace 30L cable if corrosion, chafing, or separation is present at either the connectors or the ground cable. See Fig. 10.</p>
