SS 3172-FTL Tire Pressure Monitoring System (TPMS) Water Intrusion Through Perimeter Seal

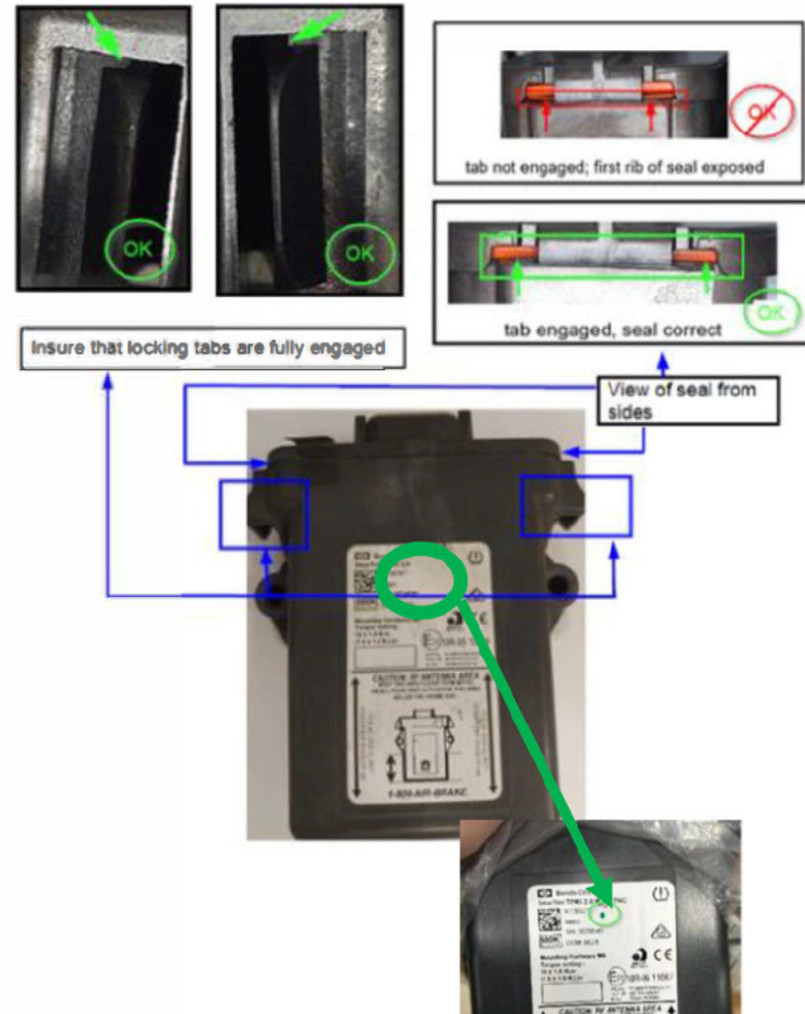
The updated improvement to the perimeter seal requires more force to fully seat the perimeter seal and latch the front cover of the TPMS to the housing. Failure to fully latch the cover to the housing can result in water intrusion into the TPMS module.

If encountering either of the symptoms listed above, and it is determined that the TPMS module is the cause, upon replacing the module inspect the TPMS module to see if the front cover latches are fully engaged and inspect the perimeter seal to see if any of the ribs from the seal can be seen, reference figure 1. If either front cover latch is found to not be fully engaged, and or the perimeter seal is showing a single rib or multiple ribs exposed, then if the vehicle is still under warranty, and warranty claim is being submitted, make sure to include this solution number in the claim.
