SS 784-WST ICC5 Erroneous Electric Power Steering Warning Message

X Series Western Star vehicles with optional ICC5

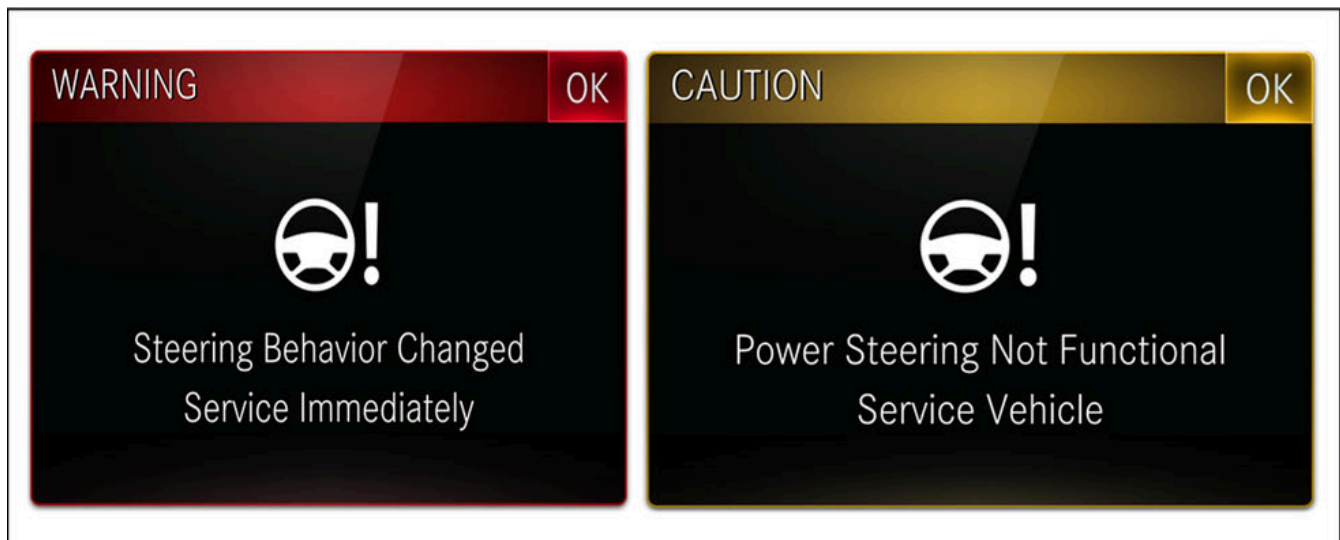
On diesel powered vehicles with a particular variant of Instrument Cluster, ICC5, two messages relating to electric vehicle malfunctions may erroneously appear. These are nuisance messages only and do not indicate actual fault conditions.

For vehicles built up to model year 2023 either of the warning messages pictured in Figure 1 could be displayed. The red message "Steering Behavior Changed Service Immediately" was never intended to show up on any of these vehicles.

For all vehicles with the ICC5 built after model year 2023 only the warning message in the amber color "Power Steering Not Functional Service Vehicle" could be displayed.

In both groups mentioned above, the warning messages were never intended to be displayed on the ICC5 for X-Series Western Star Vehicles.

If the X Series Western Star vehicle encountering either of the warning messages, then use the middle button on the left side of the steering wheel to clear either message. Both messages should be considered nuisance messages as neither apply to the X Series Western Star Vehicles.
