54-372 Connect 5 Instrument Cluster (ICC5) Nuisance Fault Code

TSB-54-372-FTL

Creation Date: 2025-02-04
Last Revision Date: 2025-04-01

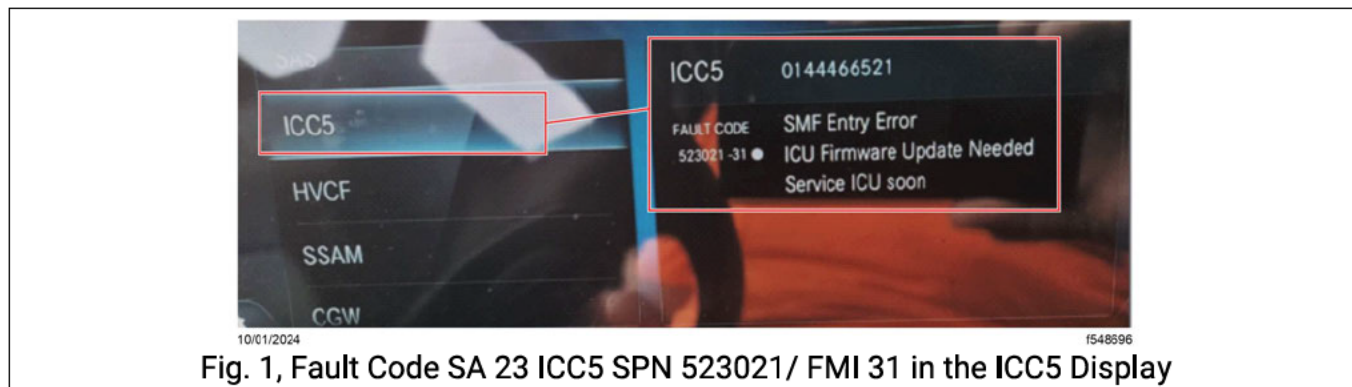
Vehicles equipped with a Connect 5 Instrument Cluster (ICC5) and ordered with the software package identified by sales codes 81Z-008, 81Z-308, or 81Z-808 (related to model year 2023 or software version 22.50.30) may display the fault code 'SA 23 ICC5 SPN 523021/ FMI 31 - The list of Electronic Control Units (ECUs) in the Warning Database (WDB) does not match the list of ECUs parameterized in PID 0x20.' This is considered a nuisance code and does not require any troubleshooting or programming changes.

Figure 1 shows what the fault code 'SA 23 ICC5 SPN 523021/ FMI 31' looks like on the ICC5 display.
