GENERAL MOTORS  
DCS7210  
URGENT - DISTRIBUTE IMMEDIATELY

Subject: REVISION: N242468490-01 - Service Update  
Missing Chassis Harness Plugs  
Revised Parts Table

Models: 2024 – 2025 Chevrolet Blazer EV

## N242468490 Missing Chassis Harness Plugs

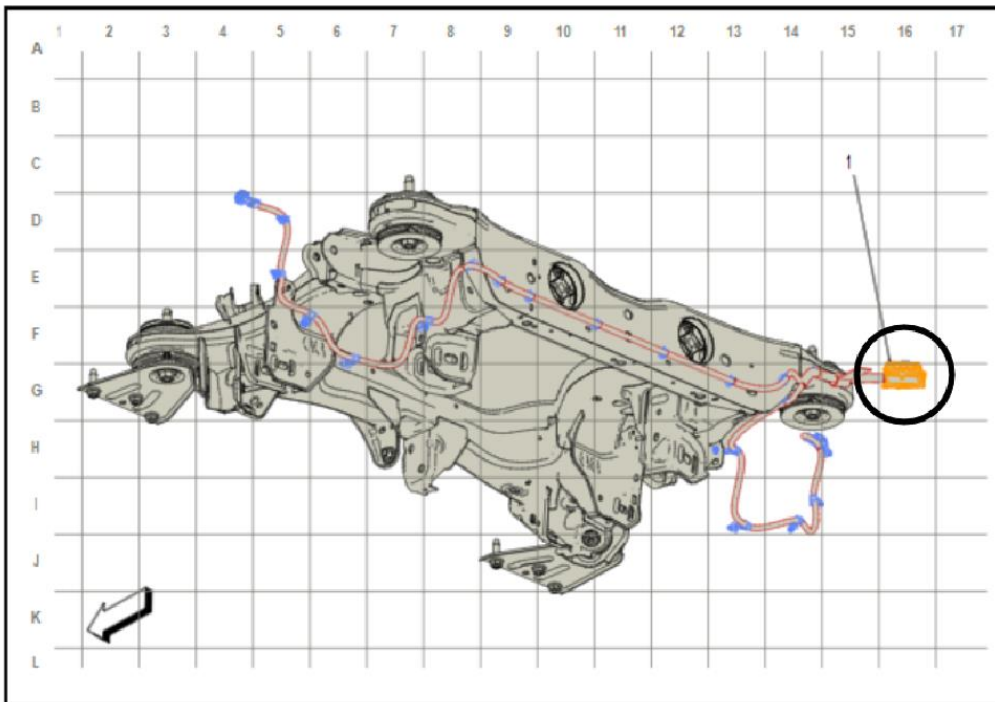
6778757

(1) X606 Body Wiring Harness to Chassis Wiring Harness

4. Locate and disconnect the X606 Body Wiring Harness to Chassis Harness Connector.
5. Verify there is no corrosion within the connector.
  - 5.1 If corrosion is found in either connector, replace the corroded terminals and thoroughly clean the connector. Refer to *X606 Body Wiring Harness to Chassis Wiring Harness* in SI for terminal location and proper tools. Refer to *Wire and Connector Repair* in SI for further instruction.
  - 5.2 If no corrosion is found: remove the plastic cover on the backside of the connector (if applicable) and proceed to the next step.

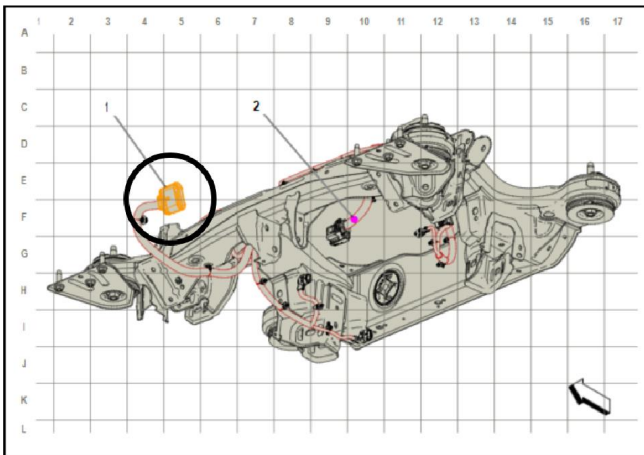
6780028

- (1) X610 Body Wiring Harness to Chassis Rear Wiring Harness (X0D / X0E)
- (2) J491 Chassis Rear Wiring Harness (X0D / X0E)

4. Locate and inspect X610 Body Wiring Harness to Chassis Rear Wiring Harness. Verify there is no corrosion within the connector.
  - 4.1 If corrosion is found at either connector, replace the corroded terminals and thoroughly clean the connector. Refer to *X610 Body Wiring Harness to Chassis Wiring Harness* in SI for terminal location and proper tools. Refer to *Wire and Connector Repair* in SI for further instruction.
  - 4.2 If no corrosion is found, clean and dry the connector and proceed to the next step.

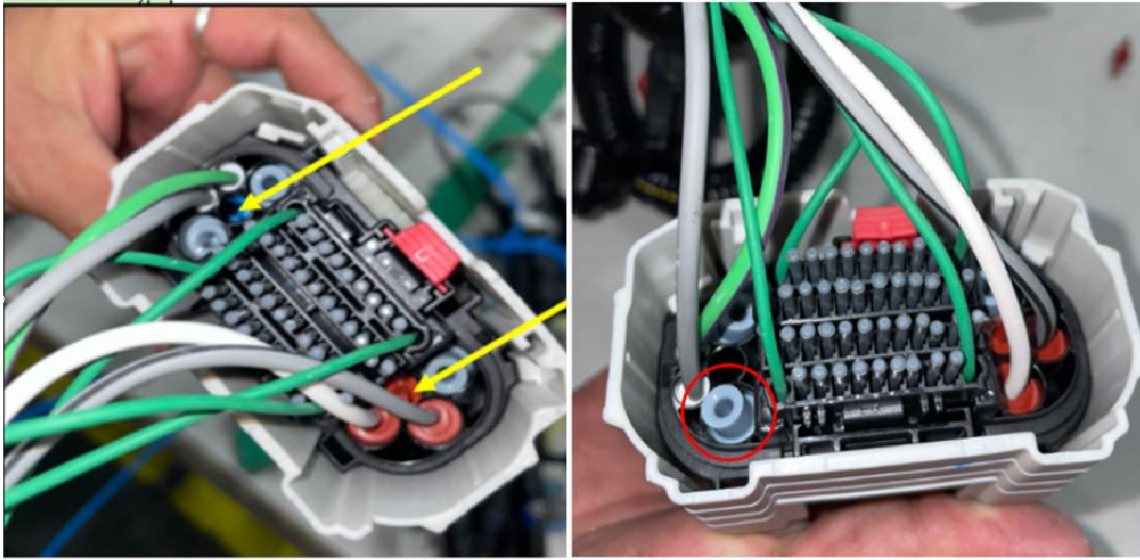
6781647

5. Inspect ALL blue and red cavity plugs to ensure they are seated flush and centered within the connector body.

5.1 If any of the cavity plugs **PROTRUDE** as indicated in the image above, use a small round or flat bladed tool to insert them correctly into the connector. Ensure the cavity plug seats flush and centered within the connector.
