## Check engine light with reduced power with fault codes P300A6D, P300974, P300DFB, or P300DE8

| Topic number | LI09.40-N-079144 |
| Function group | 09.40 - Turbocharger |
| Validity | Model 907 with OM654 |

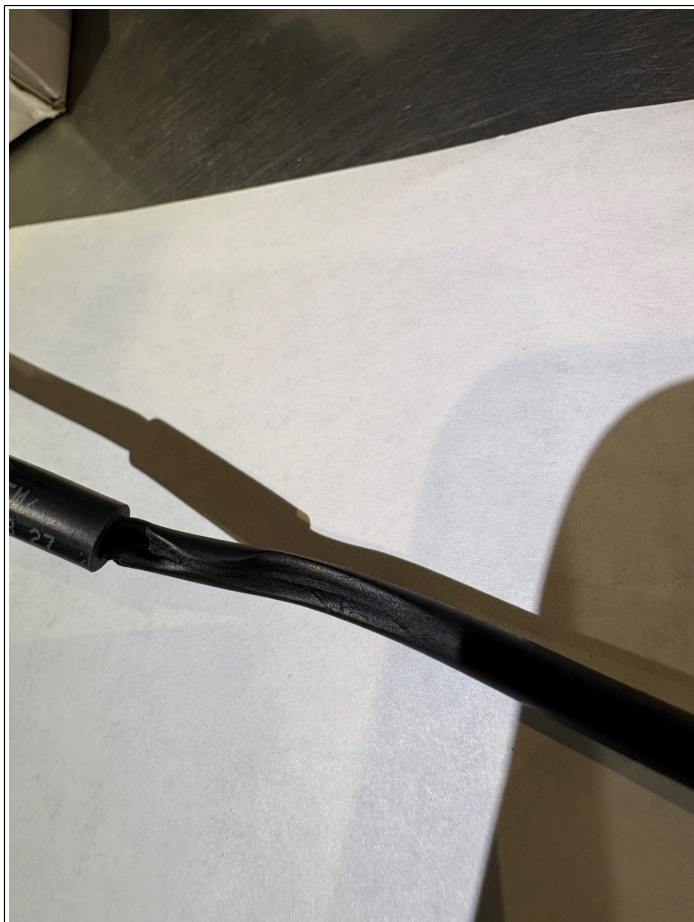
| Attachments | |
|--|--|
| <a href="#">Melted line.jpg</a> | Vacuum Line melted under Low Pressure EGR Cooler |

- Check the vacuum at all vacuum components (such as the Wastegate and Boost Pressure Control Y77, Y100/2) while driving, and compare it to the source vacuum.
- Thoroughly inspect all vacuum lines and connections for signs of wear, cracks, or disconnections.
- Refer to the Attachments for the OM654 Vacuum diagram.
