EGR Valve Diagnosis and Cleaning Procedure using TU-NAP 926® on 906, 907 Sprinter with OM642 Diesel Engine

| Topic number | LI14.20-N-073867 |
| Function group | 14.20 - Exhaust gas recirculation |
| Validity | 906, 907 Sprinter with OM642 V6 Diesel Engine |

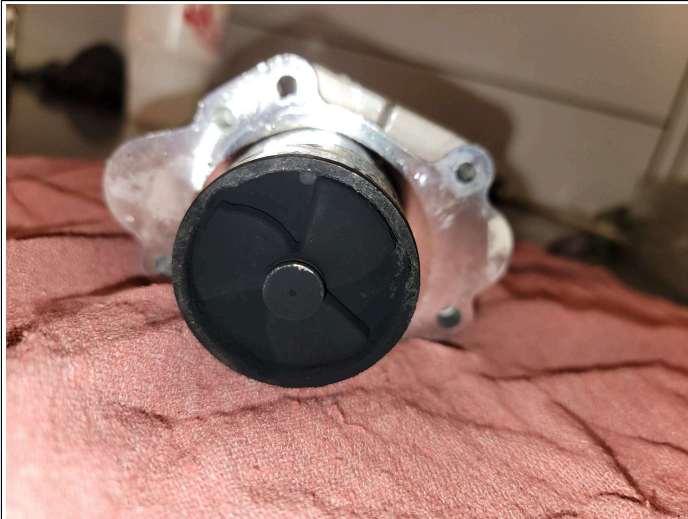
| Attachments | |
|---|---|
| <a href="#">OM642 EGR Valve before 1.jpeg</a> | Bottom of sooted EGR Valve. |

Cause of Complaint B:  
Soot deposits between the EGR Valve blade and seat leading to the EGR Valve no longer being able to meet the desired target of the EGR Valve position controller.

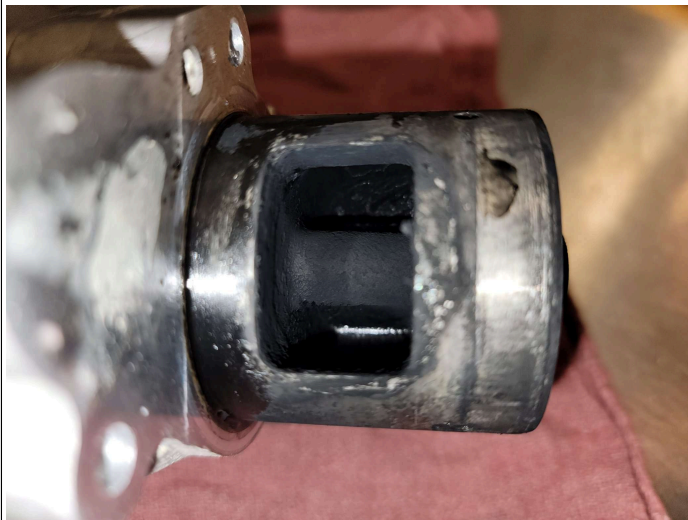
[OM642 EGR Valve before 2.jpeg](#)

Side view of sooted EGR Valve.

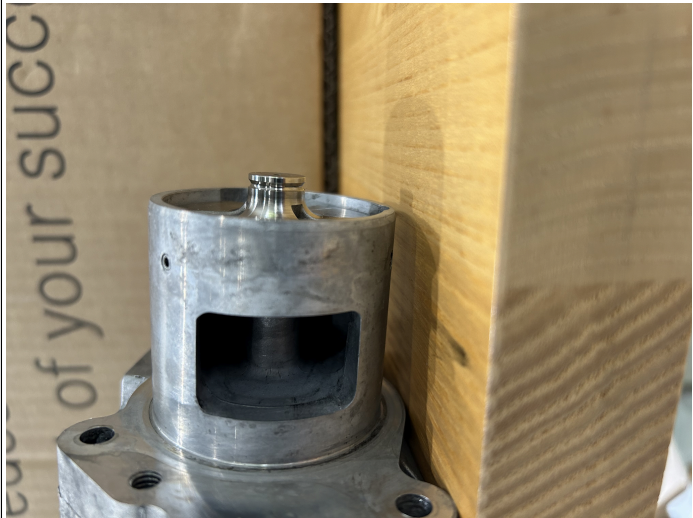
OM642 EGR After Cleaning 2.JPG

Side view of cleaned EGR Valve.

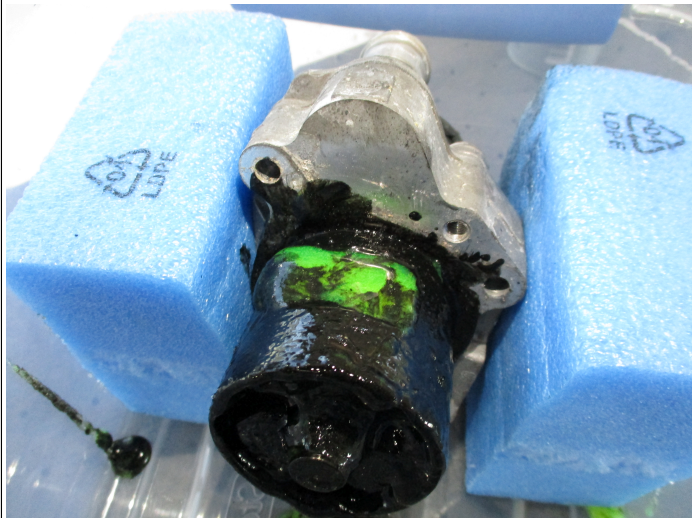
EGR Valve Cleaner Application.JPG

EGR Valve with cavity filled, and blades covered in cleaner.

2. Position EGR Valve so open cavity is facing upward. Fill the cavity with cleaner, and then proceed to apply cleaner to the blades from the outside. Additionally, apply cleaner to the outside where additional soot is found.

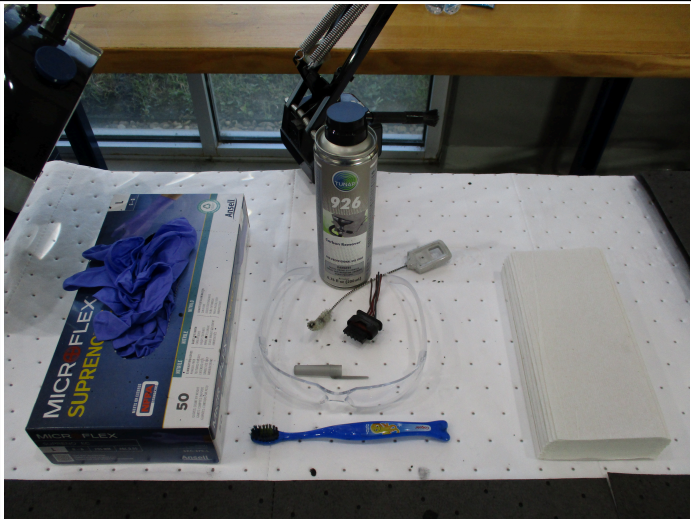
Brushes.JPG

Non-metallic soft brushes to assist in cleaning, and pen cap used to hold blades open for cleaning.

3. Allow 15 minutes for the cleaning gel to take effect.
4. Carefully brush the areas with the supplied cleaner brush or another suitable non-metallic brush with soft bristles; e.g. Kids' size toothbrush and straw cleaning brush (see picture in attachments).

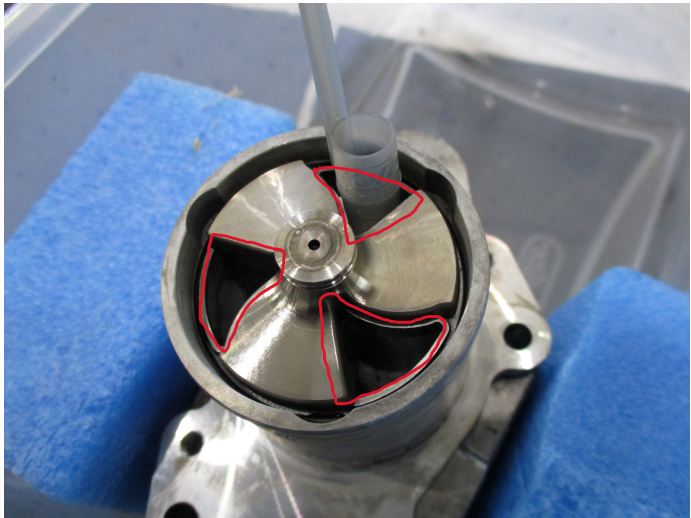
Blades Open.JPG

Hold blades open to clean using suitable non-metallic holder/wedge placed in the hole directly in front of the open cavity (i.e. pen cap) to clean blade seats.

5. Continue to clean the EGR Valve by turning the EGR Valve blades clockwise to the open position to enable cleaning the blade seat area. Hold blades in open position by placing a suitable non-metallic holder/wedge in the hole directly in front of the open cavity (see picture labeled "Blades Open" in attachments).
