SIB 65 08 25

INTERMITTENT FAILURE OF CID SIDE OF MULTIFUNCTION DISPLAY

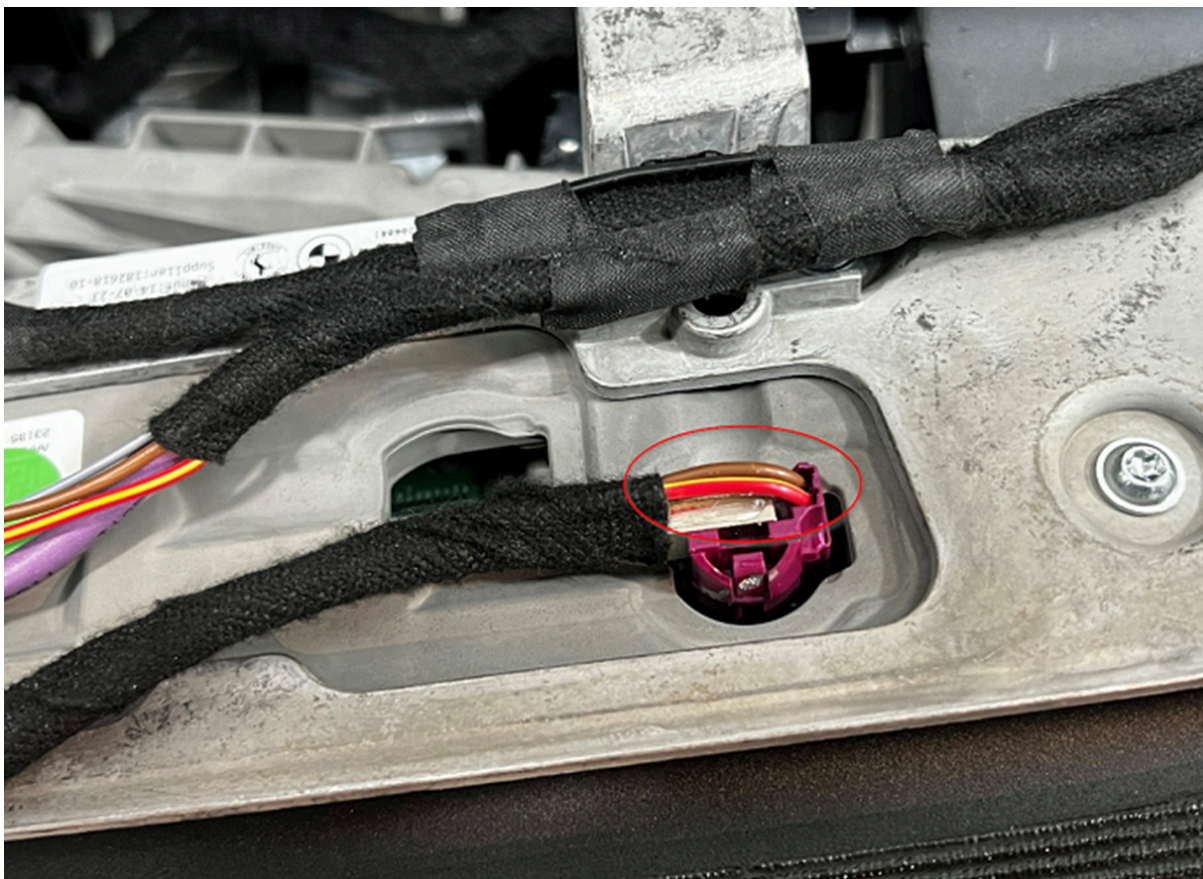
The wiring in Connector A664*1B (LVDS data line) may be under excessive tension.

1. Before carrying out a Vehicle test, access Connector A664*1B the Multifunction Display as per **Repair Instructions 65 50 210 – “Removing and installing instrument cluster”**.
2. Check the tension of the wires at pins 5 and 6 on Connector A664*1B in the location shown in the picture below
