**SIB 63 02 22****EXCESSIVE CONDENSATION IN THE HEADLIGHT(S)**

2025-04-25

This Service Information Bulletin (Revision 2) replaces SI B63 02 22 **dated September 2022**.

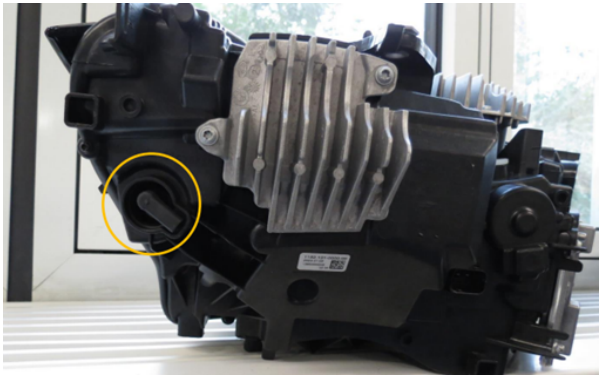
The headlight ventilation grommets may allow excessive moisture to enter the headlight.

3. Using a suitable tool, remove the outer ventilation grommets from both headlights (circled in yellow).

Replace both headlight ventilation grommets with the updated part.

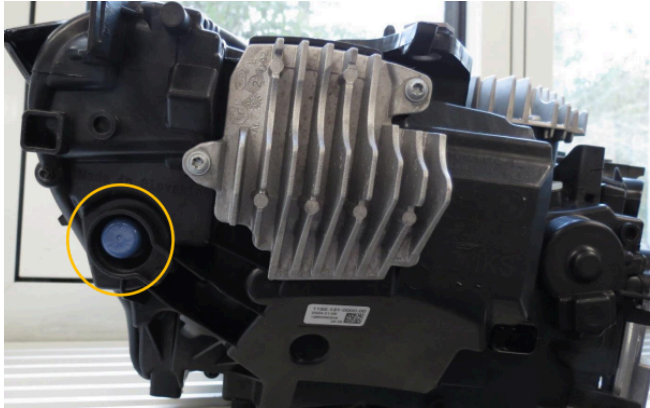
4. Install the updated plugs on both headlights (circled in yellow).

Note: Make sure to fully seat the ventilation grommet onto the headlight.
