Service Bulletin

Bulletin No.: PIE0825

Subject: Engineering Information - (EI Lite) - (Pictures ONLY) for Pre-Delivery Inspection (PDI) and Customer Vehicle Issues Up to 500 Miles. Using the CSMT App do Field Product Reporting (FPR), Please Submit a Report for the Following Issues: Paint Issues or Damage (EXCEPT for Transportation), Moldings, Appliques, Emblems Loose, Warped, Crooked or Missing / Weatherstrips Misaligned, Mis-formed / Sheet Metal and/or Trim Panels Misaligned / Interior Trim Loose, Crooked, Missing / Seats, Seat Trim

Brand:	Model:	Model Year:		Breakpoint:		Engine:	Transmission:
		from	to	from	to		
Cadillac	VISTIQ	2026	2026	—	—	—	—

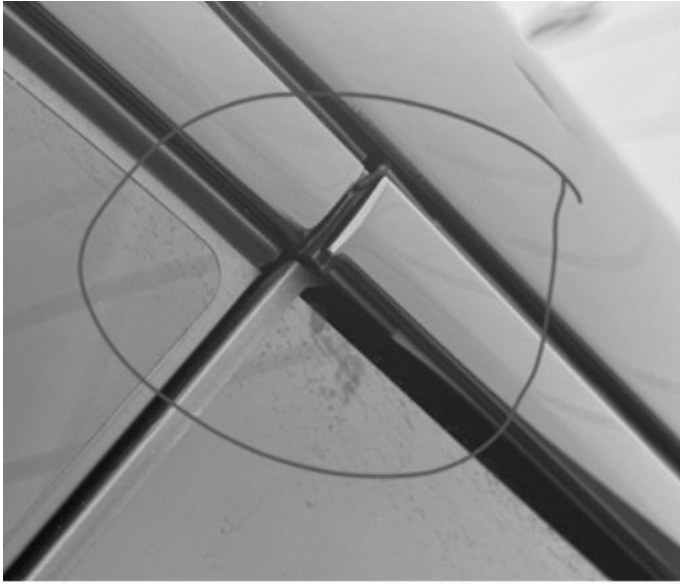
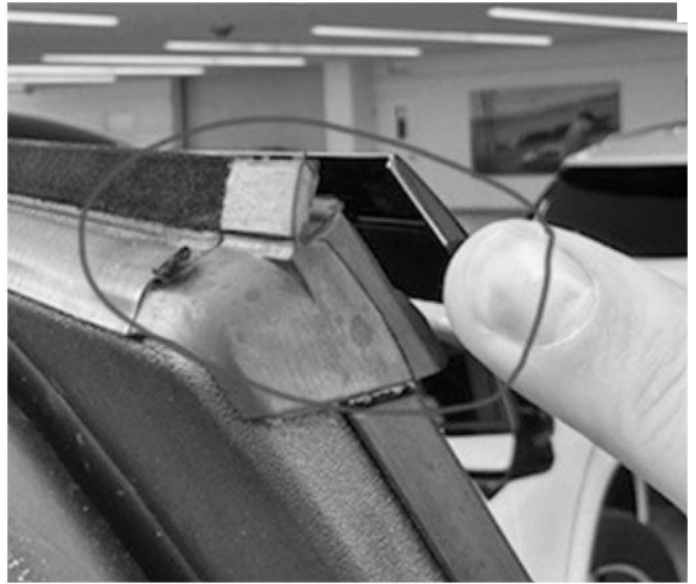
6850471

1. Shown in the picture above are examples of the entire area of the vehicle showing the location of the issue/part on the vehicle.

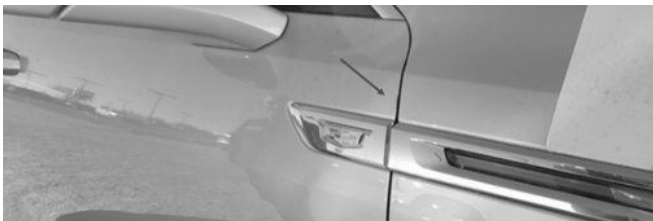
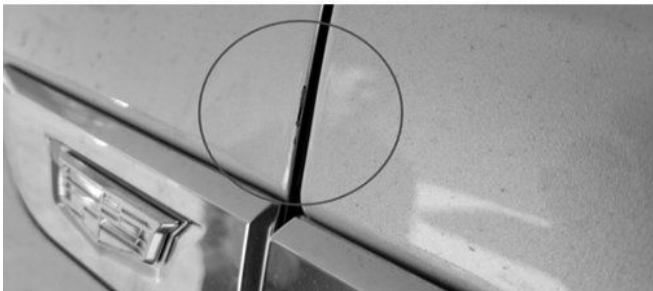
6850475

2. Shown in the pictures above are examples of clear close-up pictures to better show the detail of the issue/part.

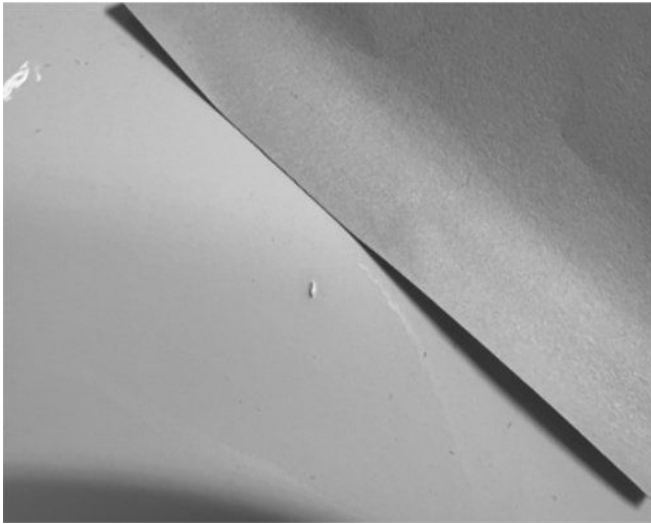
6850535

3. Shown in the pictures above are examples of paint issue. When reporting paint concerns, please take wide shot of the vehicle to help orientate the location and a close-up to identify the issue.
